Investigation of Reinforcing Steel Corrosion-Related Spalling of Balconies in Two 22-Story 1970s Highrise Buildings in an Oceanfront Environment in Luquillo, Puerto Rico

Sandy Hills
Luquillo, PR 00773

August 21, 2020
CMC 0720138

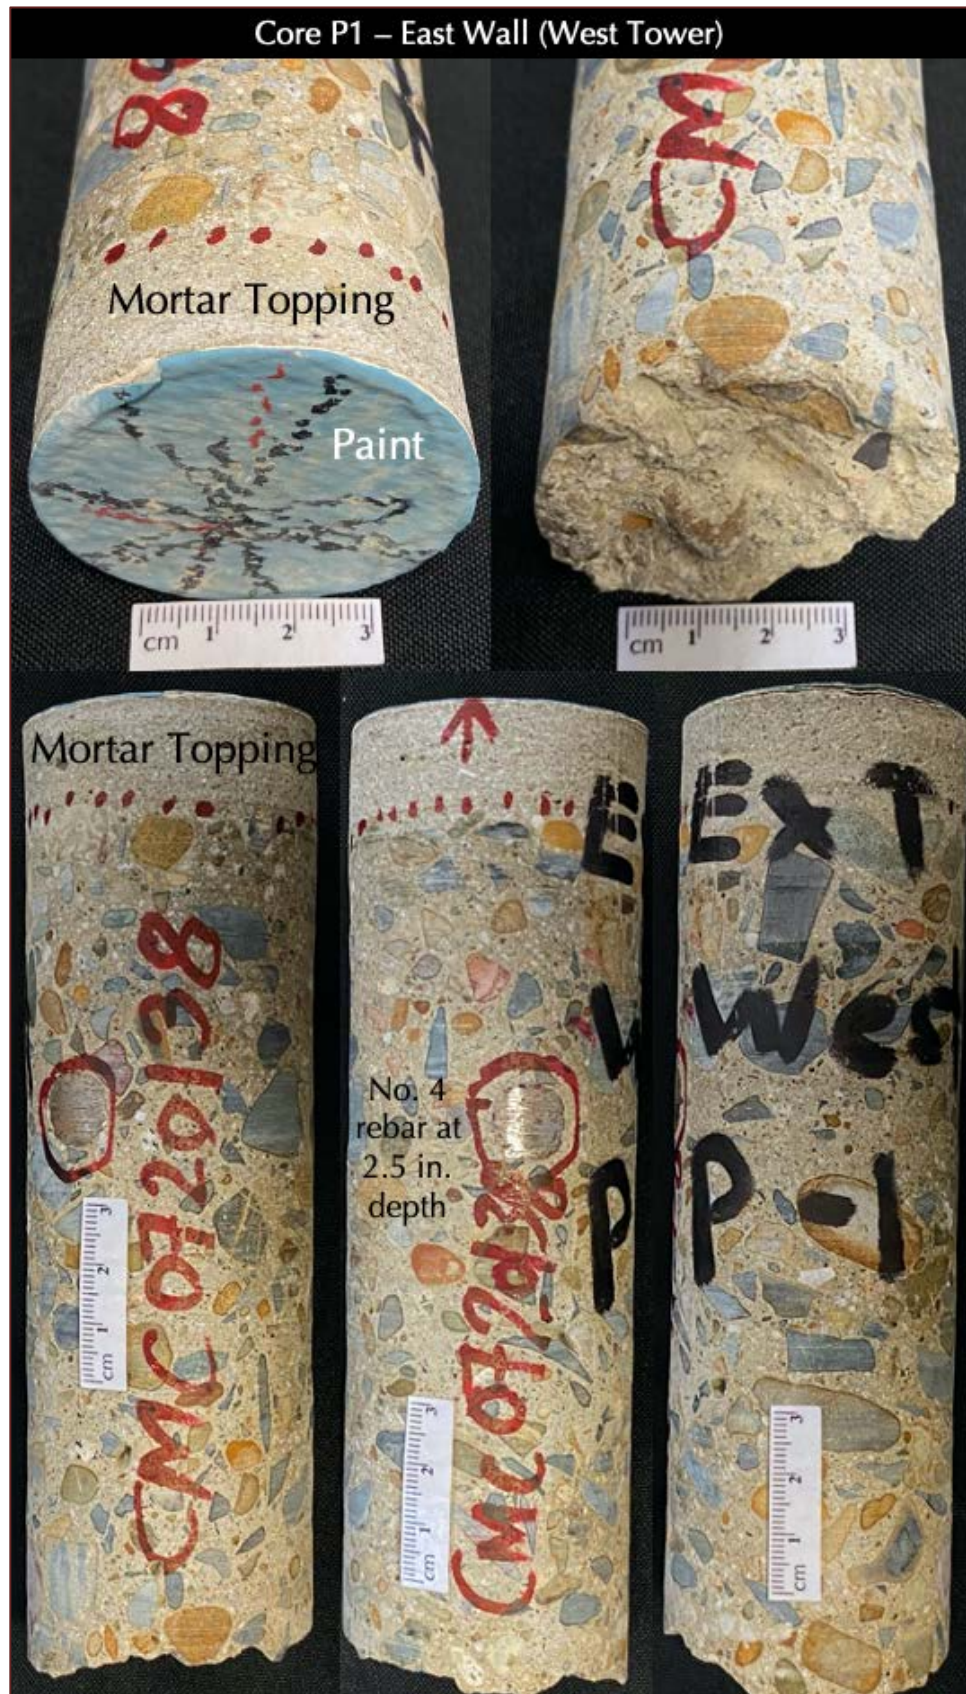
The top exposed end of Core P-1 is painted light blue, where paint is well-bonded to the concrete; the opposite end is fresh fractured. The core showed the top paint coat, followed by a 17 mm thick cementitious mortar coat, which is well-bonded to the paint coat above and to the main concrete body below.

Figure 4: Shown are the exterior painted surface (top left), interior fractured end (top right) and side cylindrical surfaces of the Core P-1 from West Wall.

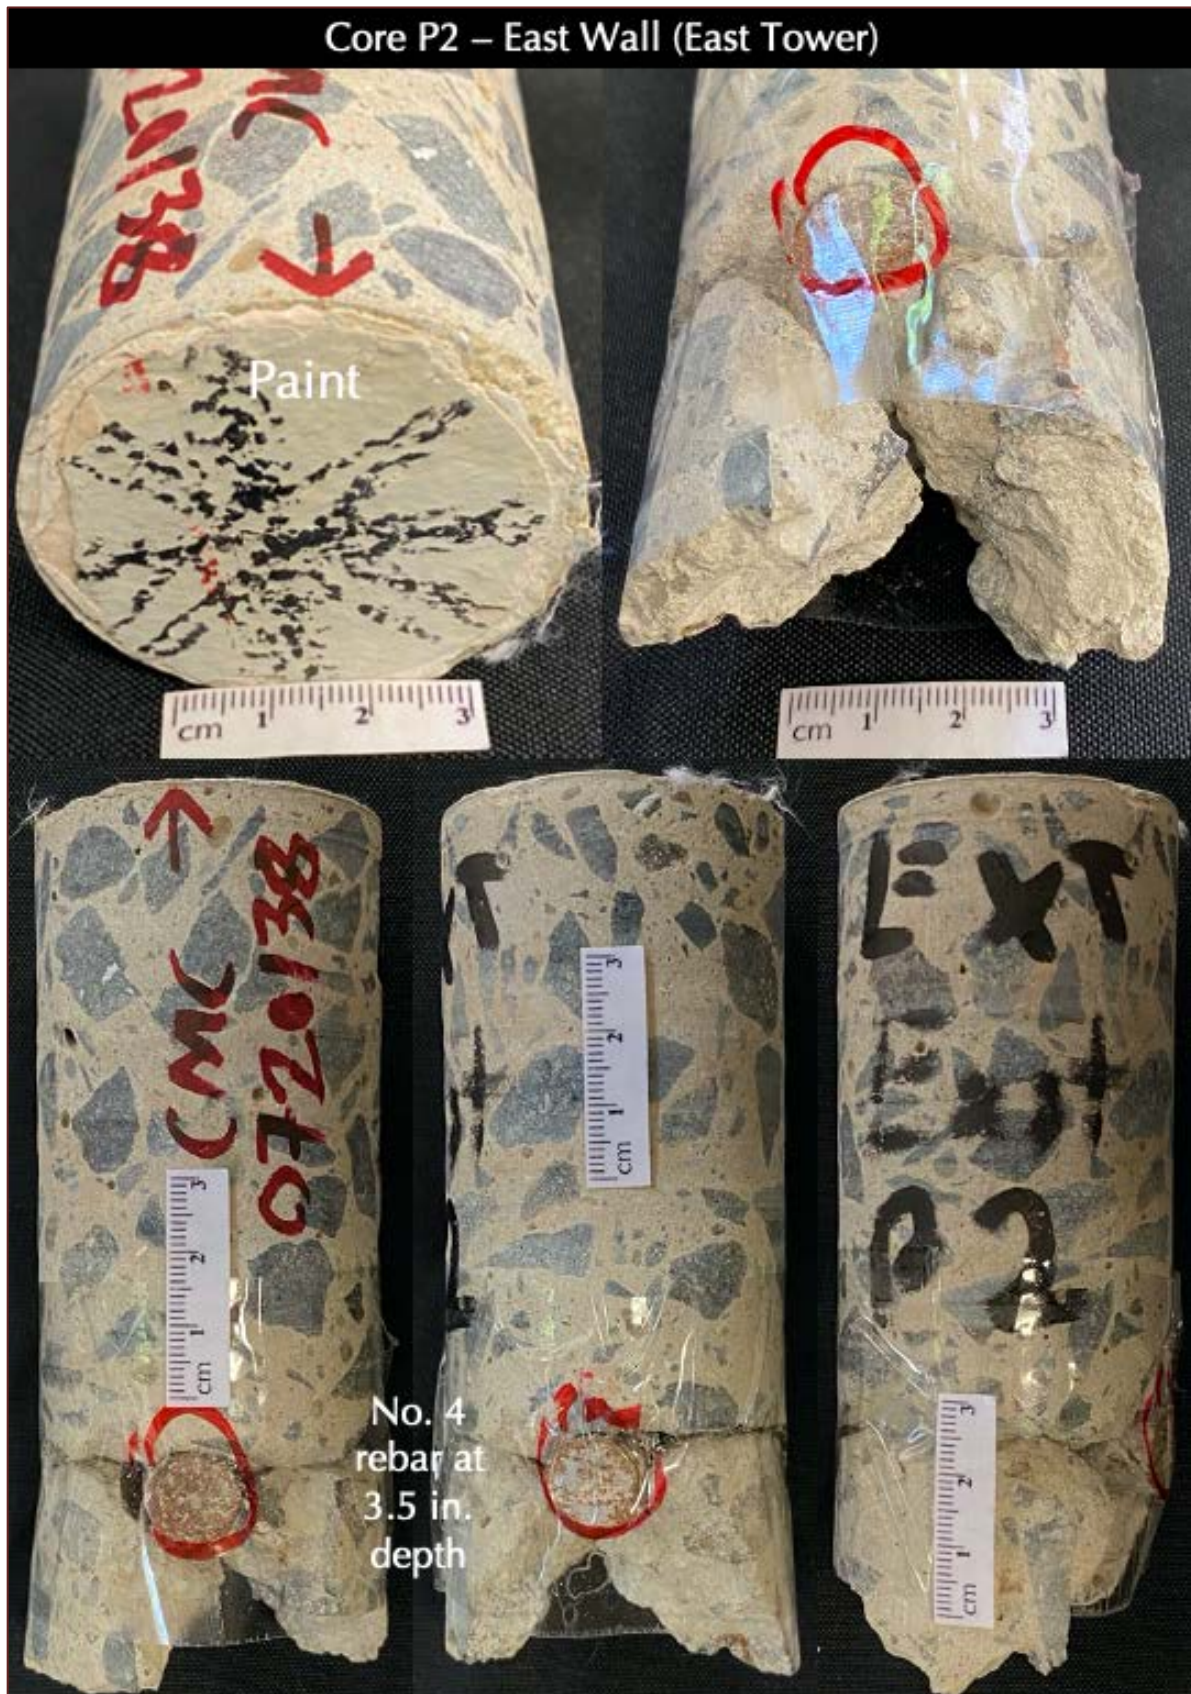
The top exposed end of Core P-2 is also painted light blue, well-bonded to concrete but the concrete in P-2 lacks a cementitious mortar coating found in P-1, the opposite end is fresh fractured.

Core P-1 is free of any visible cracks, but P-2 shows cracking and separation of a bottom 1½ in. thick portion of concrete at the No. 4 reinforcing steel situated at 3½ in. depth.

Figure 5: Shown are the exterior painted surface (top left), interior fractured end (top right) and side cylindrical surfaces of the Core P-2 from East Wall.

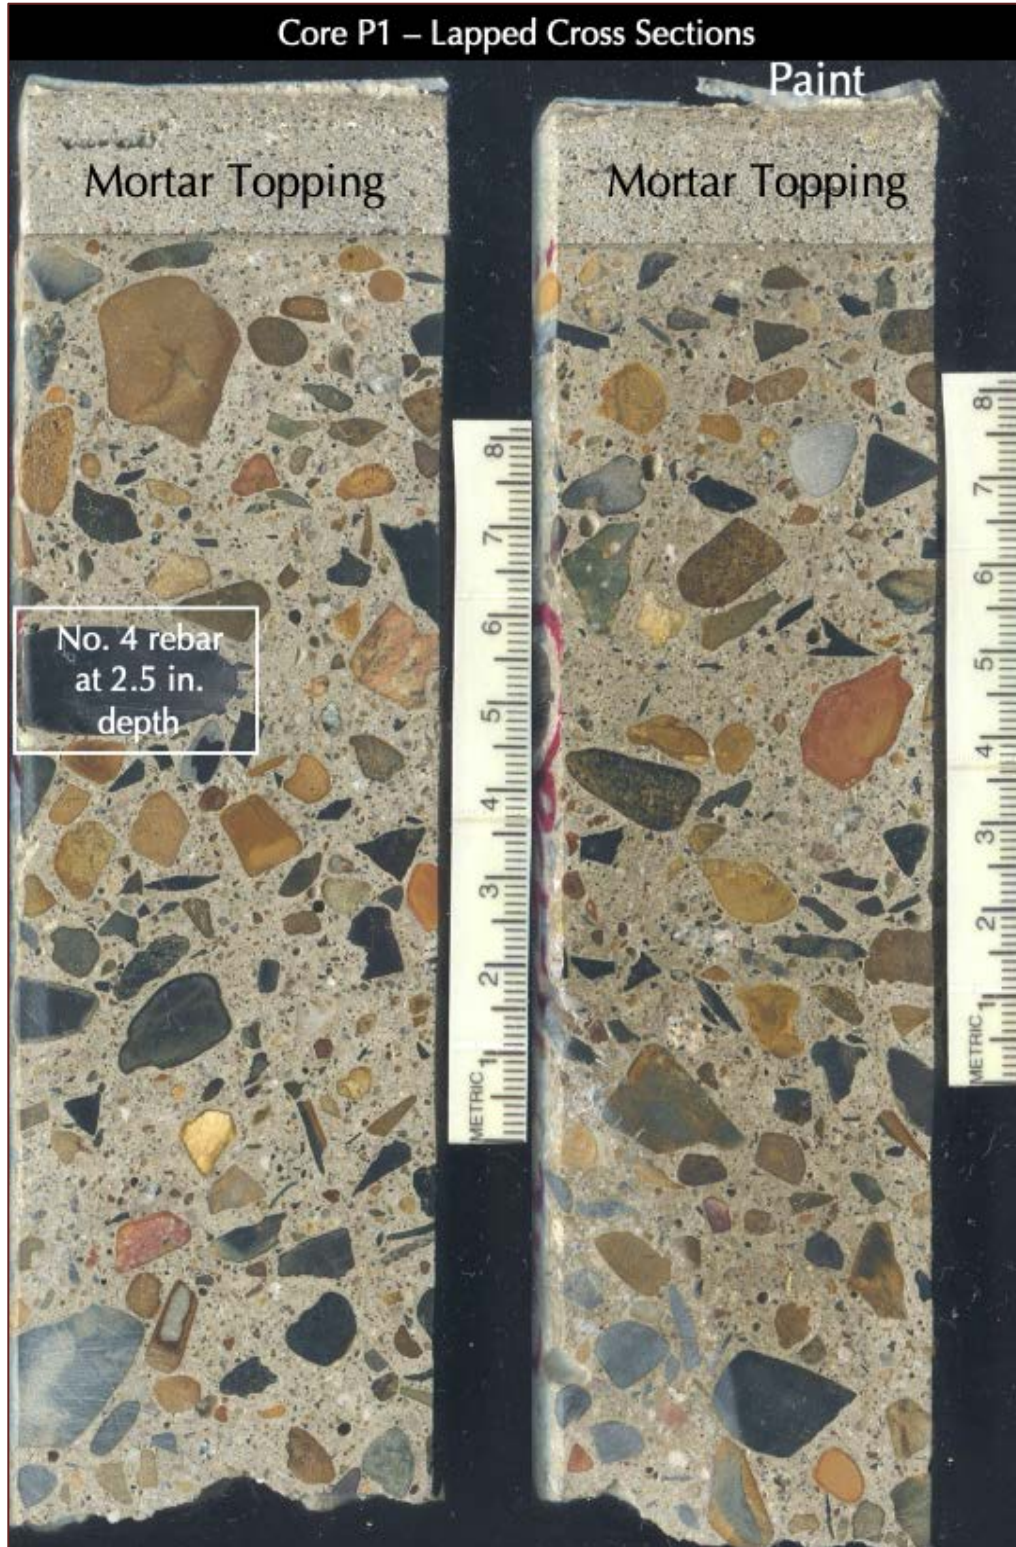
Figure 6: Two parallel lapped cross sections of Core P-1 from West Wall showing:

(a) A thin **paint coat** at the top well-bonded to mortar topping, having a nominal thickness of < 1 mm;

The mortar topping was bonded to concrete beneath when received but de-bonded during the lapping operations.

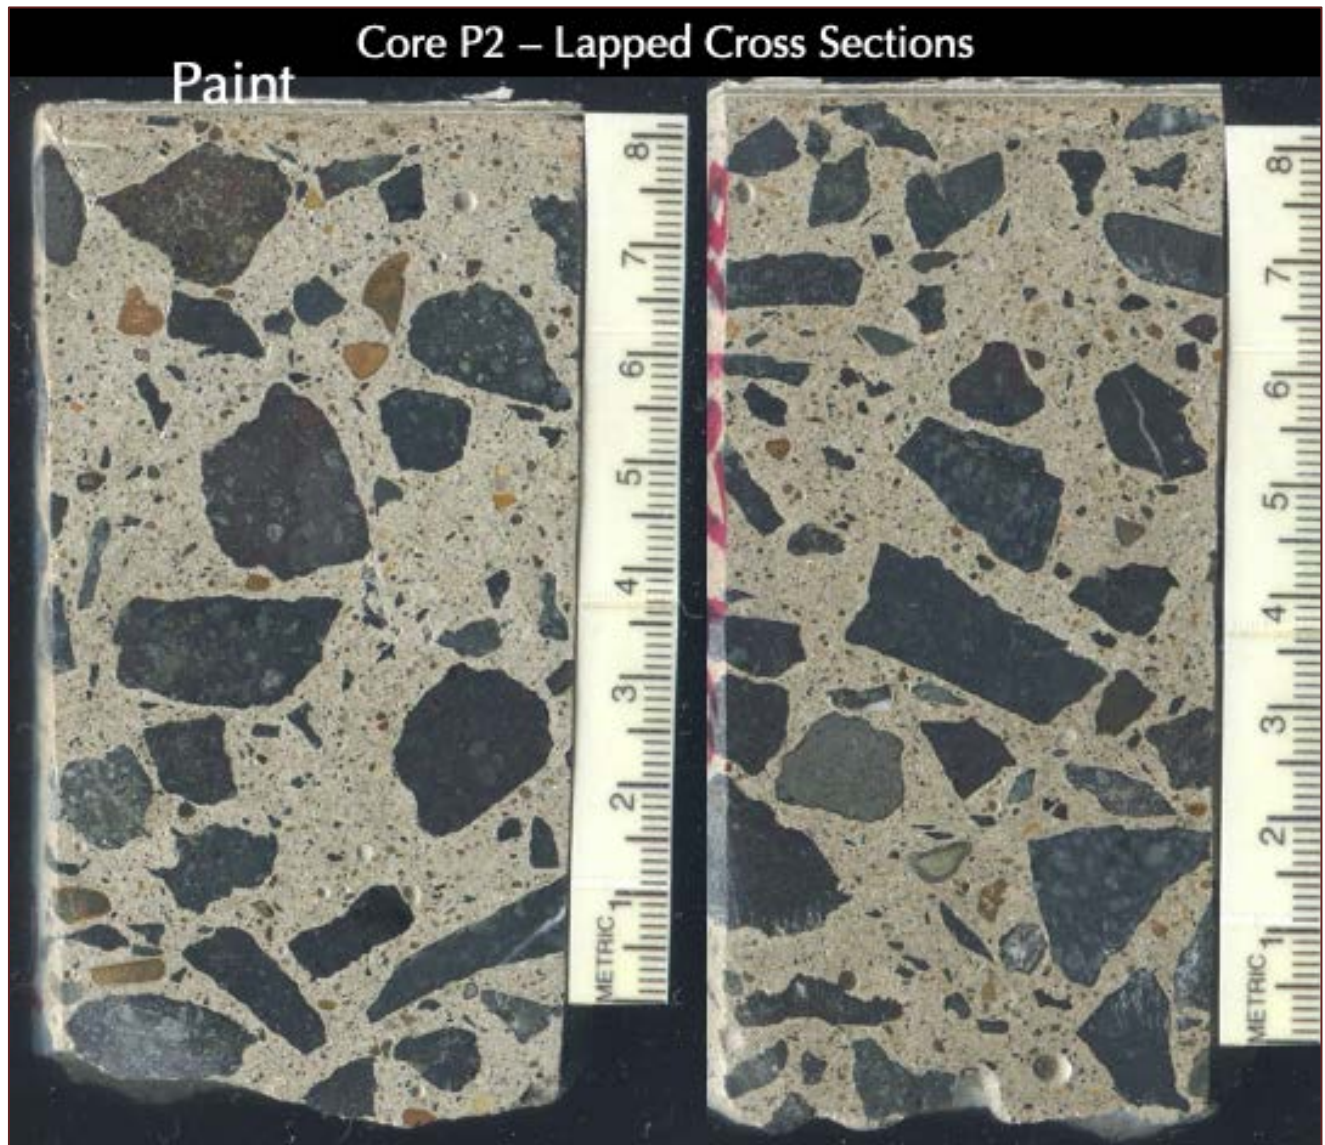
Figure 7: Two parallel lapped cross sections of Core P-2 from East Wall showing: (a) a thin paint coat at the top well-bonded to concrete; (b) no repair coat mortar topping found in the Core P- 1 from West; (c) good grading and well-distribution of the crushed stone coarse aggregate which is very different from the crushed gravel coarse aggregate found in Core P-1 from West, and siliceous sand fine aggregate particles; and (d) the overall sound, dense, well-consolidated nature of the concrete in the body of the core.

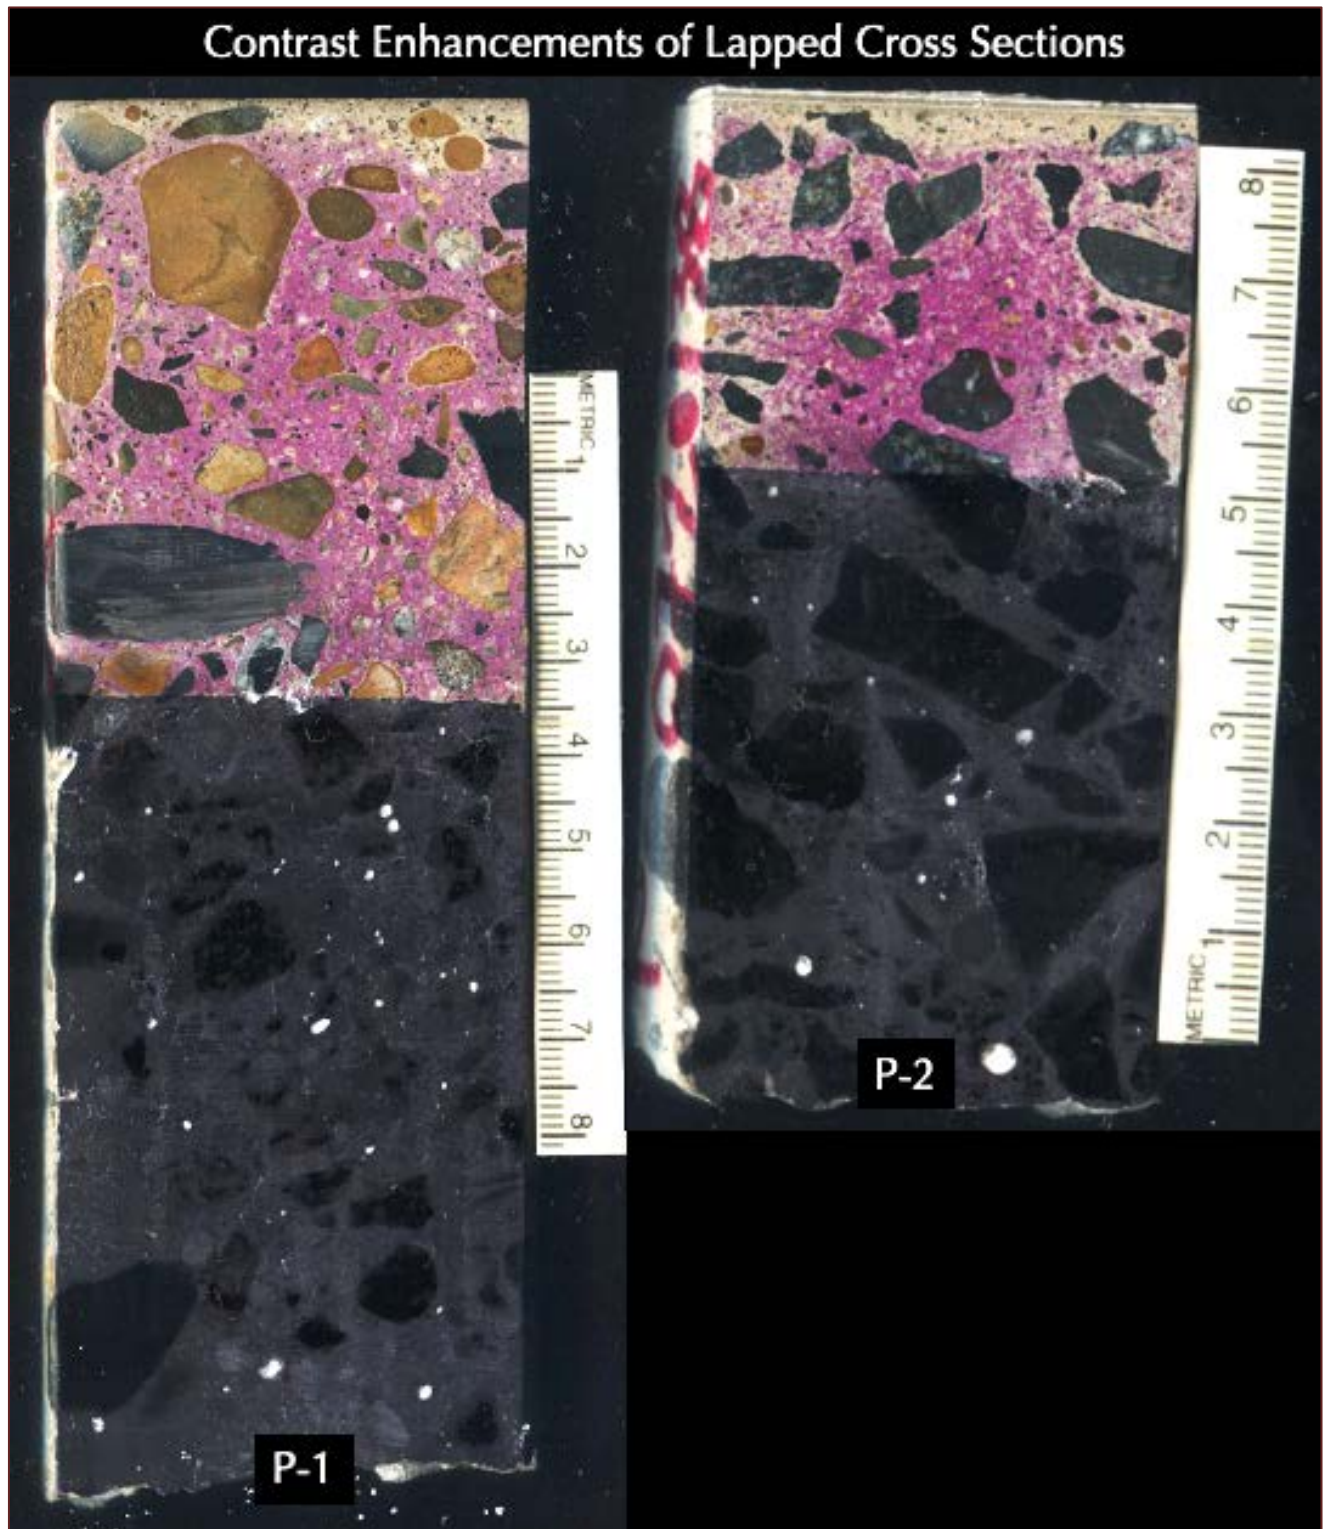
Figure 8: Lapped cross sections of cores after contrast enhancement to show: (a) the depth of carbonation of concrete by treatment of top halves of the cores with a phenolphthalein alcoholic solution where carbonated portion remained in its natural color tone of paste, whereas the non-carbonated interior paste has turned into pink discoloration; and (b) black and white contrast enhancement to highlight air voids in white against everything else in black for determining air content and air-void systems of concretes.

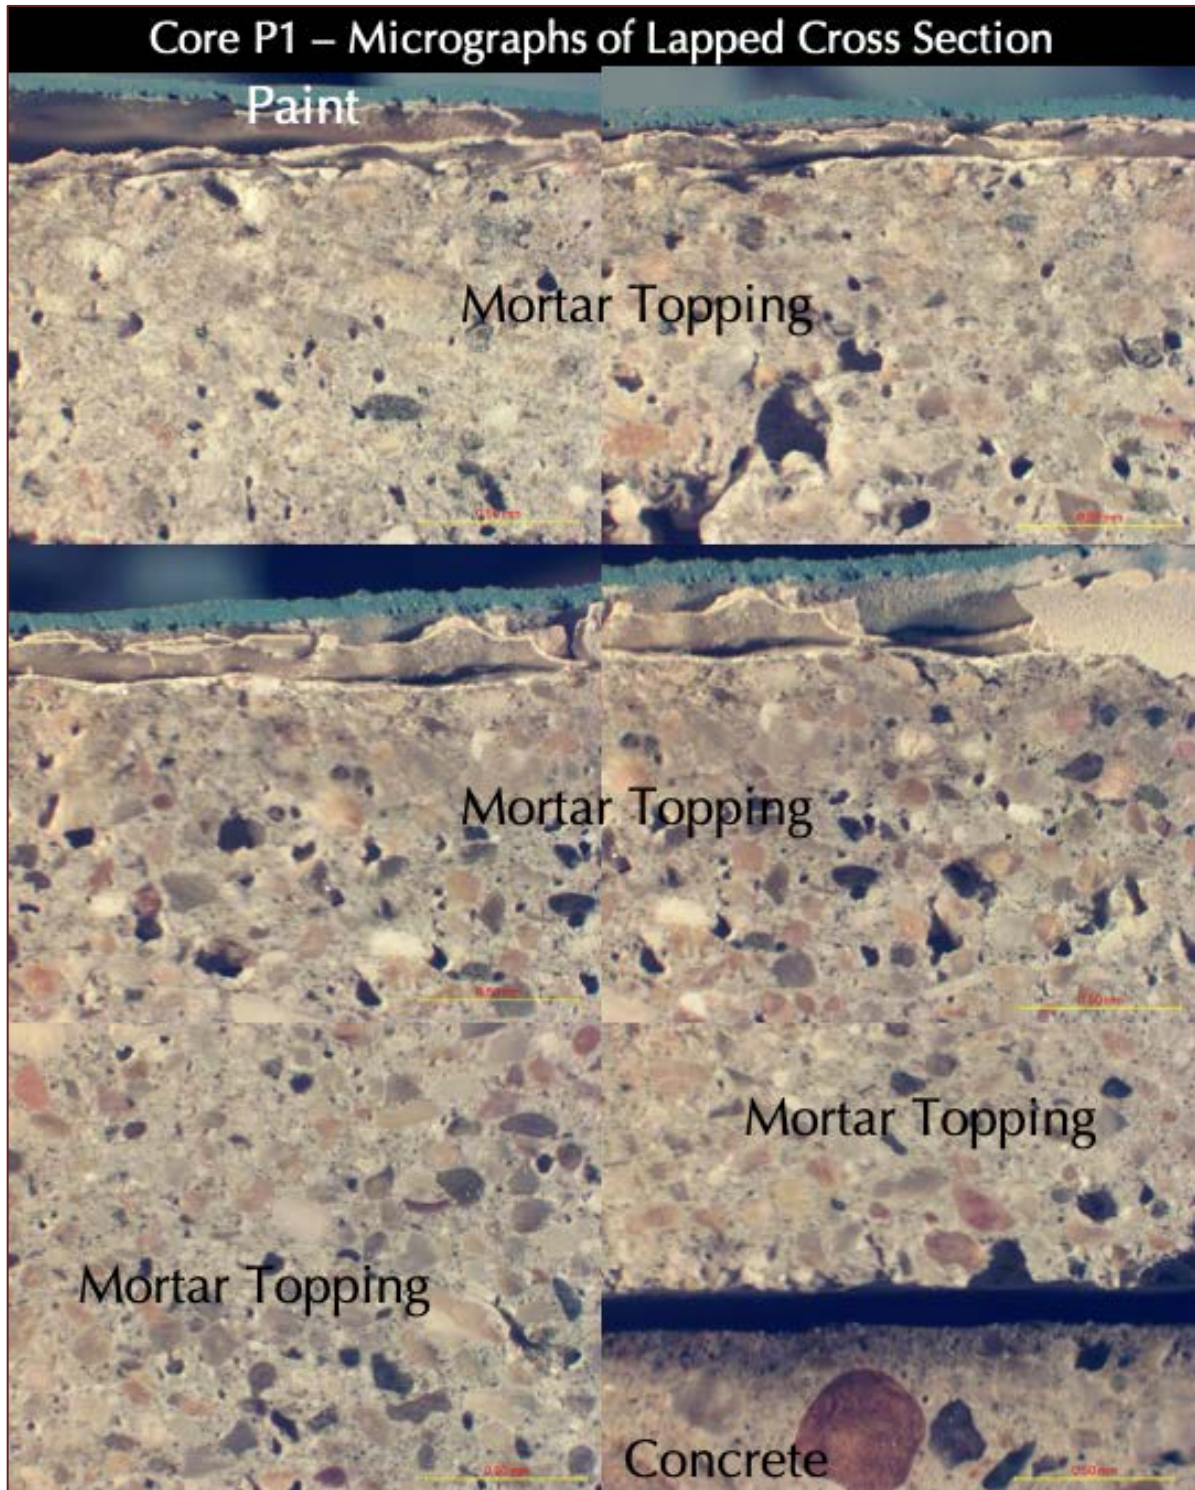
Figure 9: Micrographs of lapped cross section of the core from P- 1 West Wall showing: (a) the **paint coat** at the top bonded to the **mortar topping**; (b) the dense mortar topping containing sand particles, medium gray paste and many coarse entrapped air voids; (c) de-bonding of mortar topping from the concrete beneath, which has occurred during the lapping operations (the topping was bonded to concrete when received); (d) the dark gray dense paste at the top end of concrete seen in the bottom right photo, and dense sound nature of the **main concrete body** beneath the mortar topping as seen in the bottom right photo. Scale bars are 0.5 mm.

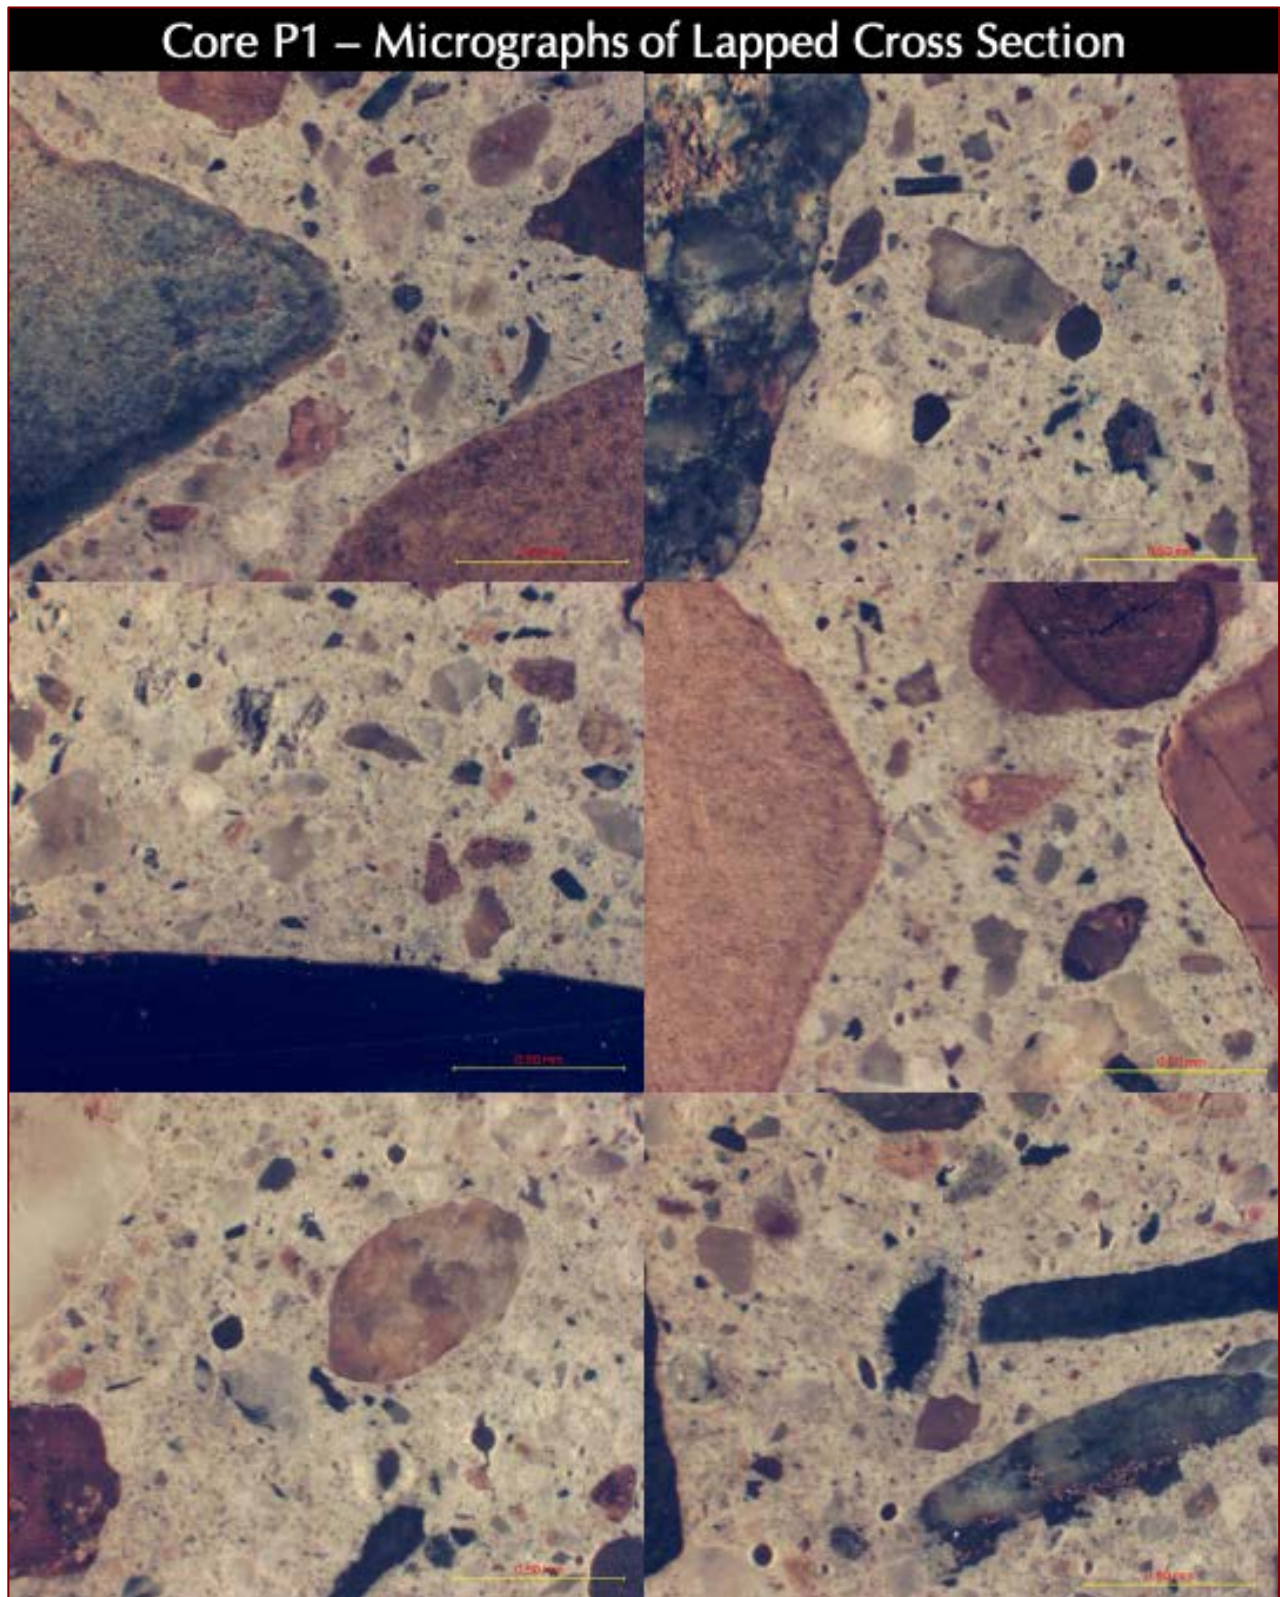
Figure 10: Micrographs of lapped cross section of the Core P-1 from West Wall showing the **main concrete body**, consisting of: (a) the crushed gravel coarse aggregate and natural siliceous sand fine aggregate, (b) lack of any entrained air voids indicating the non-air-entrained nature of the concrete, and (c) overall dense and well-consolidated nature of concrete. Scale bars are 0.5 mm.

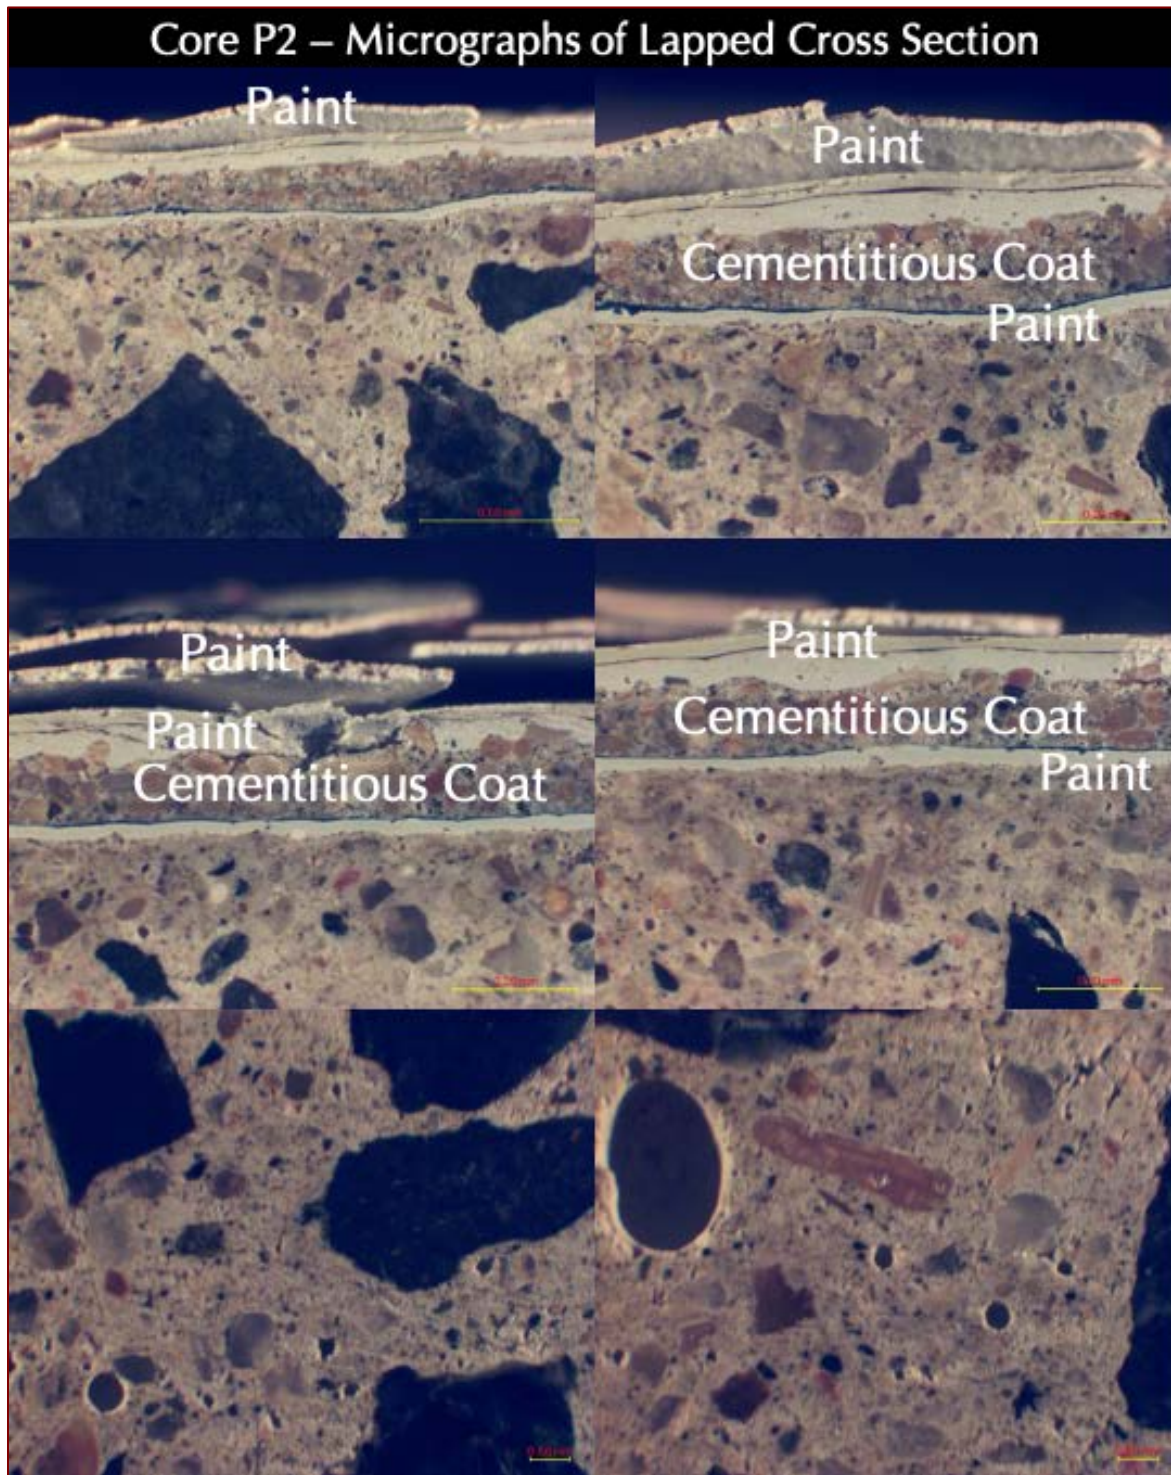
Figure 11: Micrographs of lapped cross section of the Core P-2 from East Wall showing the top **protective coating** of concrete consisting of alternating layers of **paint coats** and a middle **cementitious coat** where the latter is sandwiched between two paint coats, altogether applied over the **main concrete body**. The concrete contains dark gray crushed stone coarse aggregate which is very different from crushed gravel found in Core P-1 from West Wall, natural siliceous sand fine aggregate, Portland cement paste, and some spherical entrained air voids indicating marginally air-entrained nature as opposed to non-air-entrained nature of concrete in Core P-2 from West Wall, and overall dense and well-consolidated nature of concrete. Therefore, the concrete used in the East Wall at the core location is from a different mix having different crushed stone coarse aggregate and some air-entraining agent compared to the concrete used in the West Wall at the location of Core P-1. Scale bars are 0.5 mm.

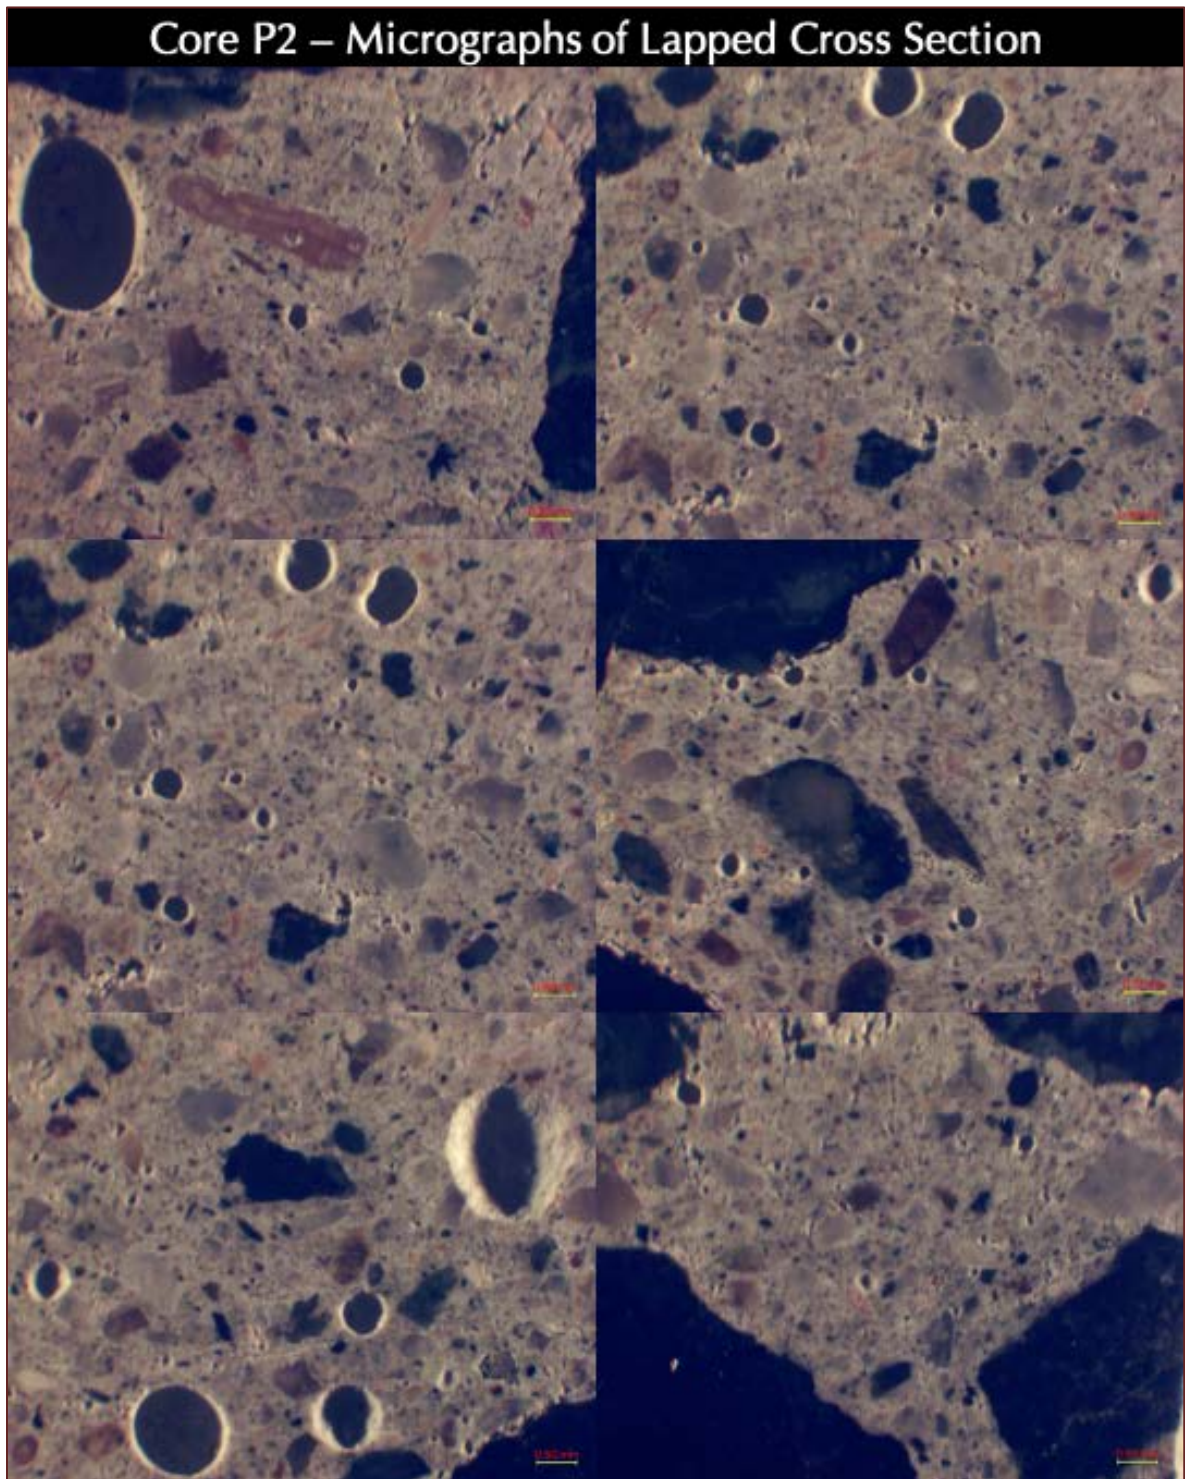
Figure 12: Micrographs of lapped cross section of the Core P-2 from East Wall showing the **main concrete body** consisting of: (a) the dark gray crushed stone coarse aggregate which is very different from crushed gravel found in Core P-1 from West Wall, (b) natural siliceous sand fine aggregate, (c) Portland cement paste, (d) some spherical entrained air voids indicating marginally air-entrained nature as opposed to non-air-entrained nature of concrete in Core P-1 from West Wall, and (e) overall dense and well-consolidated nature of concrete. Therefore, the concrete used in the East Wall at the core location is from a different mix having different crushed stone coarse aggregate and some air entraining agent compared to the concrete used in the West Wall at the location of Core P-1, and (d) overall dense and well-consolidated nature of concrete. Scale bars are 0.5 mm.

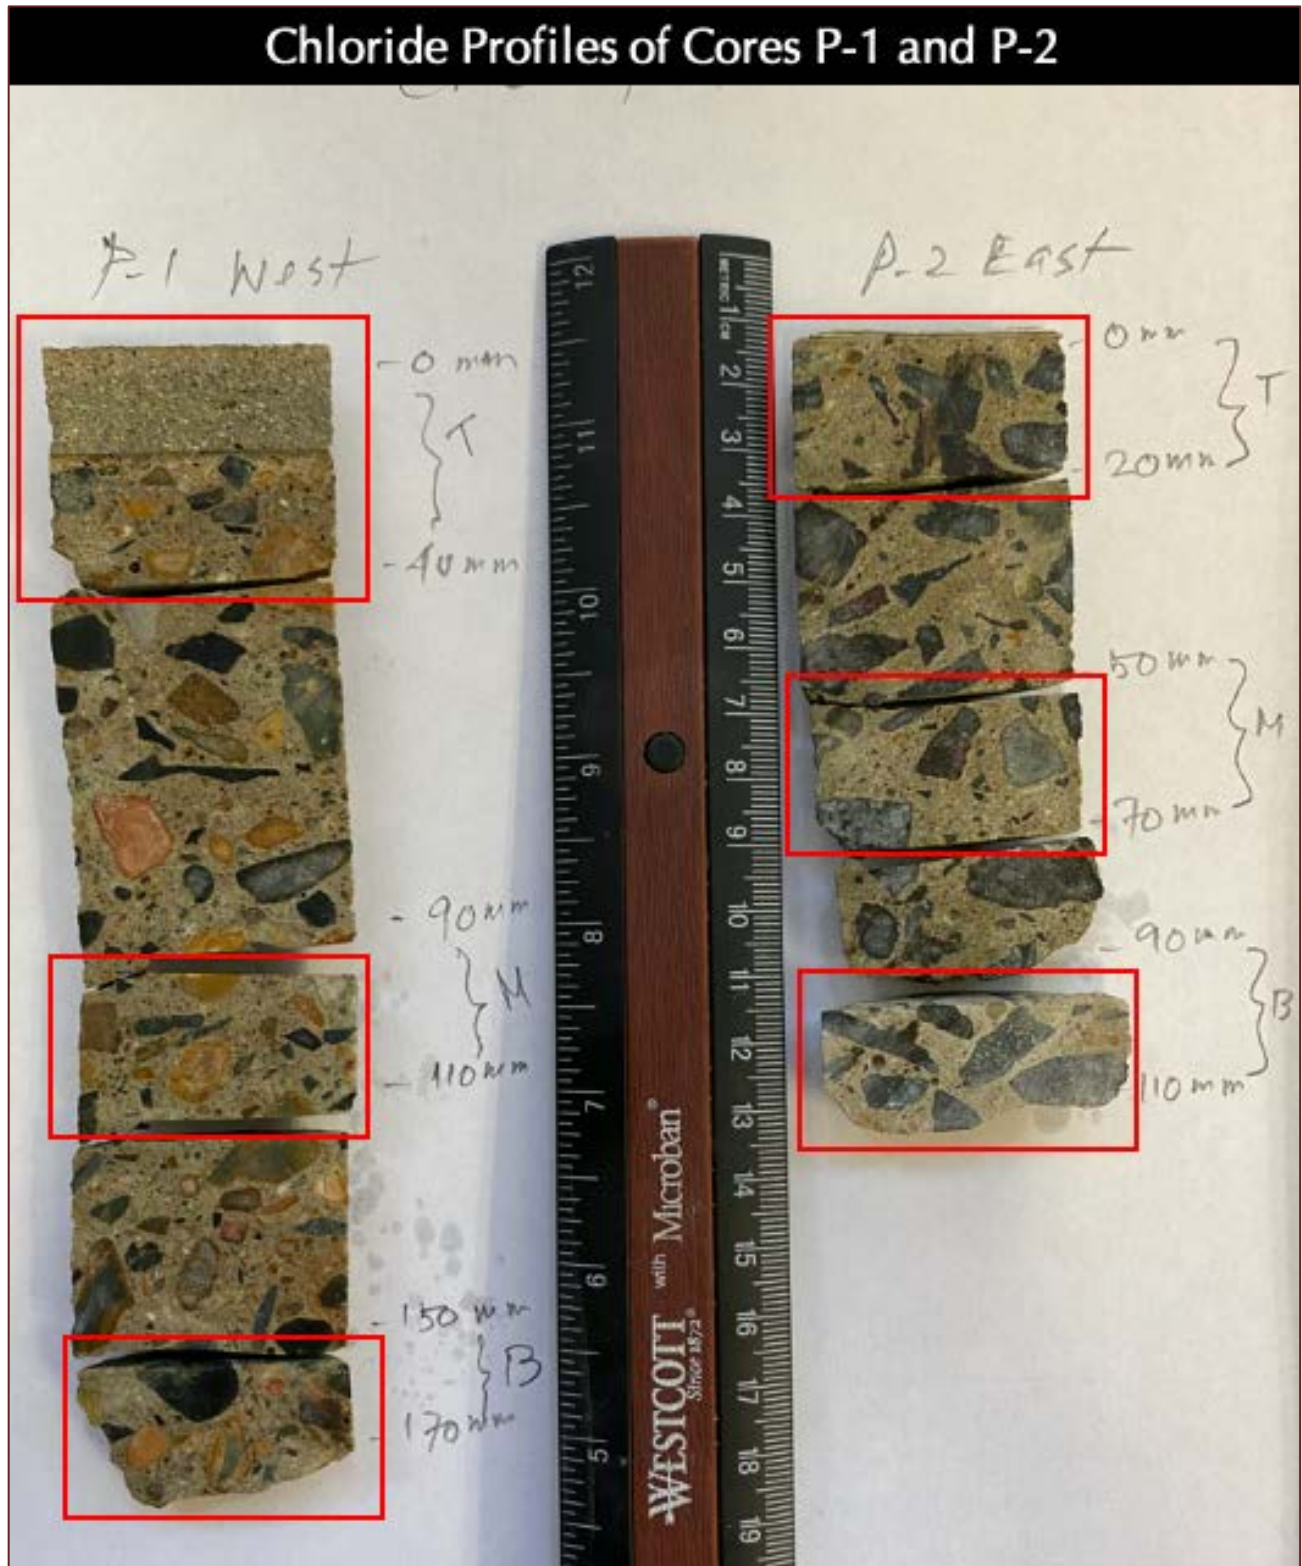
both cores beyond the exposed surface regions in the mid-depth locations and inside are found to be free of any chloride-induced corrosion especially in the East Wall core.

Figure 33: Sections from each core selected for chloride analysis.
