ACID ATTACK IN A VITRIFIED CLAY PIPE (VCP) SEWER LINE – A PETROGRAPHIC AND CHEMICAL INVESTIGATION

THE DISTRESSED 33-IN. VCP OF THIS STUDY

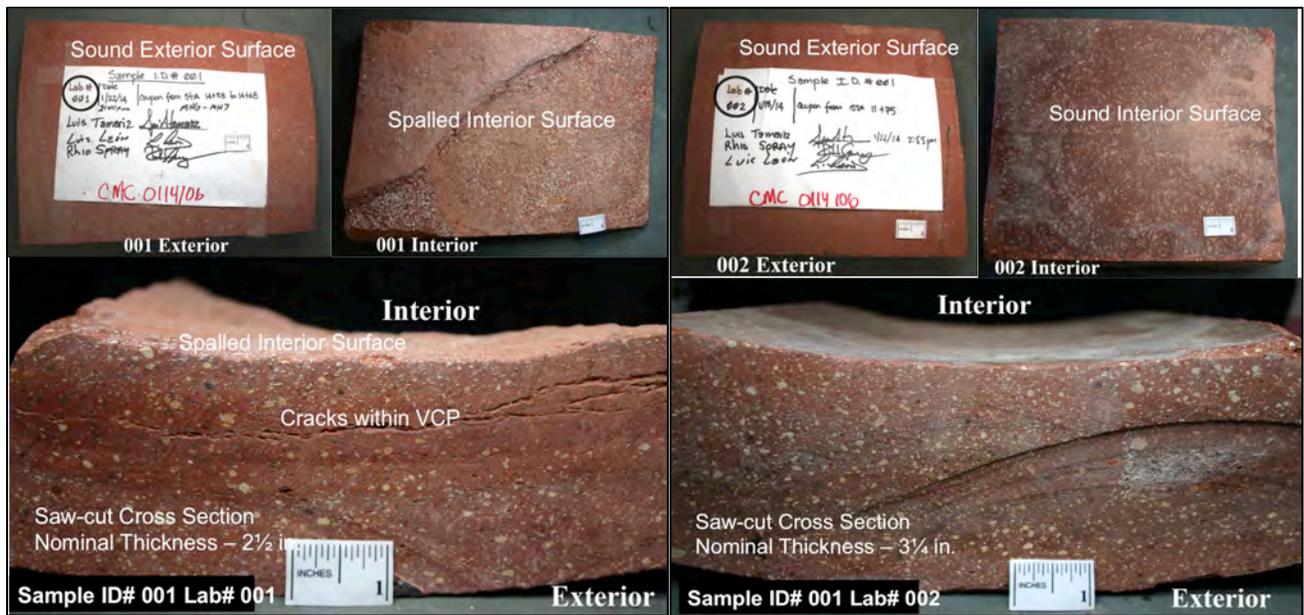
Figure 2: Conditions of VCP samples received.

The top two and the bottom left sets of photos are from the three samples of the distressed 33-in. VCP that show spalled interior walls of the pipe in the first and third samples with loss of cross sectional thicknesses, as well as visible cracks in the VCP body in the first sample oriented parallel to the interior wall.

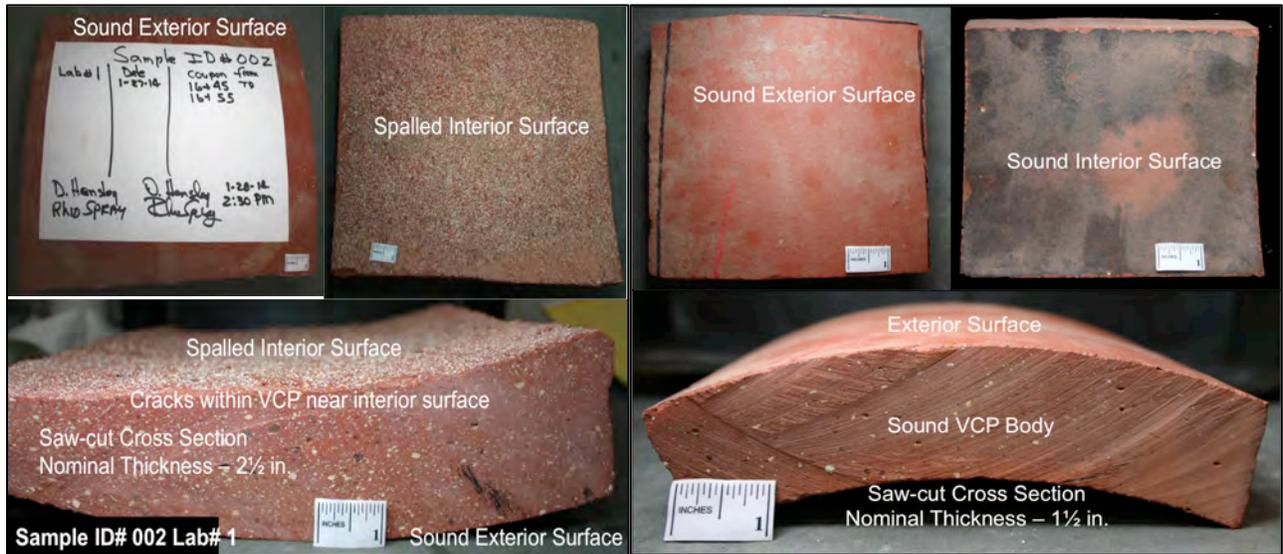
The third set (from the first left after a clockwise rotation) is for the sample from the sound 15-in. pipe that is thinner than the 33-in. pipe and is compositionally different from the 33-in. pipe. This sound pipe sample shows a dark gray sound interior (sewer-side) surface having a thin film of dried sewer sludge, and sound exterior (soil-side) surface. The sample has an overall thickness of 2 1/2 in., which represents the original thickness of the pipe wall (due to the absence of any spalling as in the distressed pipe).

Figure 3: Conditions of VCP samples received.

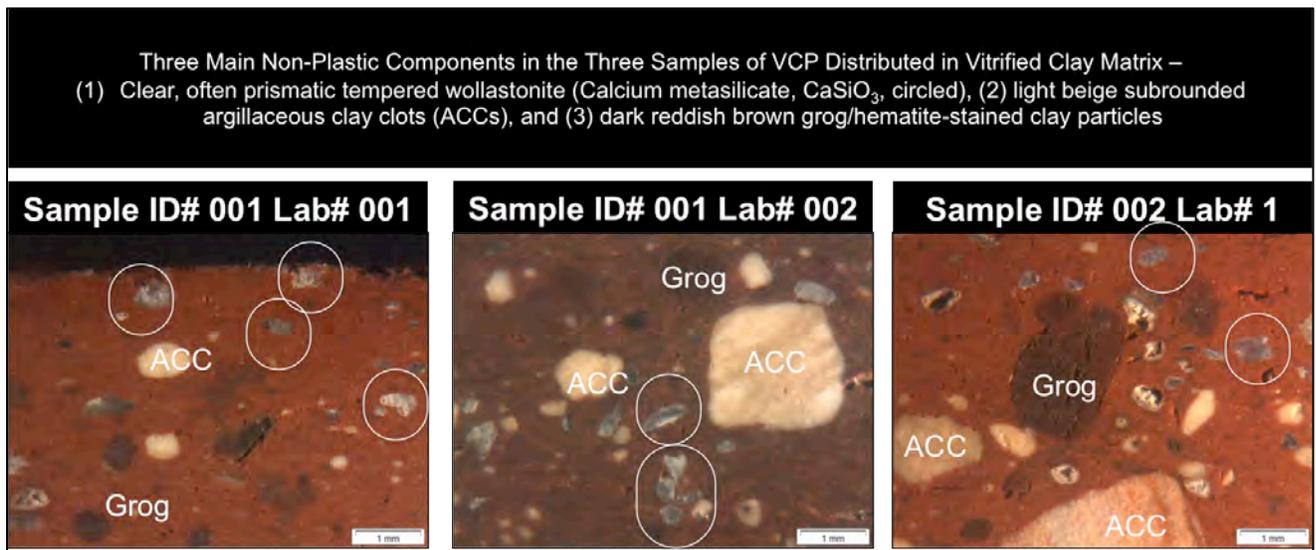
Figure 4: Non-Plastic components in VCP samples.

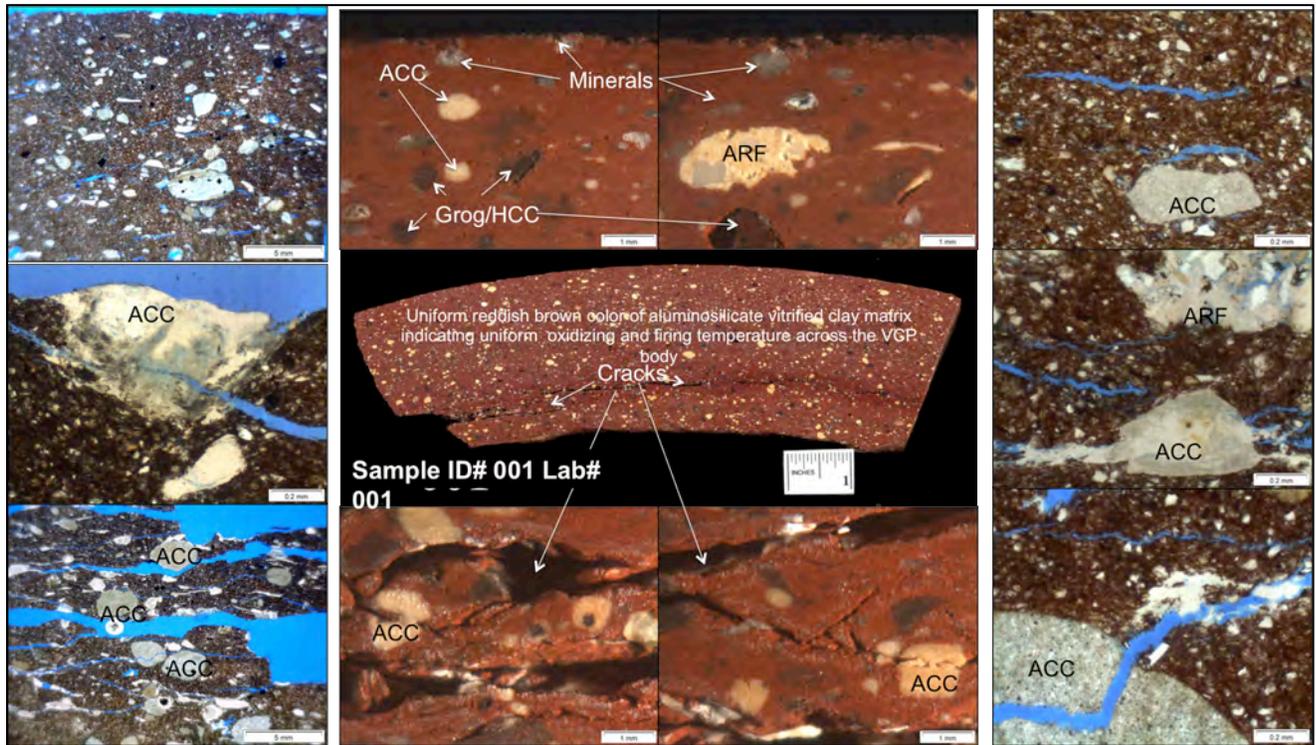
Figure 5: Lapped cross section and blue dye-mixed epoxy-impregnated thin section of VCP sample showing various plastic and non-plastic components, as well as cracking and spalling of the VCP. The left and right columns show thin section photomicrographs, and the middle column shows lapped cross section (in the middle) and photomicrographs of lapped cross section of VCP from the top and bottom surface regions of the pipe (at the top and bottom rows in the middle column, respectively).

- a) Colorless to off white short prismatic crystals of tempered wollastonite having nominal sizes of 0.4 mm along the long prism axes;
- b) Light beige subangular to round, nominal 3 mm size argillaceous clay clots (ACCs) uniformly distributed throughout the VCP bodies;
- c) Previously fired darker reddish brown grog particles and similar sized and colored hematite-stained clay clots that are relatively less abundant but uniformly distributed, and smaller in nominal sizes (1 mm); and
- d) Also present at finer size and uniformly distributed over the vitrified matrix are fine angular grains of quartz (0.2 mm nominal size).

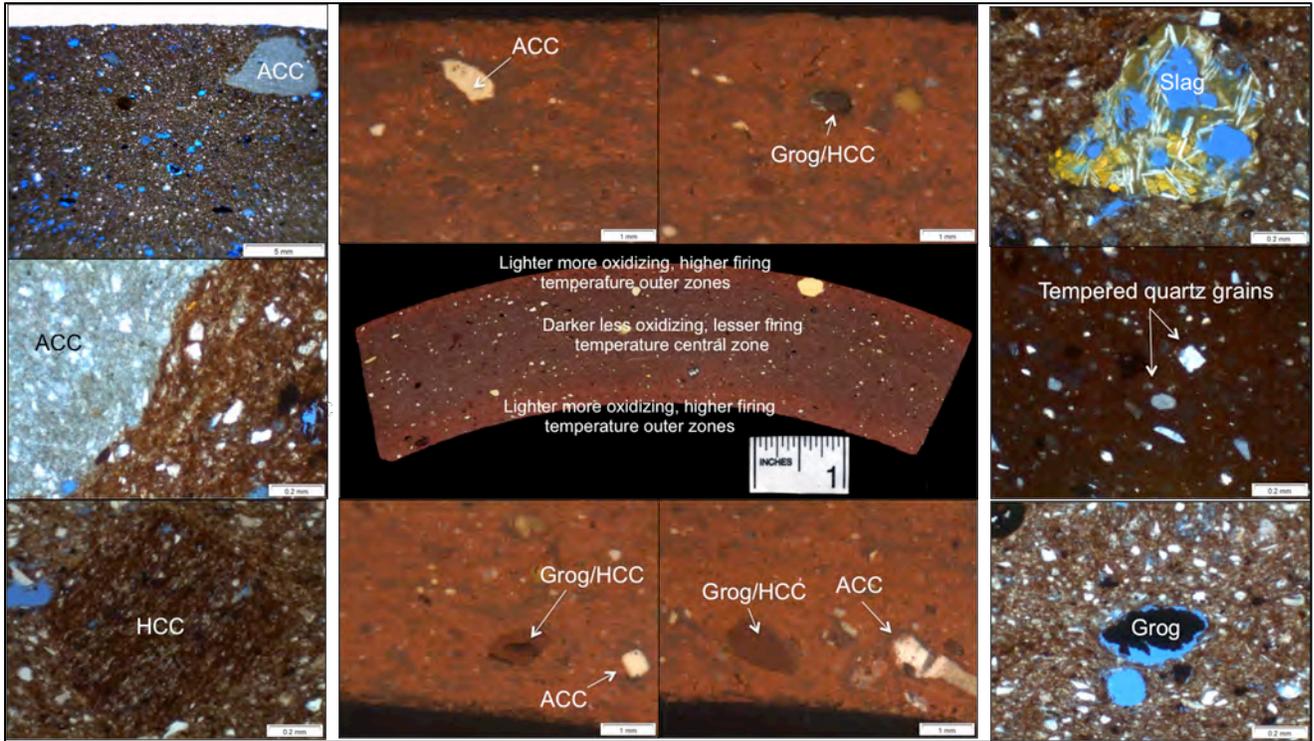
Figure 7: Lapped cross section and blue dye-mixed epoxy-impregnated thin section of sound VCP sample from 15-in. pipe showing various plastic and non-plastic components.

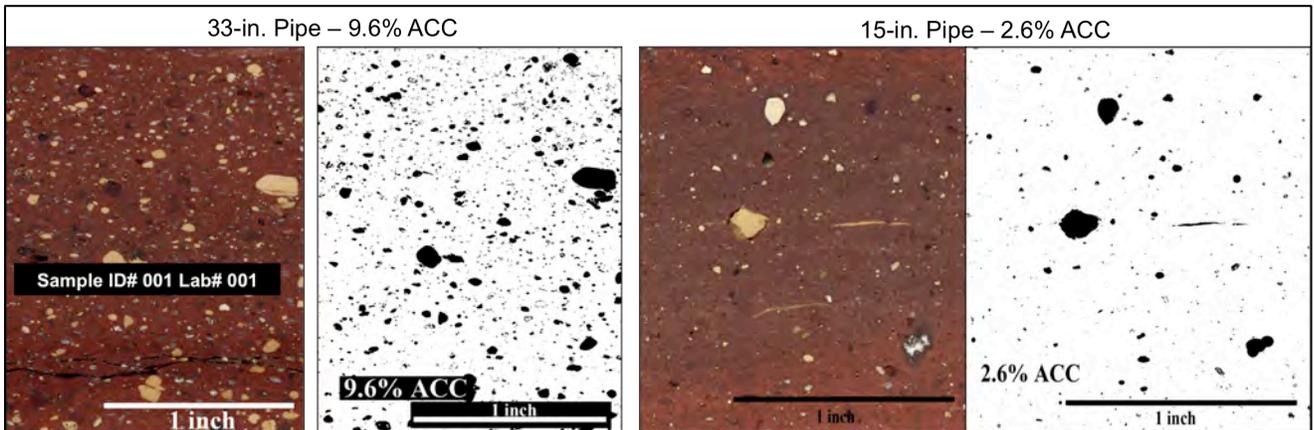
Binary images of distribution of argillaceous clay clots in Figure 8 show clear abundance of these particles in the distressed 33-in. pipe, as opposed to the sound 15-in. pipe.

Figure 8: Binary images of distribution of argillaceous clay clots show clear abundance of these particles in the distressed 33-in. pipe, as opposed to the sound 15-in. pipe.

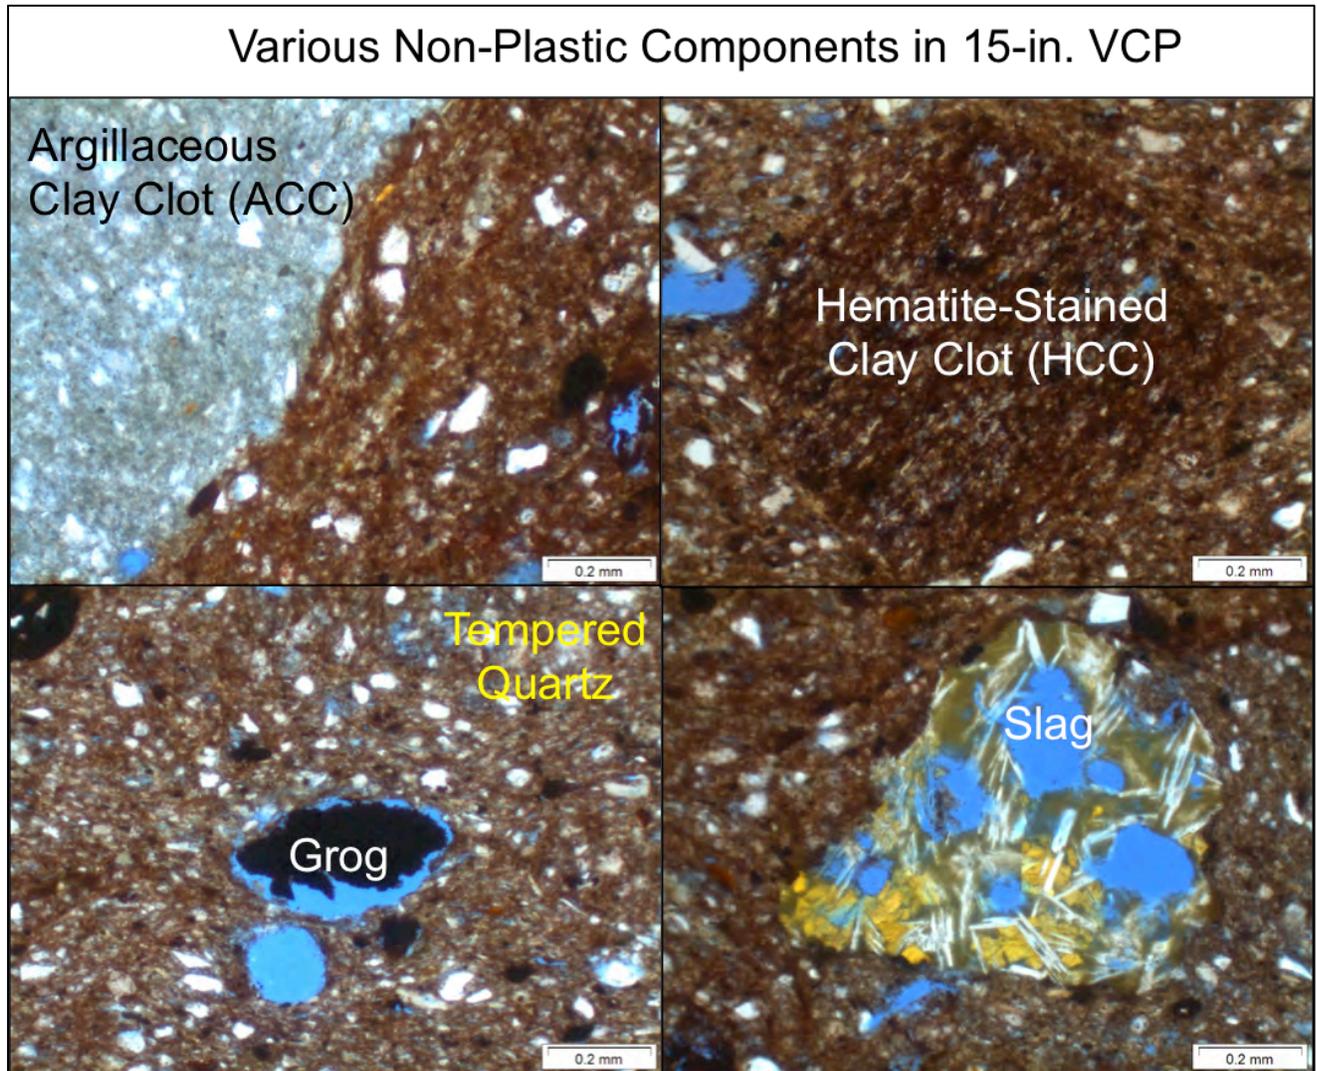
Figure 9: Thin section photomicrographs of the sample from the sound 15-in. pipe showing many non-plastic additives of 33-in. pipe, except wollastonite, and the presence of slag particles.

The major difference from the 33-in. distressed pipe samples are in: (a) far lesser abundance of argillaceous clay clots (ACCs) in the 15-in. sample (estimated to be 2.6 percent by volume), compared to as high as 9.6 percent by volume in the 33-in. pipe samples; and (b) absence of tempered wollastonite addition in the older 15-in. pipe, which is prevalent and uniformly distributed throughout the bodies of the 33-in. pipe samples.

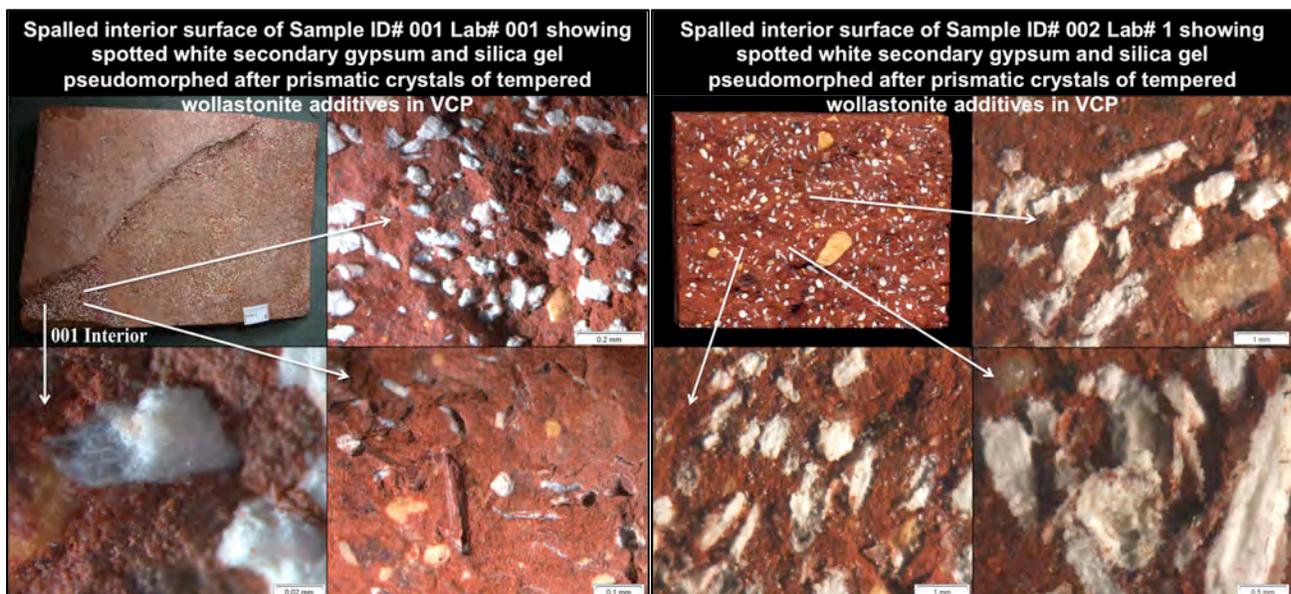
The following photos in Figure 11 show conditions of the spalled interior pipe wall surfaces in the two distressed VCP samples of 33-in. pipe that were in direct contact with the sewer elements. The spalled surfaces show a typical pitted or spotted appearance of fractured and sometimes popped-out (often left with empty pseudomorphs of crystal depressions) milky white partially dissolved tempered wollastonite crystals, distributed all over the spalled interior surfaces in both samples, many often coated with secondary gypsum crystals and spherical silica gel masses on the exposed/spalled reacted surfaces of fractured wollastonite crystals:

Figure 11: Conditions of the spalled interior pipe wall surfaces in the two distressed VCP samples of 33-in. pipe that were in direct contact with the sewer elements.

A close examination of exposed and fractured tempered wollastonite crystals on the spalled surface of distressed 33-in. samples in a scanning electron microscope shows in situ formation of gypsum and silica gel on the surfaces of wollastonite.

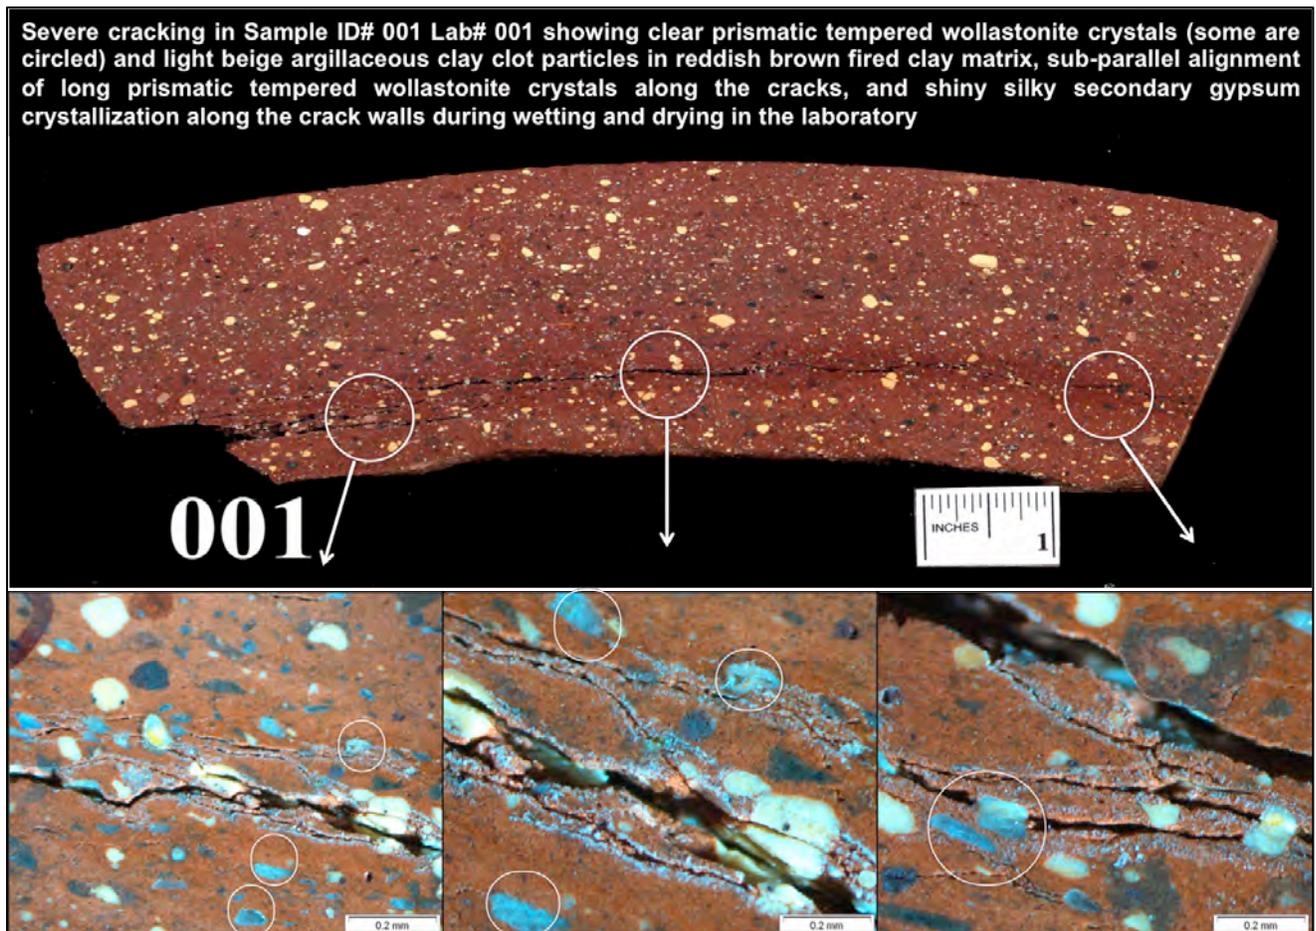
Cross-sections of the two distressed VCP samples from 33-in. pipe show visible cracks within the bottom half (i.e. interior sewer side) of the pipe, oriented parallel to the spalled interior wall surface. Spalling of the interior pipe wall surfaces, therefore, are judged to be due to the presence of these internal cracks in the VCP. Besides the inherent tempered wollastonite calcium minerals, there are no other sources of any calcium phase either inside the VCP body or around it (e.g., no mortar joints; pipe segments are reportedly joined by typical bell-and-spigot type joints in a VCP) are found that could contribute to the calcium ions for reaction with sewer acid.

The following lapped cross section photomicrographs show: (a) spectacular development of these cracks near the inside surface of VCP (at the inside half of pipe), (b) secondary gypsum crystallization along the cracks walls during wetting and drying of sample in the laboratory, (c) tempered wollastonite crystals in the VCP (some are circled in bottom row photos) and (d) light beige colored subrounded to rounded (larger in nominal sizes than wollastonite) particles of argillaceous clay clots (ACCs) – all uniformly distributed in the reddish brown aluminosilicate VCP body:

Figure 12: Cracking, secondary gypsum, tempered wollastonite, and ACCs in distressed pipe.

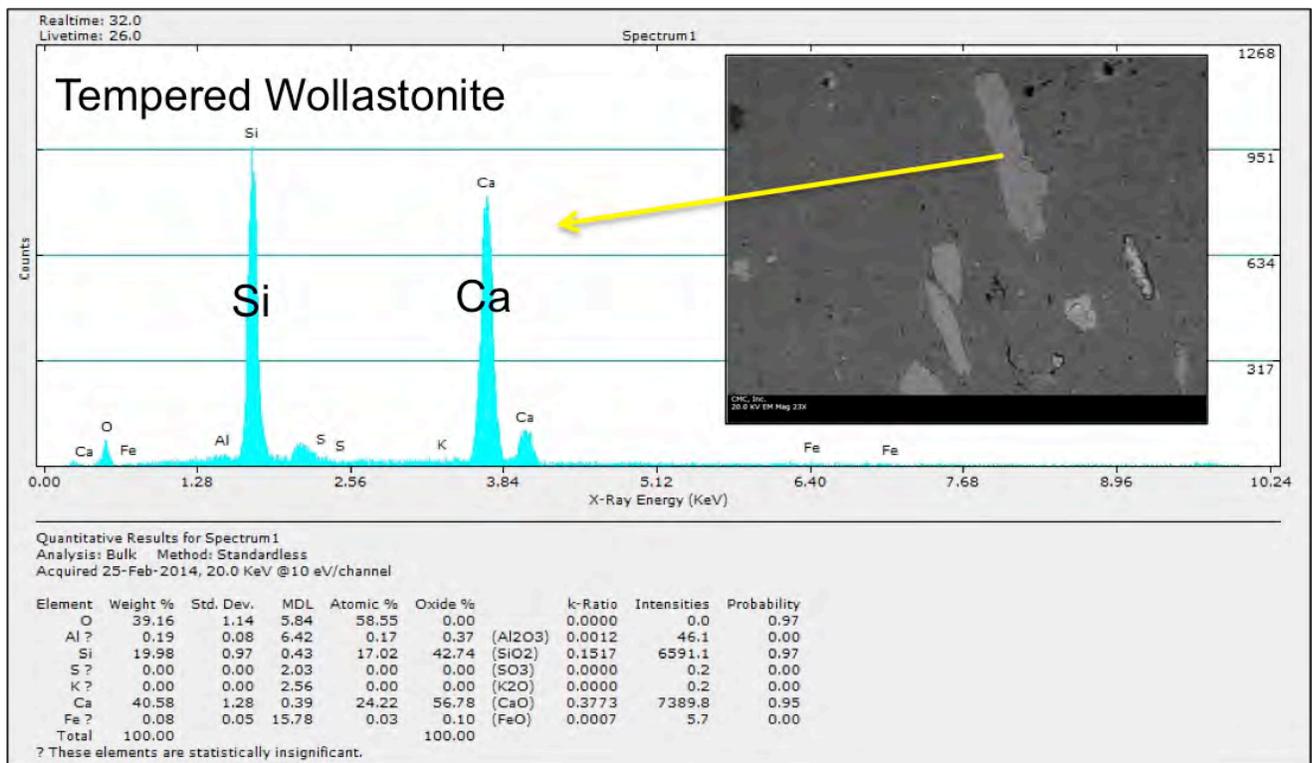
Figure 13: X-ray elemental analysis of long slender prismatic crystals of tempered wollastonite showing its characteristic calcium and silicon peaks. Inset shows backscatter electron image of an area in a distressed VCP from where compositional analysis of wollastonite crystals were done, where wollastonite appeared in brighter gray against darker gray vitrified matrix.

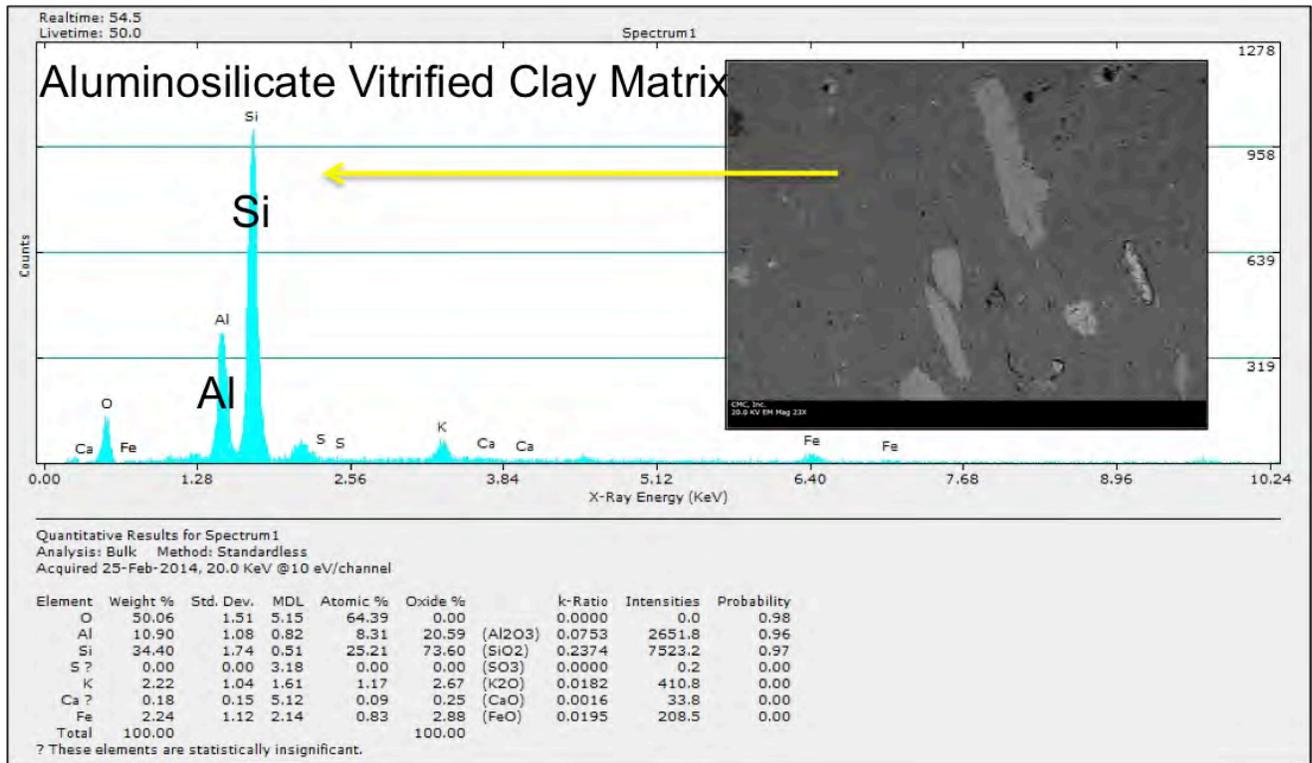
Figure 14: X-ray elemental analysis of vitrified clay matrix showing its characteristic aluminum and silicon peaks. Inset shows backscatter electron image of an area in a distressed VCP from where compositional analysis of matrix is done, where tempered wollastonite grains appeared in brighter gray against darker gray vitrified matrix.

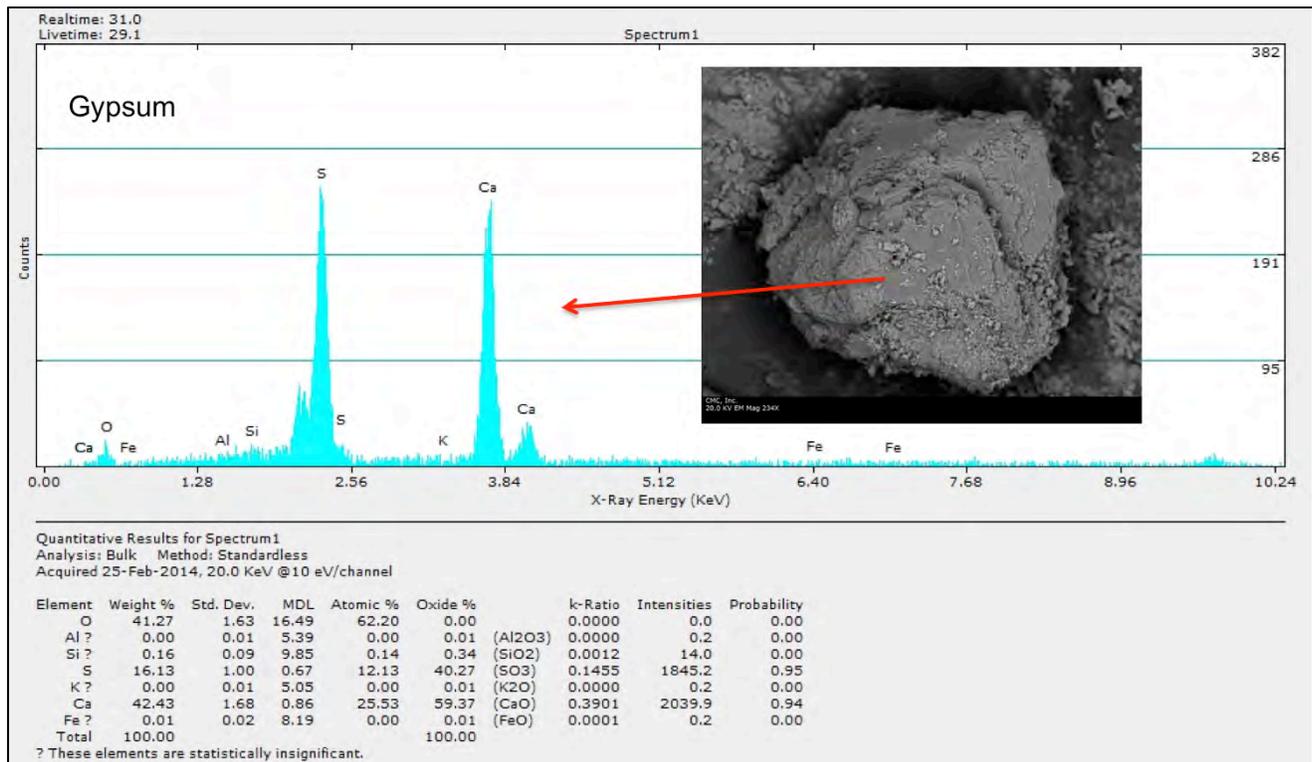
- (iii) SEM-EDS studies directly on the spalled interior surfaces of 33-in. VCP in two spalled samples in Figures 15 and 16 show dissolution of tempered wollastonite and precipitation of secondary gypsum (Figure 15), and, spherical masses of amorphous (colloidal) silica gel (Figure 16):

Figure 15: X-ray elemental analysis of secondary gypsum showing its characteristic calcium and sulfur peaks. Inset shows backscatter electron image of gypsum phase that was analyzed.

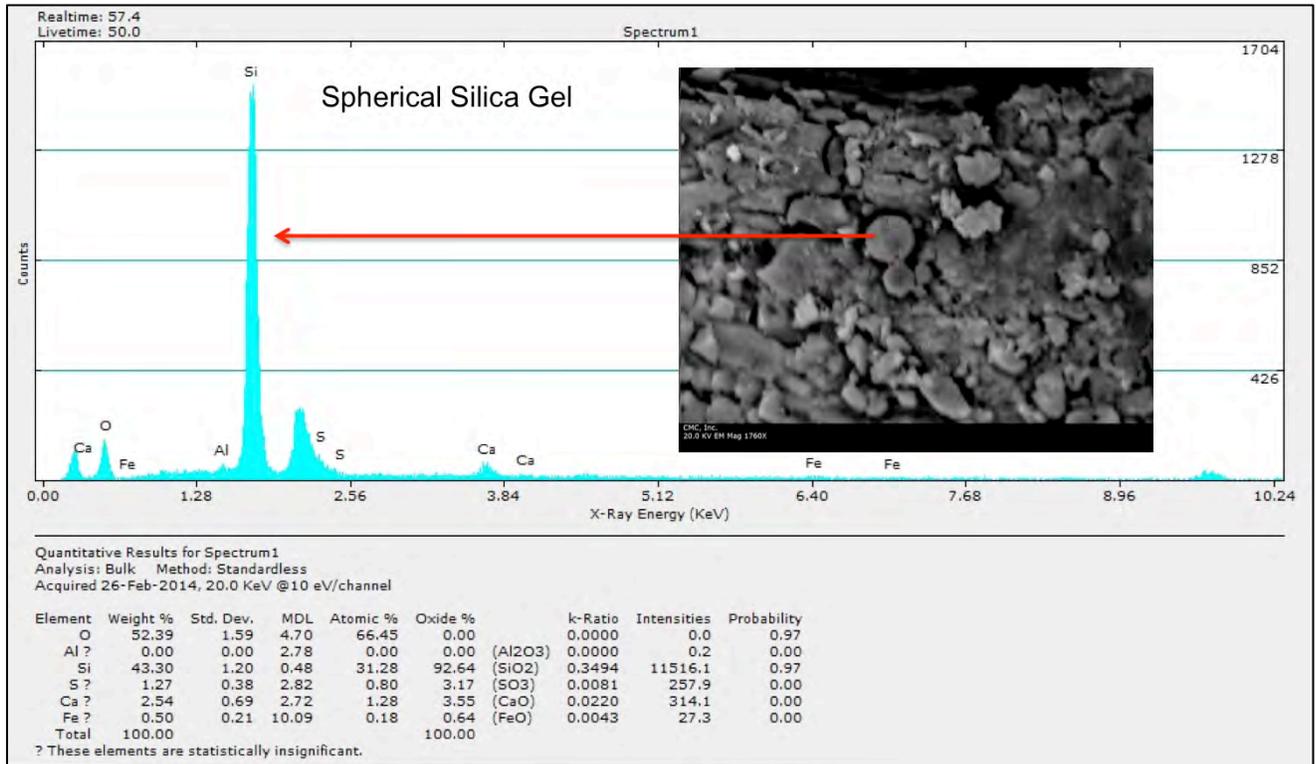
Figure 16: X-ray elemental analysis of spherical masses of amorphous (colloidal) silica gel showing its characteristic calcium and sulfur peaks. Inset shows backscatter electron image of gypsum phase that was analyzed.

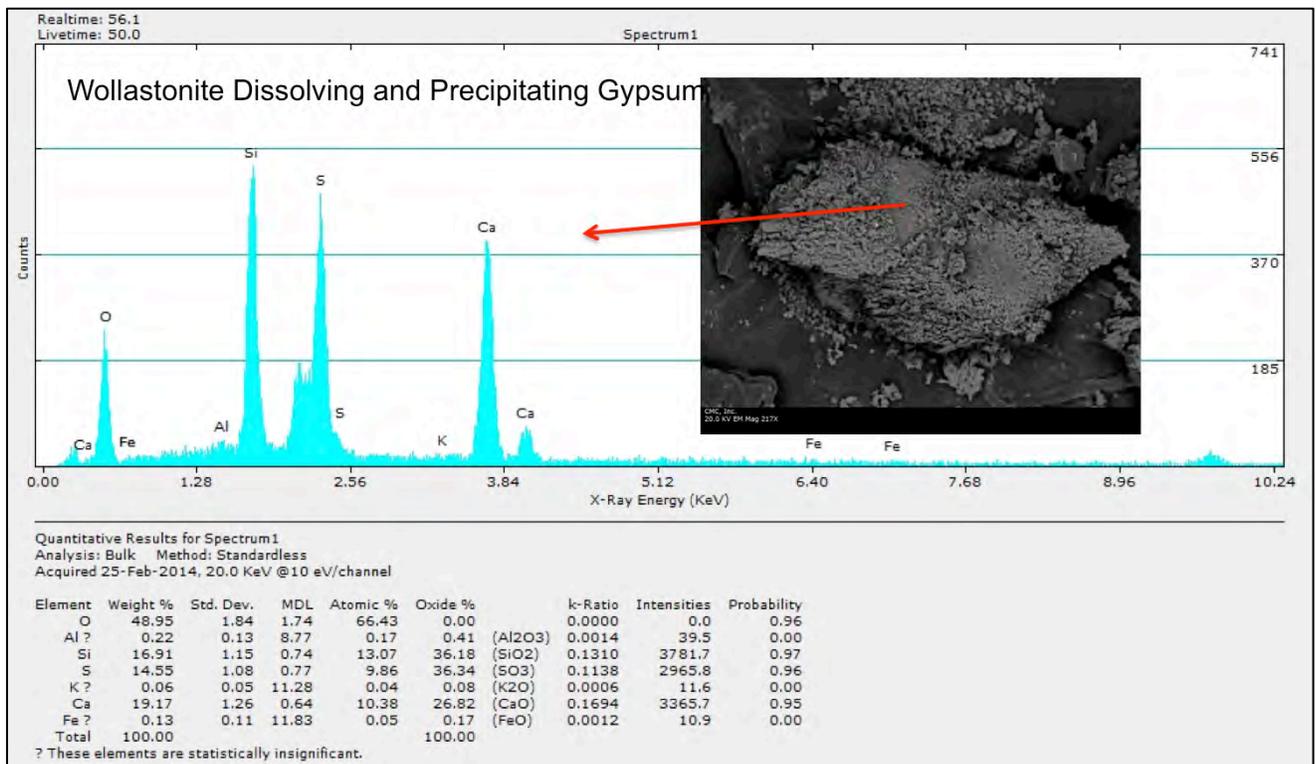
Figure 17: X-ray elemental analysis of tempered wollastonite in 33-in. VCP's spalled internal pipe wall surface - dissolving and precipitating secondary gypsum on the surface of wollastonite. Inset shows backscatter electron image of gypsum phase that was analyzed.

Photomicrographs and x-ray microanalyses in Figures 17 and 18 further showed tempered wollastonite in 33-in. VCP's spalled internal pipe wall surface - dissolving and precipitating secondary gypsum on the surface of wollastonite:

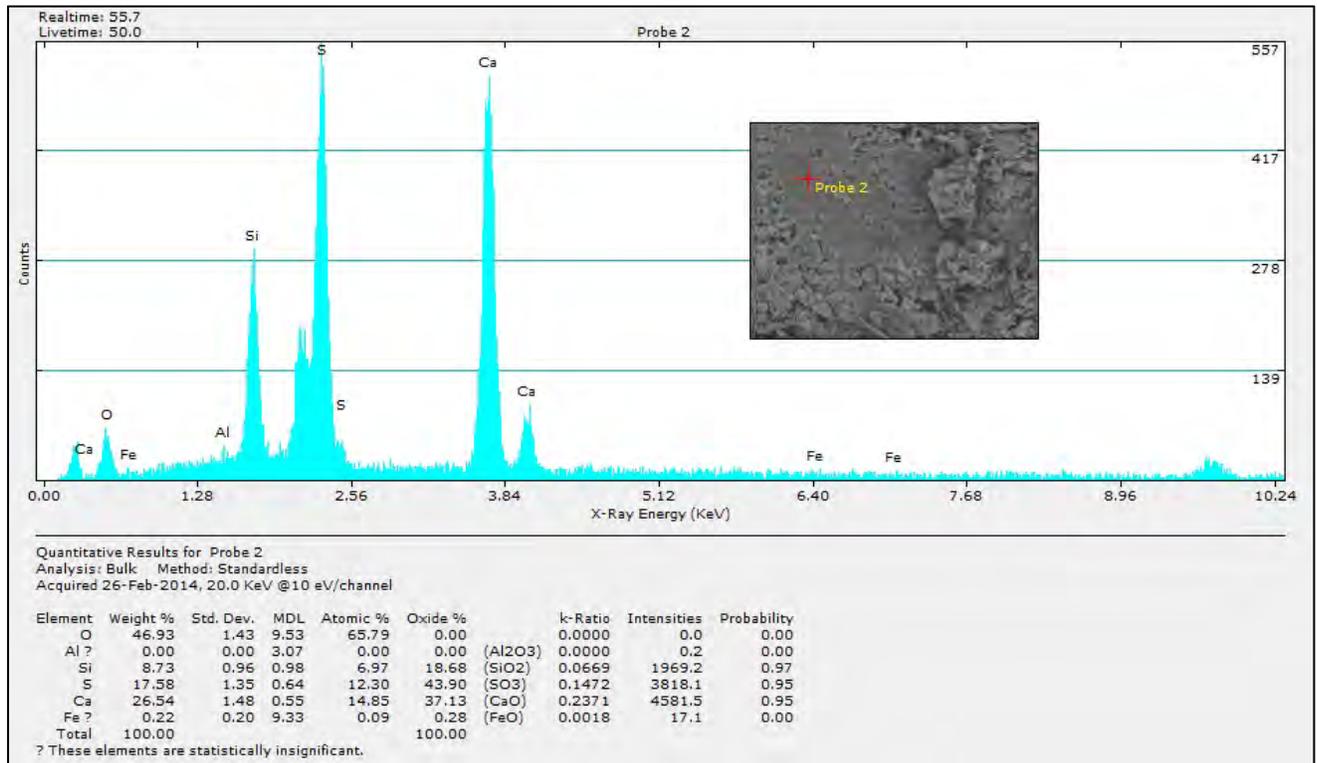
Figure 18: X-ray elemental analysis of tempered wollastonite in 33-in. VCP's spalled internal pipe wall surface - dissolving and precipitating secondary gypsum on the surface of wollastonite. Inset shows backscatter electron image of gypsum phase that was analyzed.

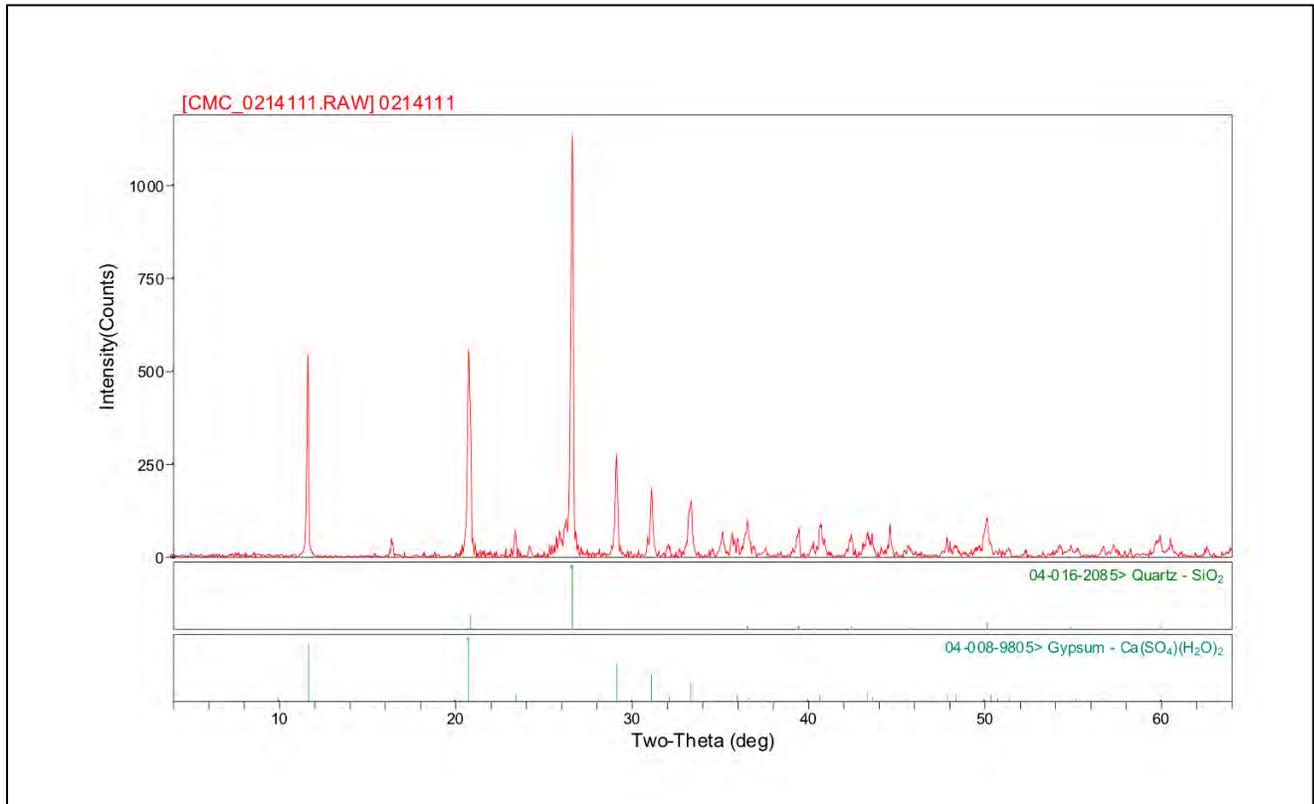
The result shows spectacular secondary gypsum crystals along with tempered and original quartz grains. Gypsum peaks in the XRD is consistent with its observation in association with tempered wollastonite in the SEM-EDS analysis.

Figure 19: X-ray diffraction pattern of pulverized portion of a thin skin of the spalled interior surface of a 33-in. VCP.

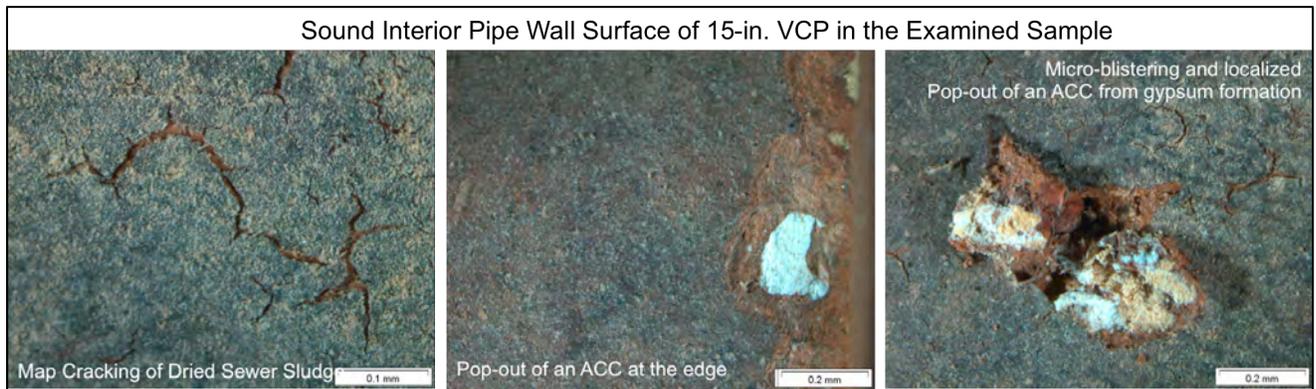
On the interior wall surface of the 15-in. line is a very thin dark gray film of dried sewer sludge that shows characteristic map cracking of the dried sludge for most of the internal wall surface, except only two locations (shown in the following photomicrographs of the interior surface in a 105 sq. in. area), apparently less than 0.5 mm in size where local micro-blistering and pop out-type localized loss are observed due to chemical reaction of minor amounts of calcite crystals in the original argillaceous clay clot masses and sewer sulfuric acid that caused localized formation gypsum within the clay clot masses from the fine, tiny calcite grains in the ACCs. None of these micro-blisters or popouts from localized gypsum formation from sewer sulfuric acid, however, caused any spalling of the VCP, or even of the sludge film let alone to cause any distress.

Figure 20: Sound interior pipe wall surface of 15-in. sound pipe.

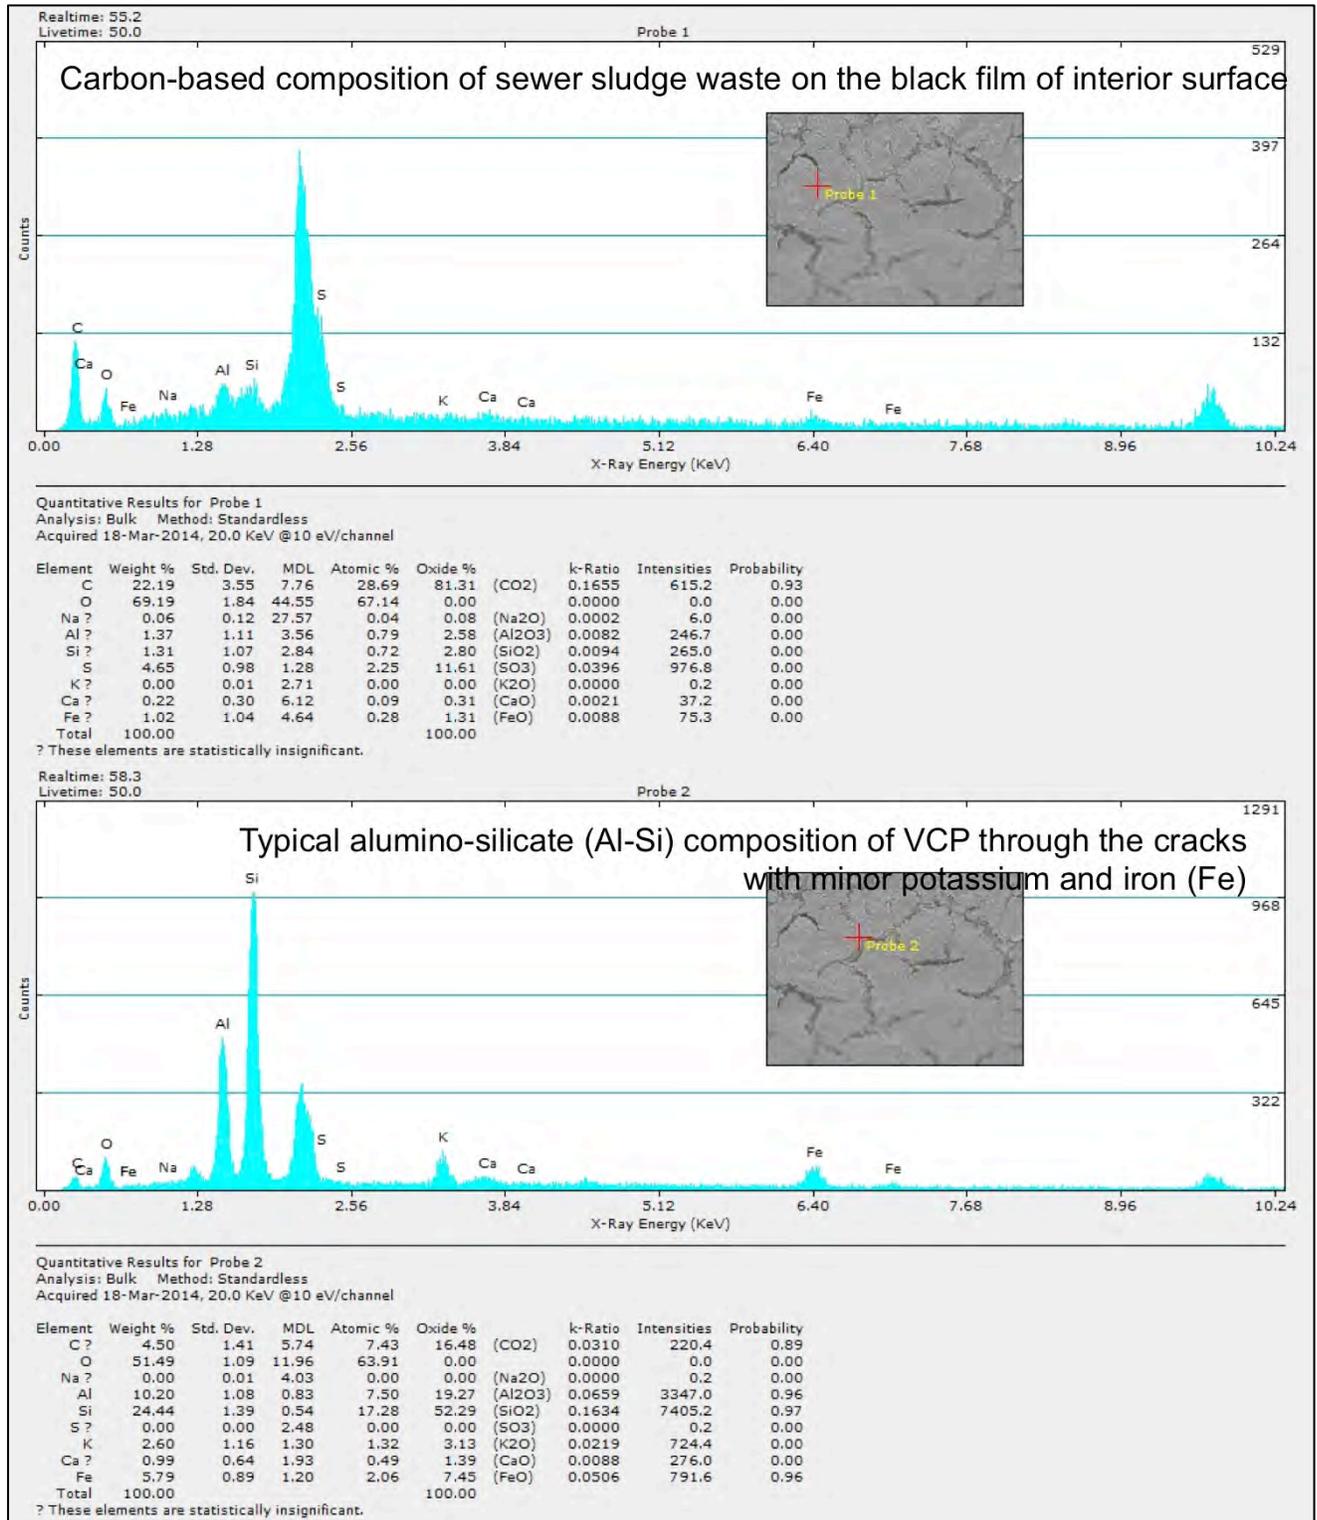
Elemental analysis from directly over dark gray dried sewer sludge film show a typical carbon-based (organic) composition of the sewer waste (Figure 21, unmarked peaks are for gold conductive coating), whereas, point-mode analyses from over a crack in the dried map-cracked sludge film shows typical alumino-silicate composition of the

Figure 21: X-ray elemental analysis carbon-based sewer sludge waste on the black film of interior surface (top) and typical aluminosilicate matrix (bottom) of sound 15-in. VCP. Insets show backscatter electron images of wall from where analyses were done at the marked points.

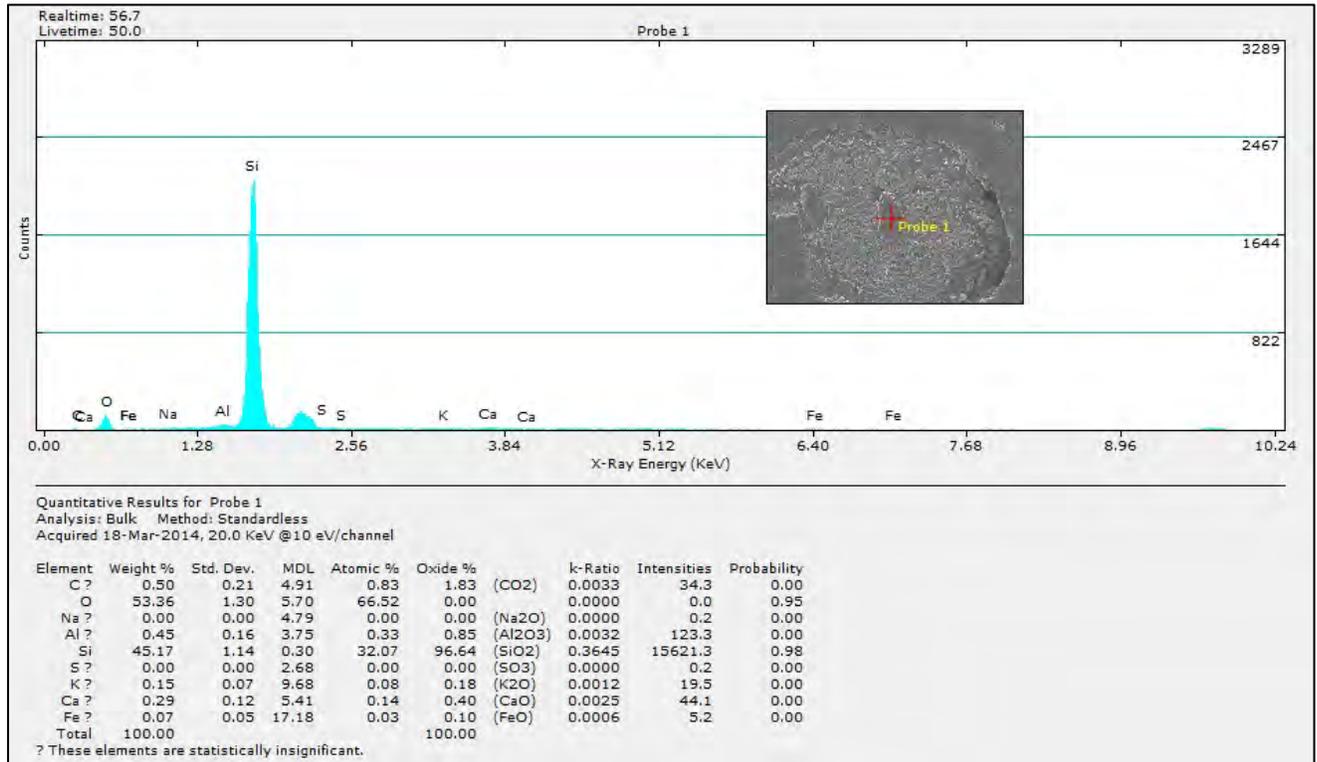
Another analysis from over an argillaceous clay clot (ACC) mass show islands of small angular quartz crystals (Figure 22) surrounded by secondary gypsum masses (Figure 23) from reactions of small calcite grains in the clots (that are indeed unavoidable in those clots) with the sewer sulfuric acid. These gypsum masses in ACCs are small enough to prevent any large-scale pipe surface failure, instead of a few local blistering and popouts of ACCs.

Figure 22: X-ray elemental analysis from over an argillaceous clay clot (ACC) mass in sound 15-in. VCP from an islands of small angular quartz crystal as shown in the inset backscatter electron image.

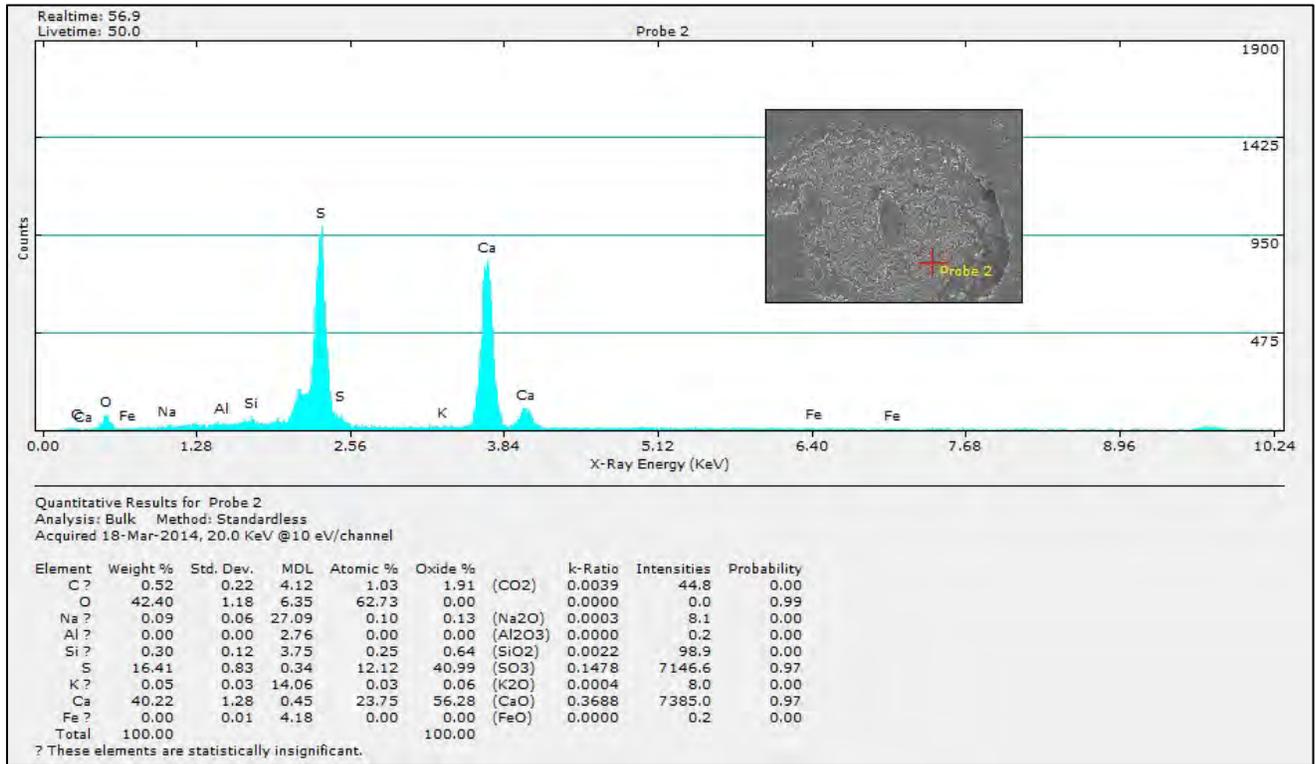
Figure 23: X-ray elemental analysis from over an argillaceous clay clot (ACC) mass in sound 15-in. VCP from secondary gypsum mass formed from reactions of small calcite grains in the clot, as shown in the inset backscatter electron image.
