ACID ATTACK IN A VITRIFIED CLAY PIPE (VCP) SEWER LINE – A PETROGRAPHIC AND CHEMICAL INVESTIGATION

THE DISTRESSED 33-IN. VCP OF THIS STUDY

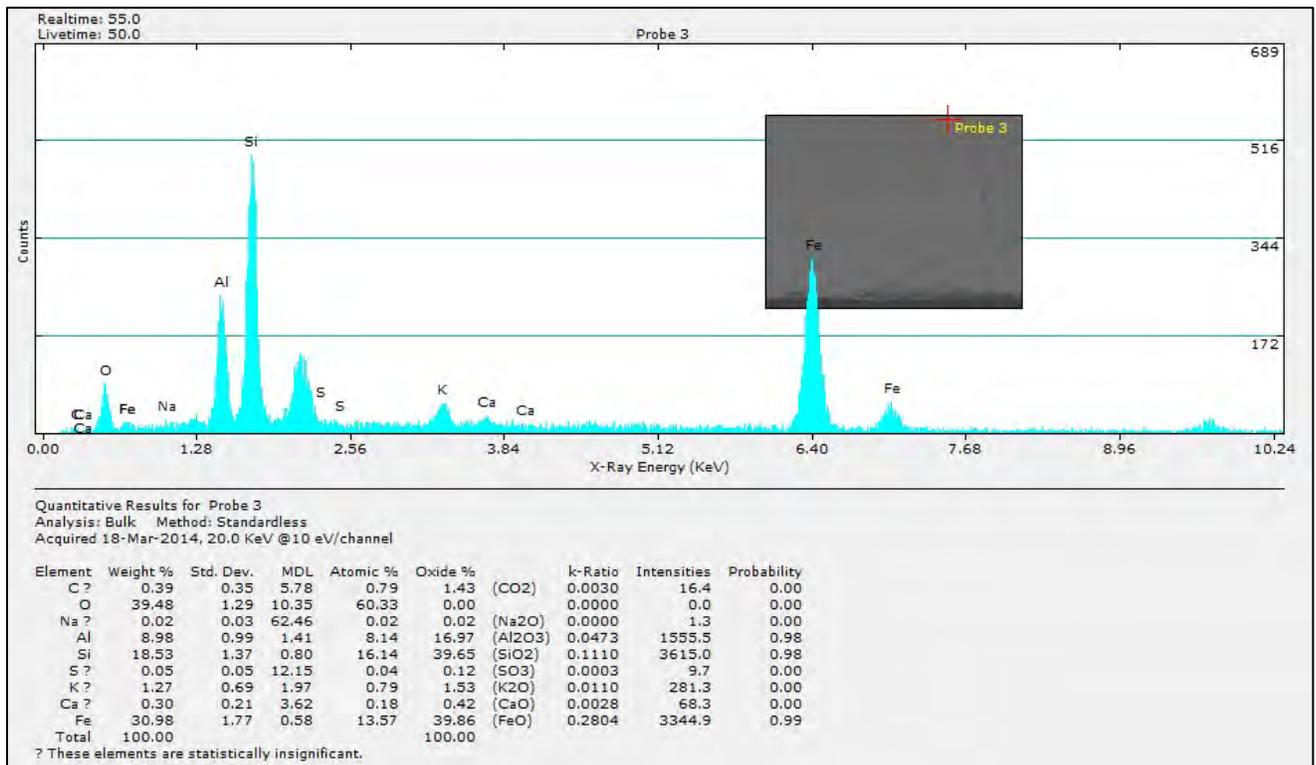
Figure 24 shows the reddish brown vitrified clay matrix, which is essentially composed of silicon, aluminum, and minor amounts of potassium, and iron. Distributed throughout the vitrified clay matrix are very fine-grained (nominal 0.2 mm size) angular tempered quartz grains, such as one shown in Figure 25.

Figure 24: X-ray elemental analysis of reddish brown vitrified clay matrix essentially composed of silicon, aluminum, and minor amounts of potassium, and iron.

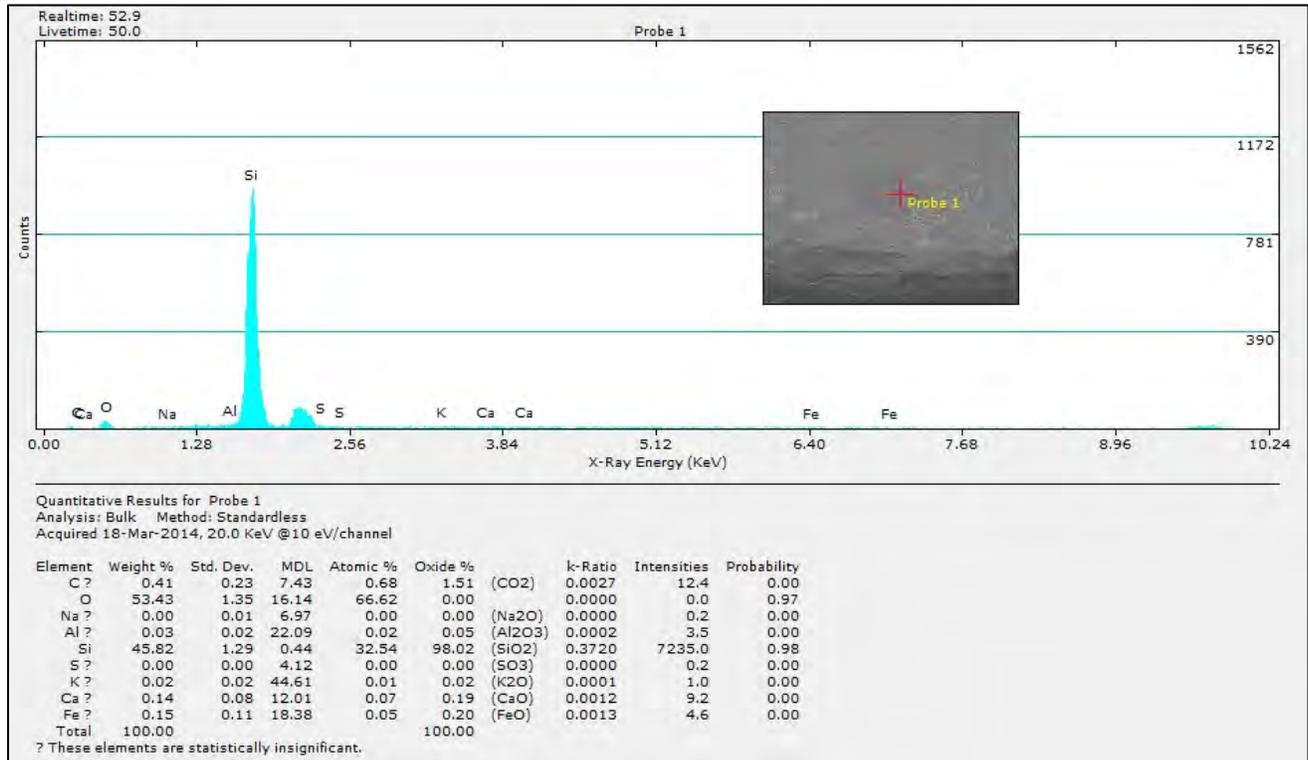
Figure 25: Fine-grained (nominal 0.2 mm size) angular tempered quartz grains scattered over the vitrified clay matrix in sound pipe.
