Historic Mortars From A National Historic Landmark In The Nation's Capital

Dipayan Jana

Construction Materials Consultants, Inc. and Applied Petrographic Services, Inc.

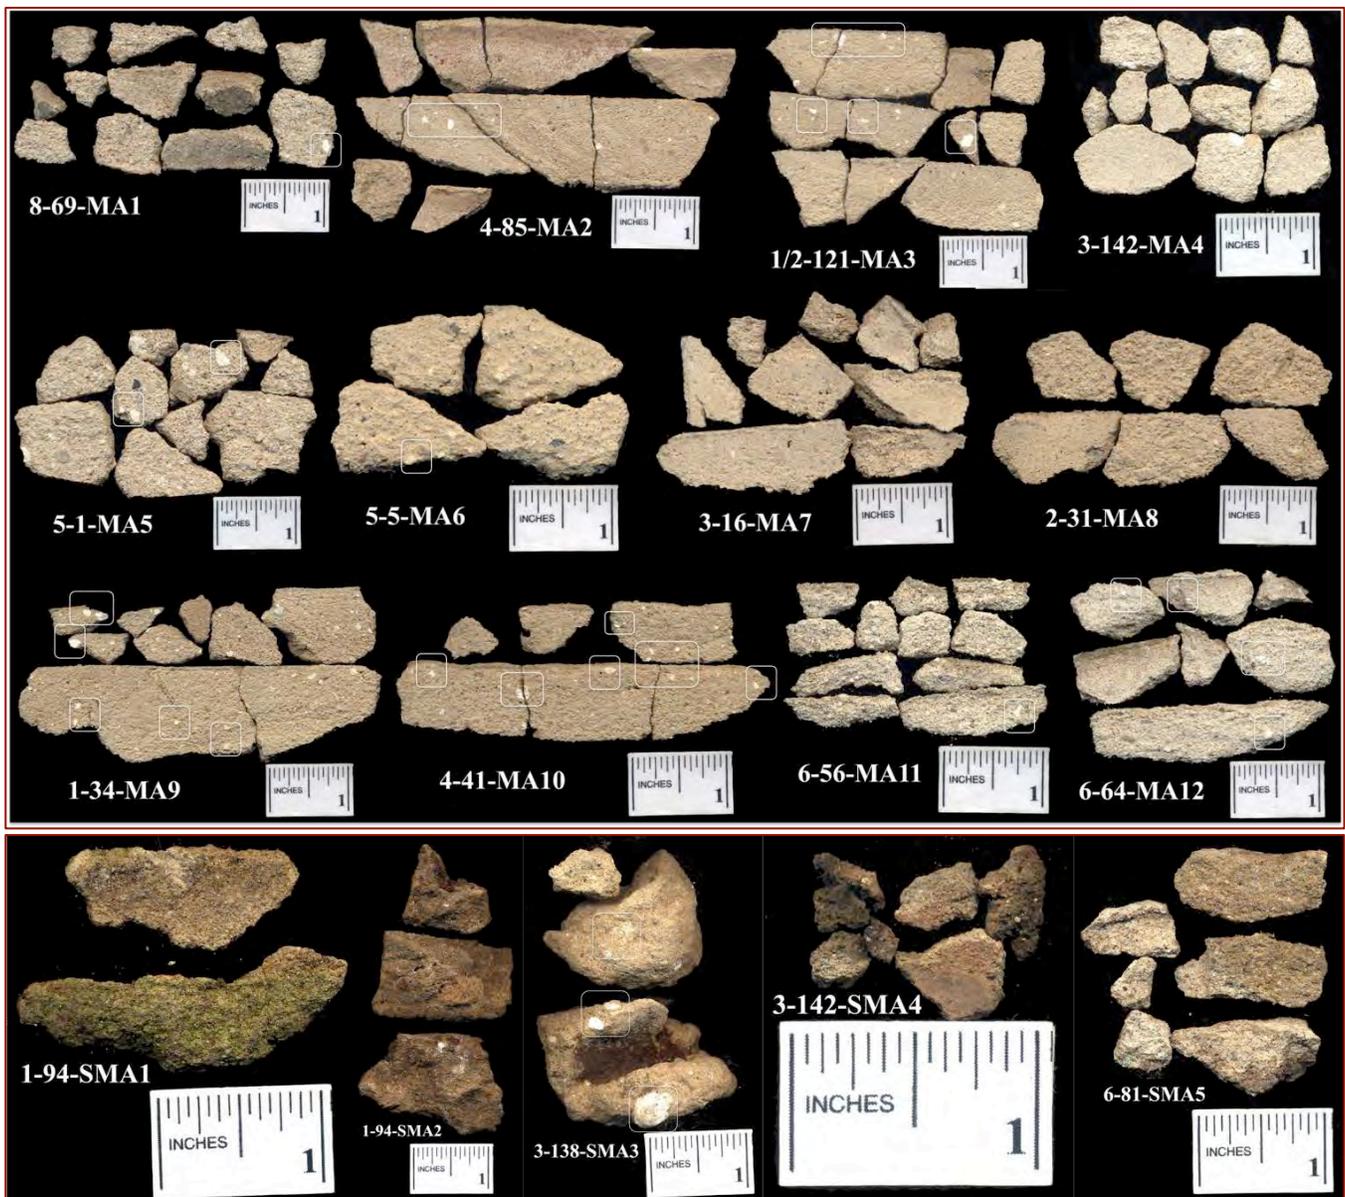
Figure 2: Intact fragments of twelve (12) brick masonry mortar samples (top), and, five (5) stone masonry mortar samples (bottom), as received. Individual pieces of each sample are scanned in a flatbed scanner. Boxes in many of these pieces enclose white unmixed lime lumps. These fragments were removed from bags that also contained an appreciable amount of powdery, disintegrated mortars that may have lost the integrity during collection and/or

Figure 2 and Appendix A2 through A10 show conditions and appearances of brick and stone masonry mortar samples, as received, in a great detail, prior to any sample preparation steps. The following Table summarizes overall weights in grams, dimensions (in inches) of largest fragments, appearance, and integrity of each sample:

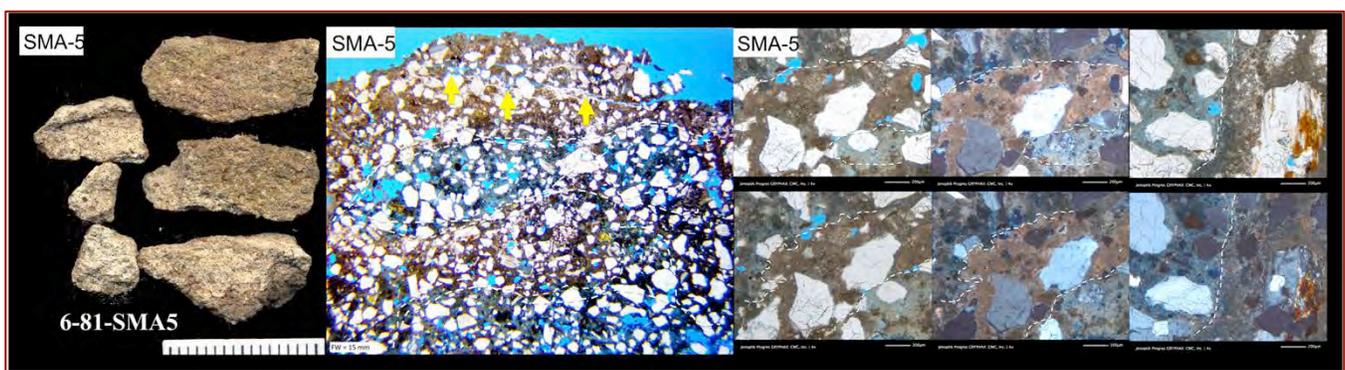
Figure 27: Stone masonry mortar SMA5. Thin section shows banded nature, similar to SMA2, having denser, lesser-carbonated, golden yellow bands of paste (in XPL) alternating with more carbonated, porous lime matrix where denser brown bands are found to have (from further SEM-EDS studies) more Ca and less Si (higher Ca/Si ratio) than the porous carbonated and leached areas (having more Si, lower Ca/Si ratio from lime leaching than the brown bands) in between the denser Ca-rich bands. Some fine surface-parallel microcracks are noticed within the denser brown band at the exposed surface as shown with yellow arrows in the second photo.
