Investigation of Concrete Surface Cracking by Laboratory Examinations of Three Concrete Cores

Appliance II
251 Bilmar Drive
Pittsburgh, PA 15205

The purpose of this present study is to investigate surface cracking of an indoor concrete slab that was placed in November of 2018 and developed surface cracking by December 2018 and January 2019. The slab, though indoor, was reportedly placed without any protection from freezing during winter weather placement. The slab was placed on a vapor retarder and received a “burned” hard steel trowel finish. A 3500-psi, non-air-entrained, fiberglass-reinforced concrete mix with added 2% non-chloride accelerator, and superplasticizer was used that provided a slump of 6 to 7.5 inches and fresh air content ranges of 1.2 to 1.8 percent. Cylinder breaks showed in excess of 3500 psi strength by 7 days (as opposed to that ‘design strength’ in 28 days) and a 170 percent increase in compressive strength to around 6000 psi in 28 days to increase the elastic modulus of concrete significantly higher than a modulus more consistent with the reported design mix. Project specification reportedly called for saw-cut control joints placed at 15 ft. intervals, whi

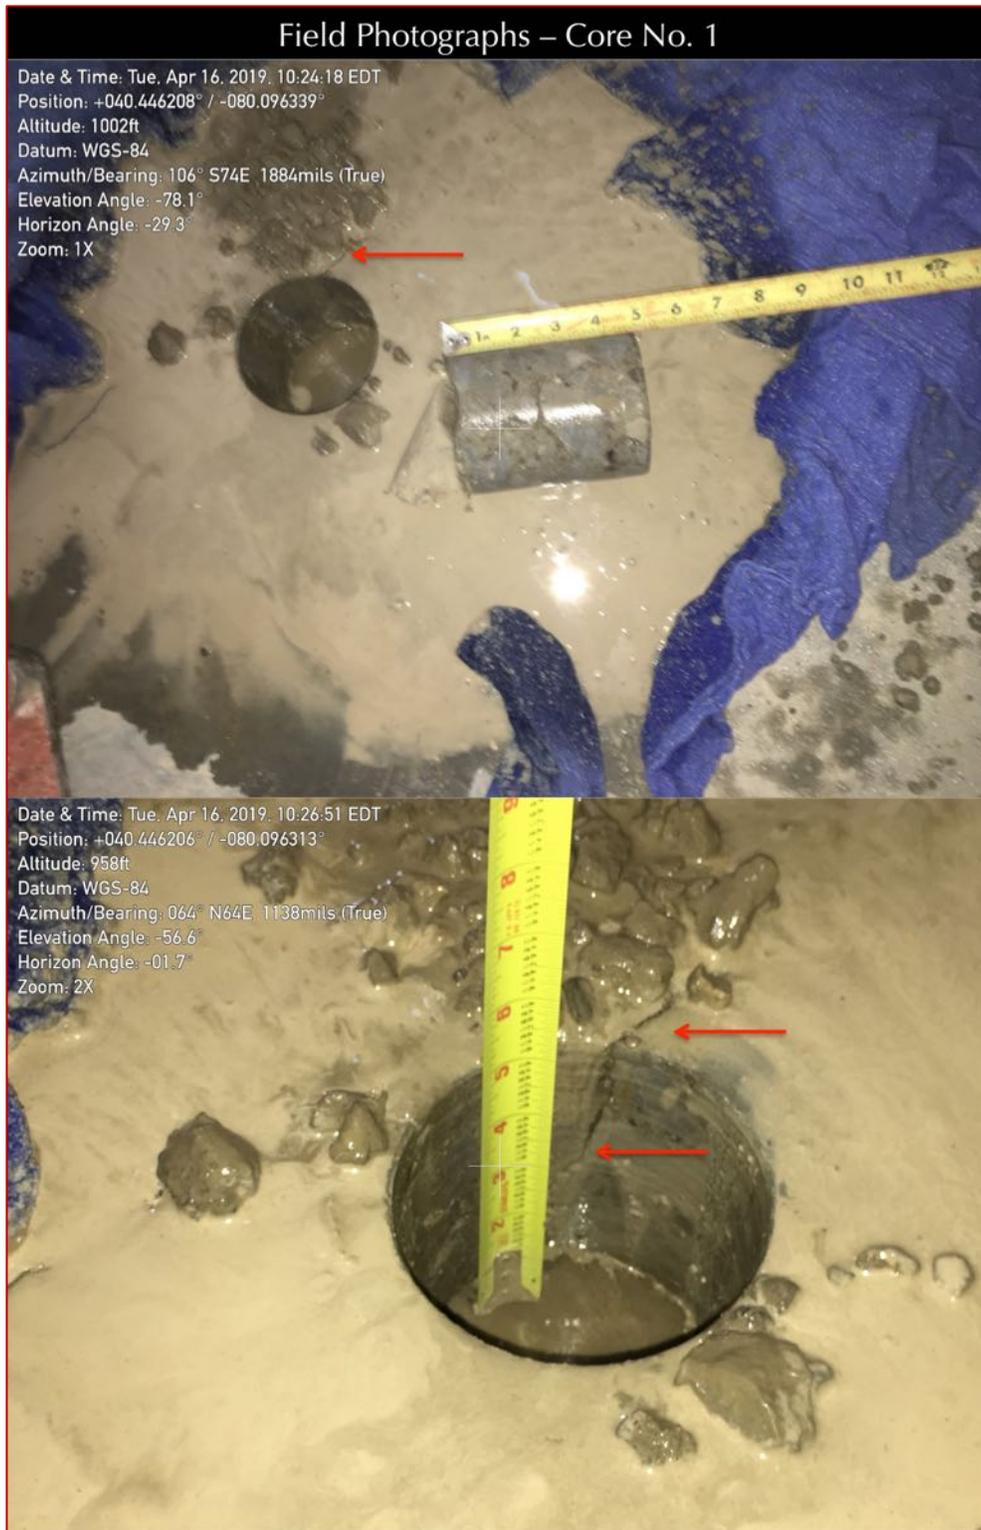
Figure 4: Reports of field inspection during placement of concrete slab, received with the cores. Notice two placement dates on November 10 and 11 of 2018 with respective 6 to 7.5 in. slump, and air contents of 1.2 to 1.8 percent of freshly placed concrete on both dates.

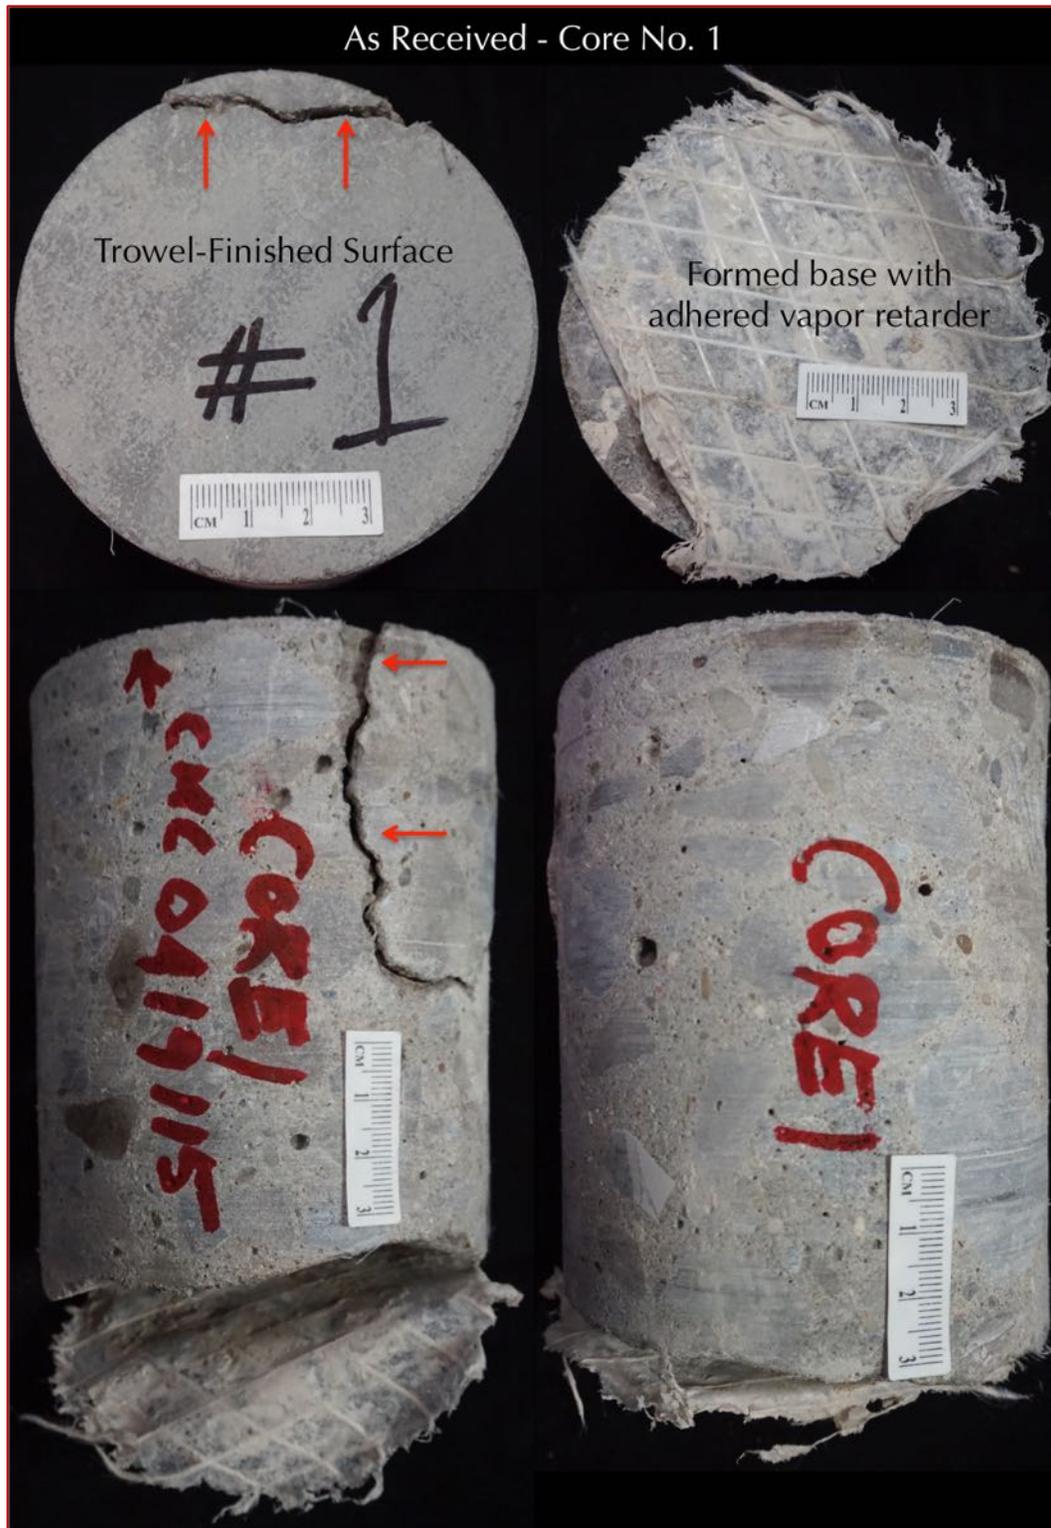
Figure 9: Photos of Core 1 as received. Top left – Top end of core showing smooth, flat, dense, hard, dark gray, trowel-finished surface of slab on which is a visible crack (arrows) that was probably widened during coring and core retrieval processes. Top right – Bottom end of core showing wavy, formed bottom surface of slab with remains of a fiber-reinforced plastic vapor retarder on which the slab was placed. Bottom row – Side views of the core showing partial-depth extension of the surface crack to a depth of about 2 inches, and overall dense, well-consolidated nature of concrete away of the visible crack.

Core 1 showed a major visible crack at one edge that has extended to a depth of 2 inches. Core 3 showed almost full-depth cracking appeared as fine hairline cracks as well as network of craze cracking on the top surface. By contrast, top surface and side of Core 2 showed no visible cracking.

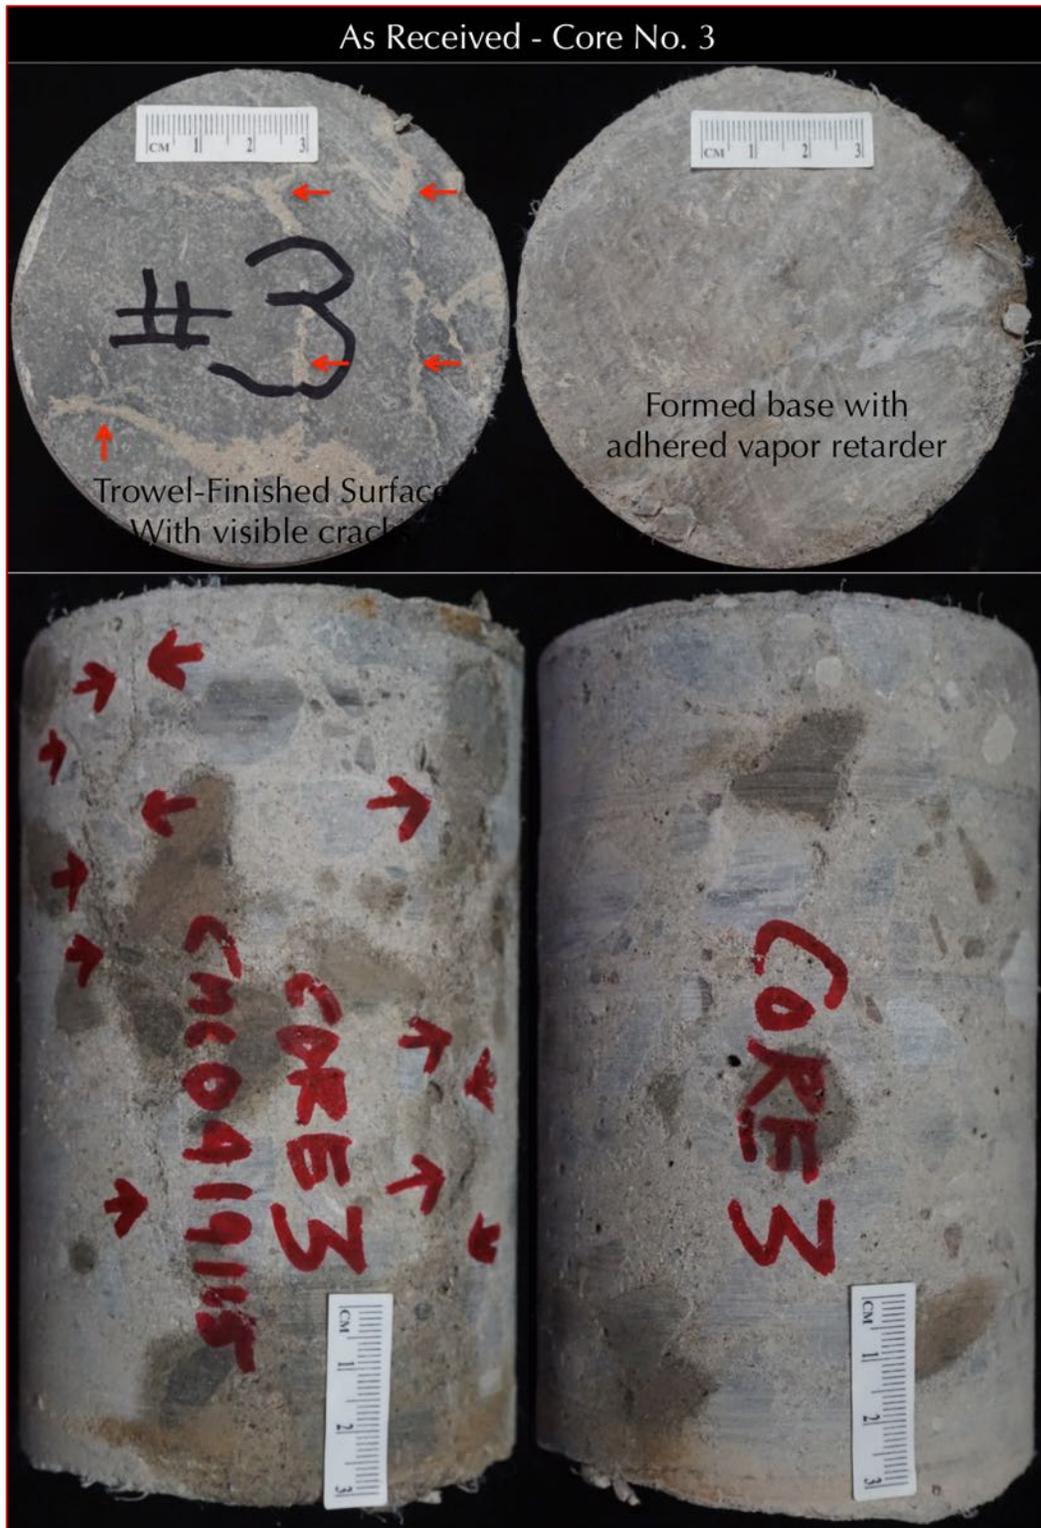
Figure 11: Photos of Core 3 as received. Top left – Top end of core showing smooth, flat, dense, hard, dark gray, trowel-finished surface of slab on which is a network of visible cracks (arrows) similar to fine, hairline craze cracking. Top right – Bottom end of core showing wavy, formed bottom surface of slab with remains of a fiber-reinforced plastic vapor retarder (not shown in the photo but received with the core) on which the slab was placed. Bottom row – Side views of the core showing almost full-depth extension of the surface cracks (arrows), and overall dense, well-consolidated nature of concrete away of the visible cracks.

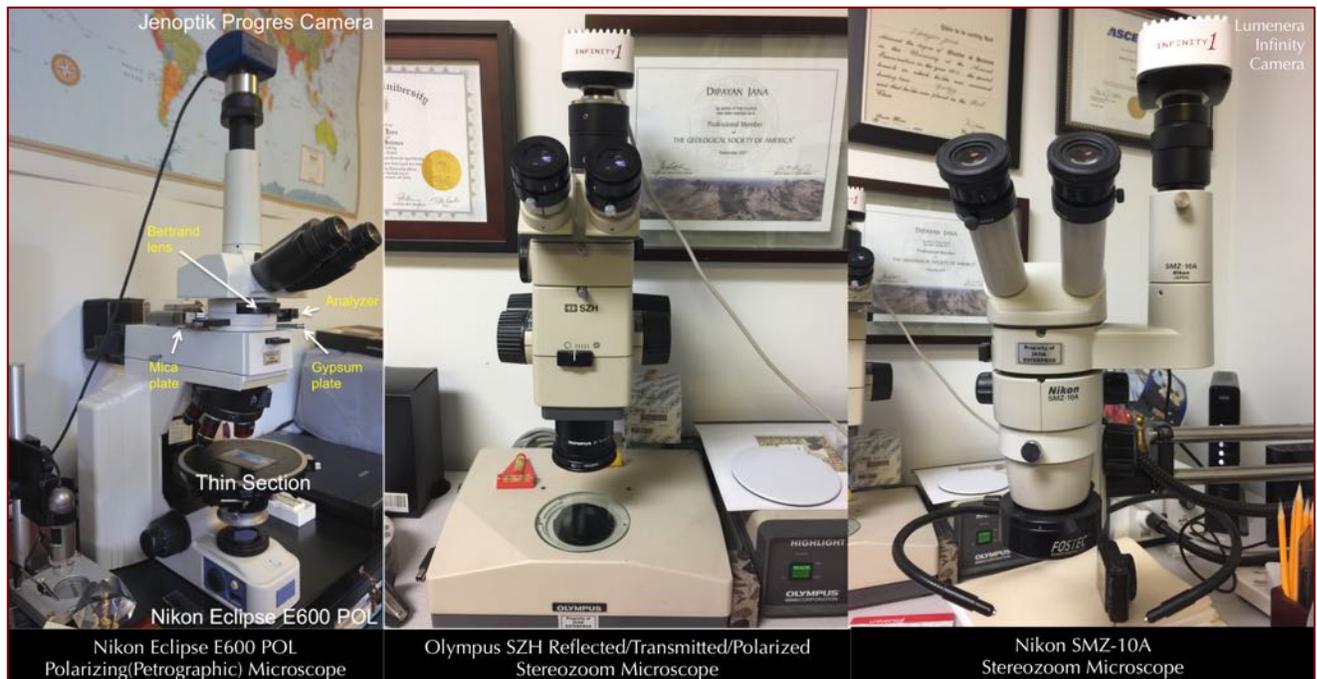
Figure 12: Nikon Eclipse E600POL Petrographic Microscope with Jenoptik Gryphax Camera (left), Olympus SZH (middle), and Nikon SMZ-10A Stereozoom Microscope (right) used for petrographic examinations.

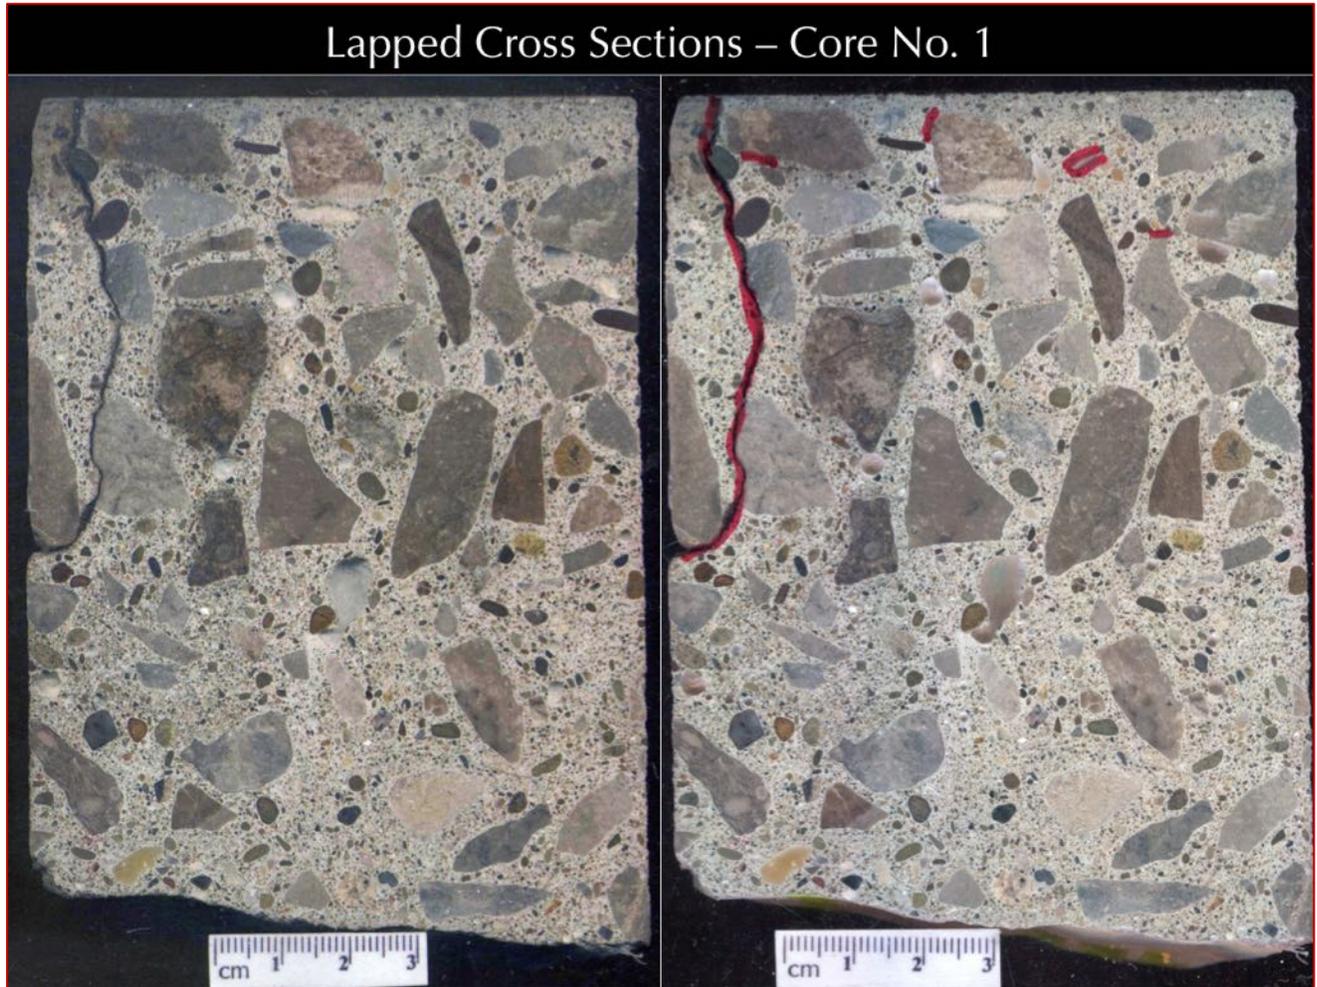
Figure 15: Lapped cross section of Core 1 showing: (a) crushed limestone-dolomite coarse aggregate, natural siliceous-calcareous sand fine aggregate, and well-graded, and well-distributed coarse and fine aggregates, (b) dense and well-consolidated nature of concrete, (c) densified finished surface region at the very top near-surface region (where paste is denser and darker gray than the body) due to trowel-finishing operations, (d) uniform color tone of paste in the body, except for the darker gray paste at the very top from trowel-finishing, and (e) partial-depth extension of the surface crack at the edge of the core to a depth of about 2 inches. The main crack and small short discontinuous separations at the top 1 in. of the finished surface region are highlighted in red in the right photo.

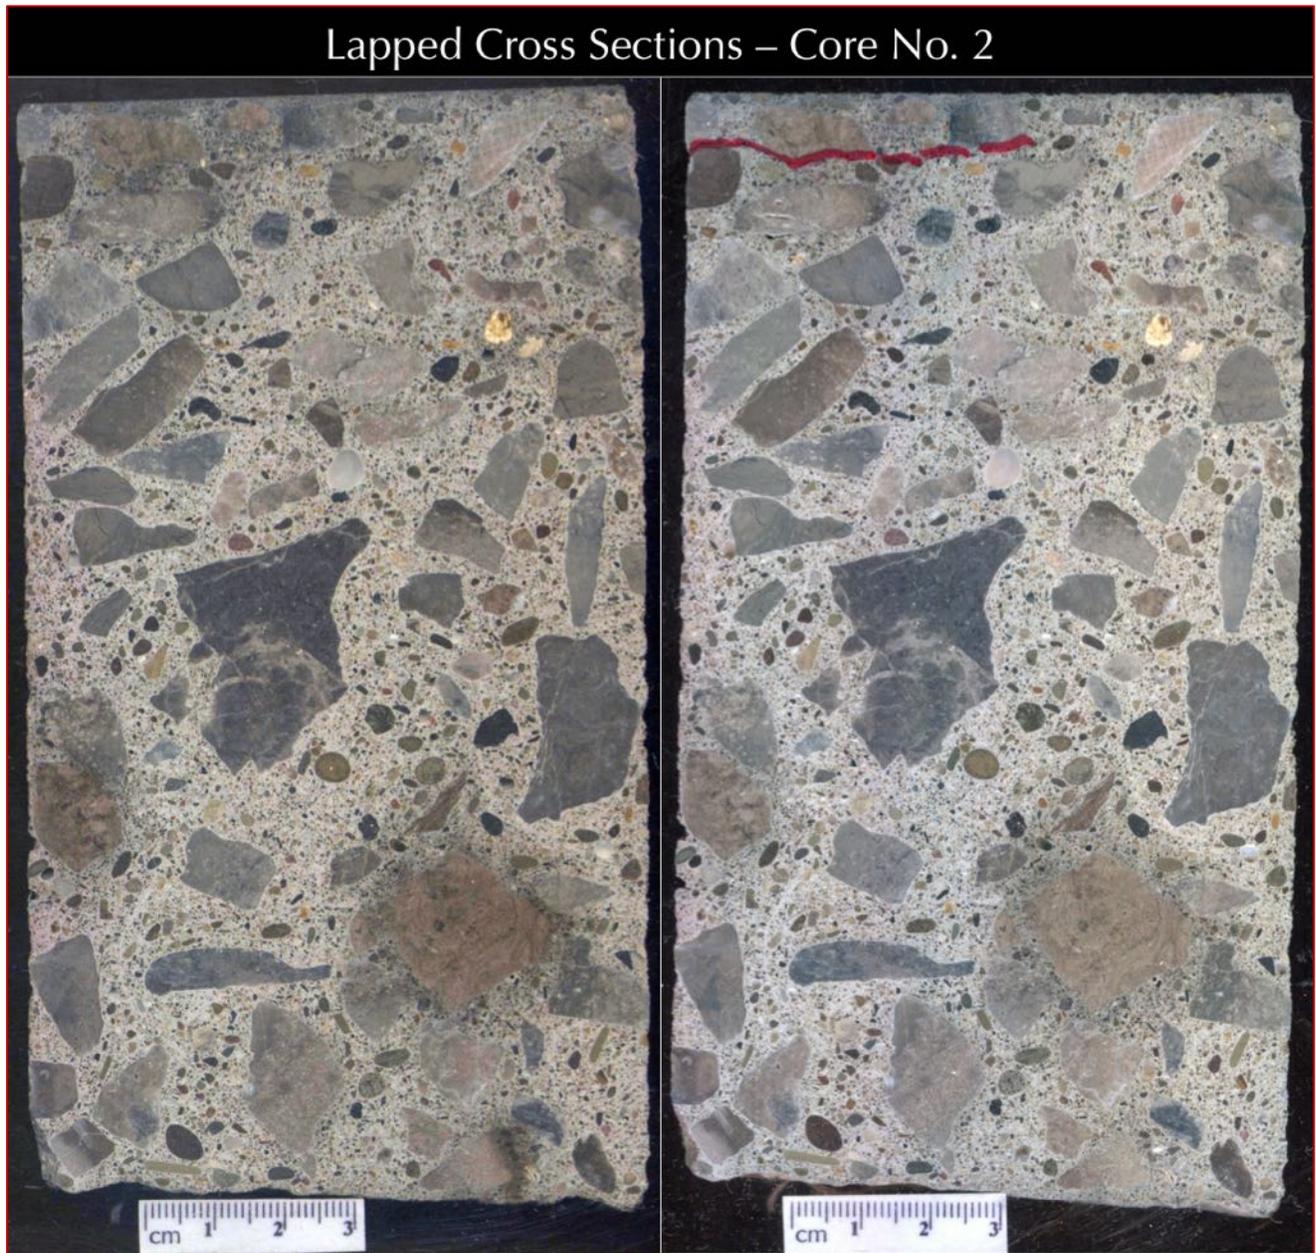
Figure 16: Lapped cross section of Core 2 showing: (a) crushed limestone-dolomite coarse aggregate, natural siliceous-calcareous sand fine aggregate, which are compositionally similar to the ones found in the concrete in Core 1, and well-graded, and well-distributed coarse and fine aggregates, (b) dense and well-consolidated nature of concrete, (c) densified finished surface region at the very top near-surface region (where paste is denser and darker gray than the body) due to trowel-finishing operations, (d) uniform color tone of paste in the body, except for the darker gray paste at the very top from trowel-finishing, and (e) occurrence of a few fine, hair-like microcracking at the near-surface region of concrete to a depth of 10 to 15 mm from the finished surface, which is highlighted in red line in the right photo. Therefore, despite the absence of any visible macro or microcracks at the top finished surface at this core location, however, the interior concrete beneath the surface showed some microcracking at a depth of 10 to 15 mm from the finished surface.
