Petrographic Examinations and Air-Void Analyses of
Four (4) Concrete Cores From
PROJECT NAME

PROJECT NAME
ADDRESS
ADDRESS

Prepared for:
CLIENT

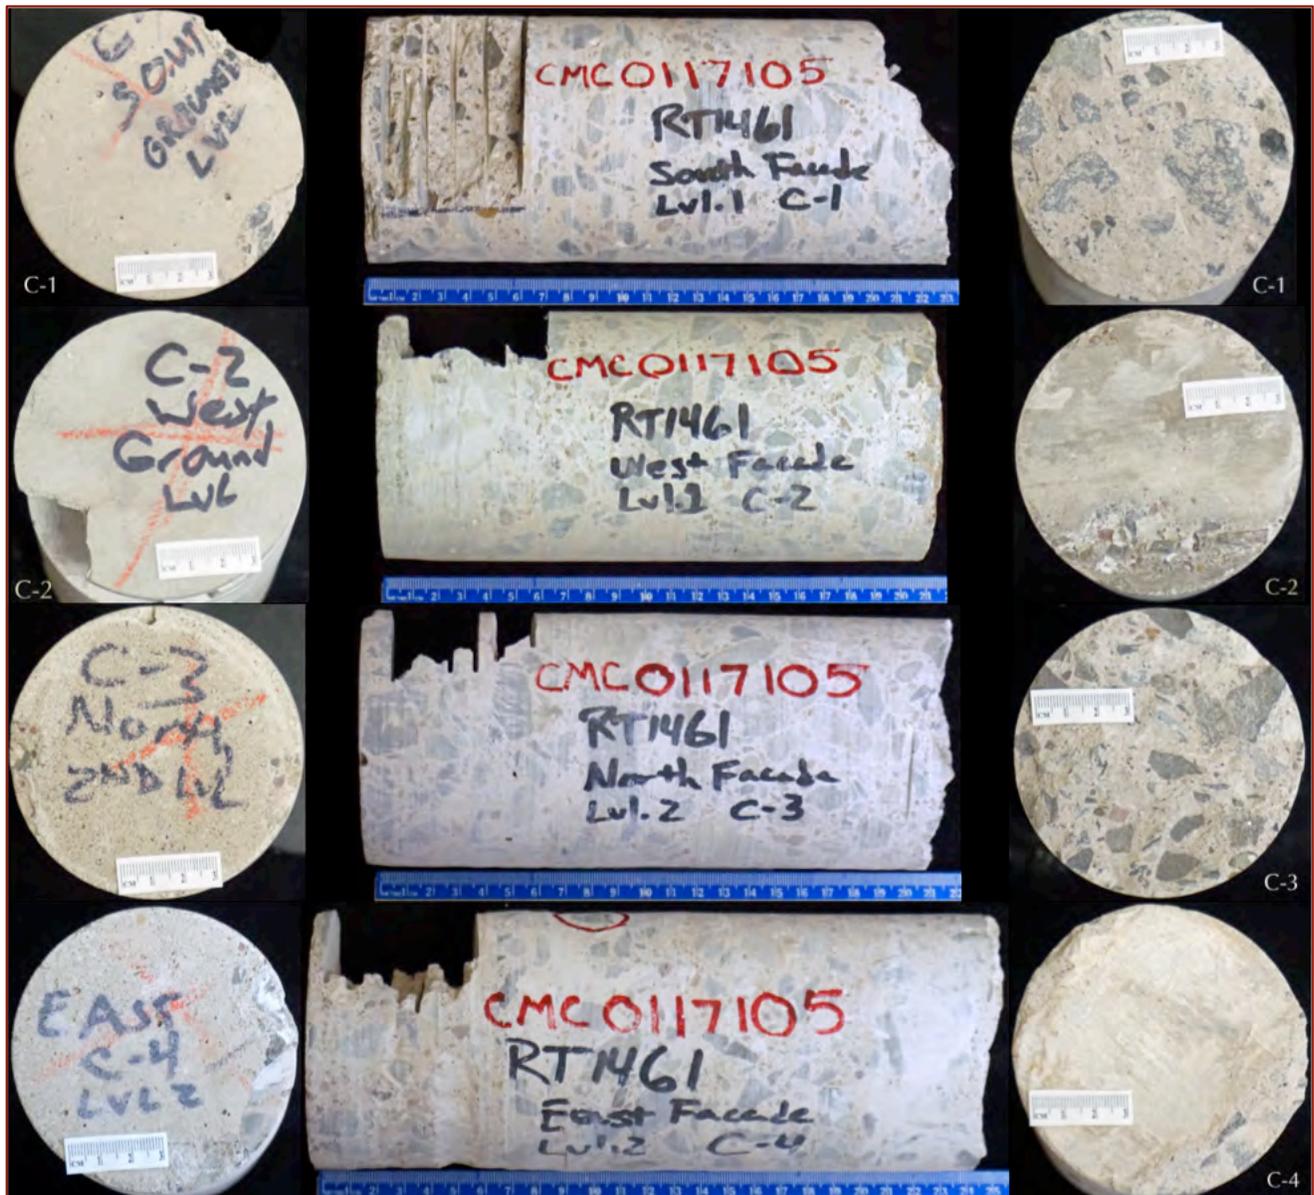
All four cores showed portions of concrete removed from depths of 1/4 in. (7 mm) to 2 1/2 in. (58 mm) from the top surfaces, as described in Table 1 and seen in the middle column along the top side cylindrical surfaces of cores in Figure 5. There are no major cracks, joints, or voids present in the cores received. All four cores were received in intact conditions, except for the above-mentioned partially removed portions.

Figure 5: Overview of concrete cores received. For each core: left photo shows the top exposed surface, right photo shows bottom surfaces, and middle photos show side cylindrical views of the cores, as received. All four cores show some removal of sample from the top 2 inches probably due to some other (e.g., chloride content) testing not requested in this study.
