Investigation Of Surface Distress of Concrete Slab-On-Grade Deck Around A Swimming Pool From Petrographic Examinations of A Concrete Core

Morio Pool
3183 Stillwater Cove NE
Solon, Iowa

July 28, 2020
CMC 0720136

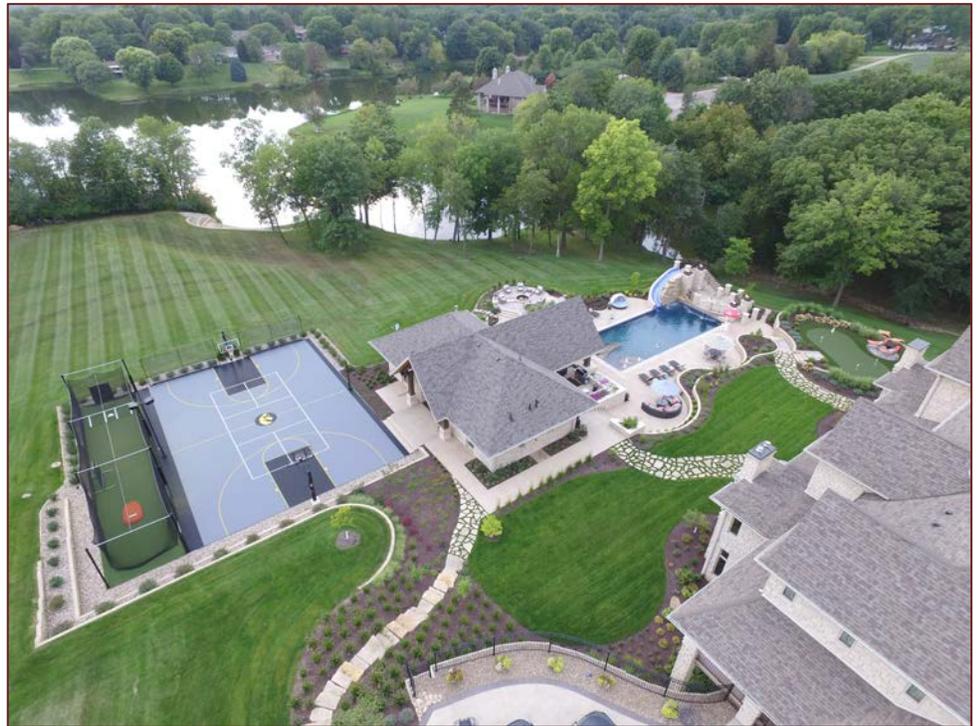
Field photos of pool deck showed several isolated areas of severe concrete surface scaling as complete loss of the finished surface to the point of exposure of underlying coarse aggregate particles, as well as 'incipient scaling,' where the finished surface is de-bonded from the main body but is still loosely adhered.

Figure 1 shows overall conditions of scaled concrete surface at the project location where the original finished surface of the concrete has been lost at isolated locations including incipient scaling where the finished surface is loosely adhered to the main body of concrete. Severe scaling of the surface to the point of exposures of near-surface coarse aggregate particles are seen in all three photos of concrete slab around the pool.

Therefore, contrary to the reported mix design of an air-entrained concrete, the present concrete in the core is found to be non-air-entrained. Absence of air entrainment is determined to be the main reason for the surface scaling of the pool deck in the presence of moisture and cyclic freezing and thawing at critically saturated conditions. The concrete delivered at the location of the core examined here lacked an air-entraining agent hence did not stabilize a network of entrained air voids to protect the concrete from freezing-related distress.

Due to the absence of air entrainment all throughout the depth of the core, surface scaling is judged to continue during the future winter seasons to worsen the condition with time. Therefore, the pool deck is best recommended to be replaced with an air-entrained concrete as specified for the project, or is protected with a new layer of a durable, dense, air-entrained, topping well-bonded to the existing slab.

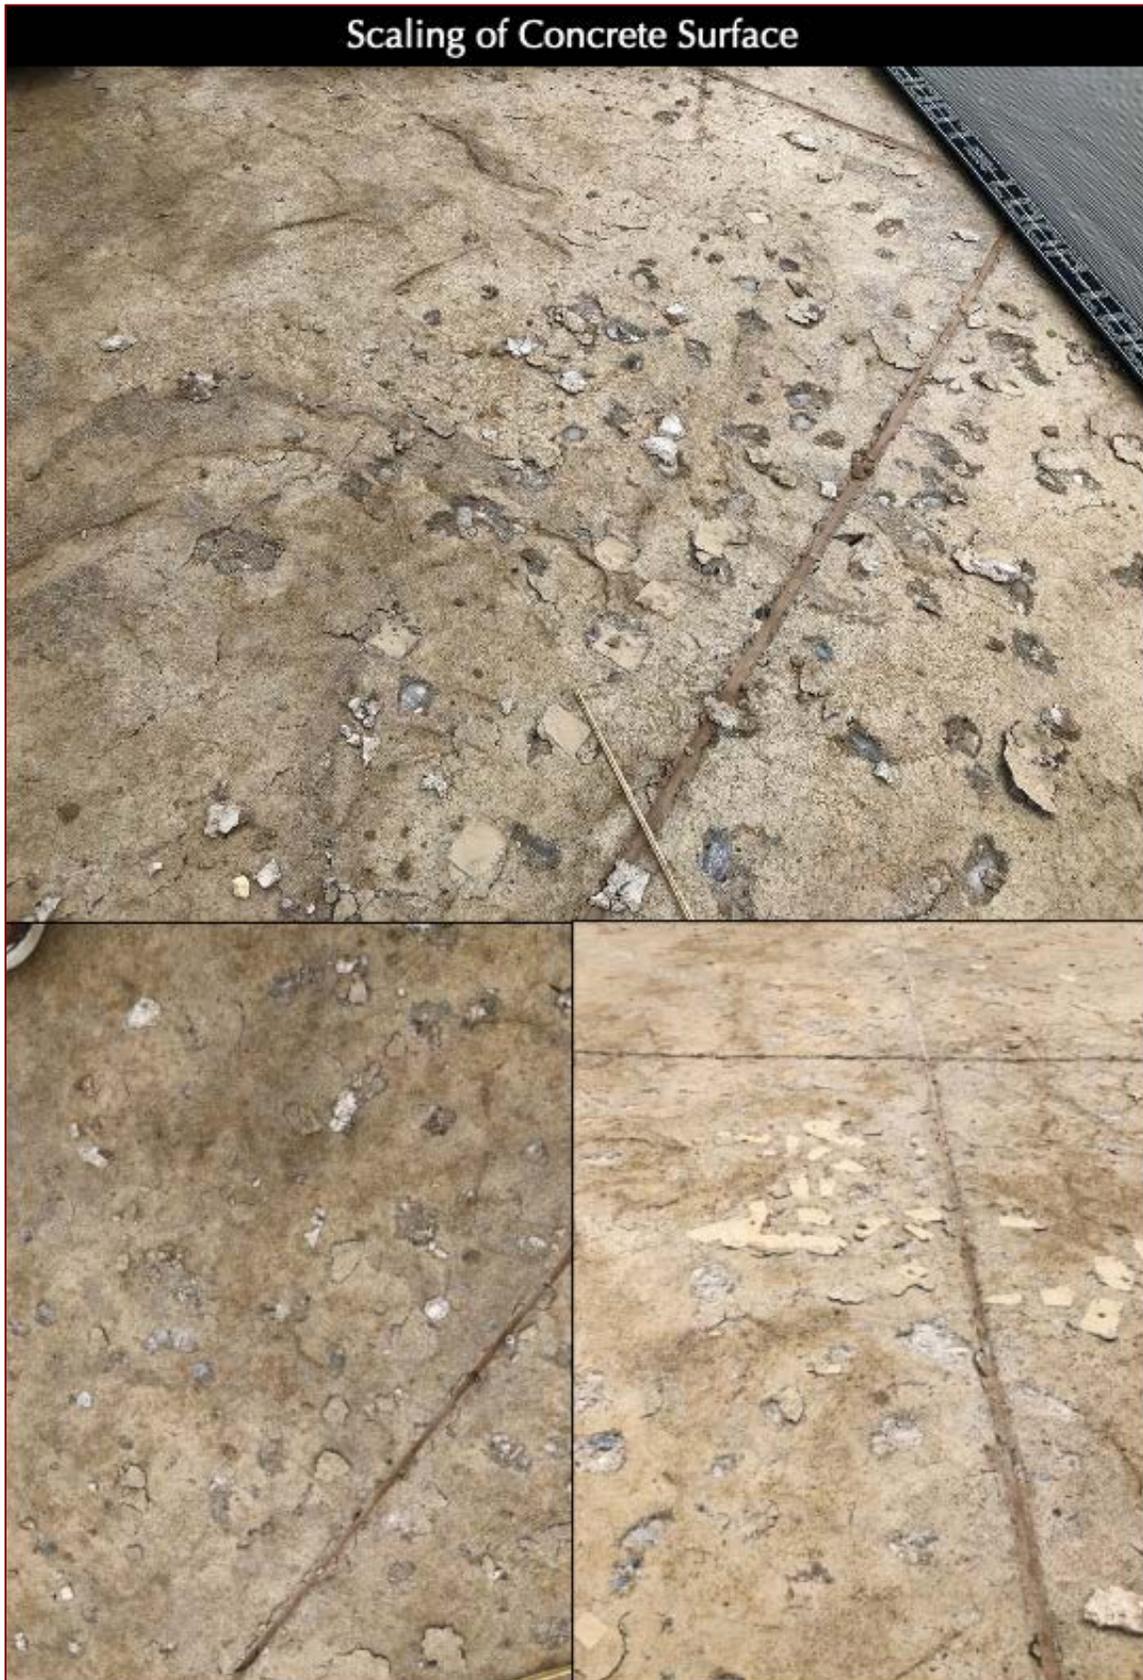
Figure 1: Field photographs showing isolated occurrences of scaling of the concrete surface around the pool deck from loss of the original finished surface of concrete.

Mortar lift-off as loss of thin sheet of the original finished surface of concrete from over the flat topside of near-surface aggregate particles is seen in field photos, which could also contribute to the surface distress. Mortar lift-off is not due to the exposed aggregate, which is sound and did not fracture (as would have been in the case of aggregate popout). Instead, the thin sheet of surface mortar was lost due to inadequate bond to the near-surface coarse aggregate. Mortar lift-off could have been avoided by deep embedding of aggregates along with a better bond of finished surface to the coarse aggregate from proper finishing operations and curing. Improper finishing can lead to mortar lift-off where flat topsides of aggregates situated very near the exposed surface do not form a good bond with the finished surface either due to repeated finishing passes and/or from excess water or other reasons.

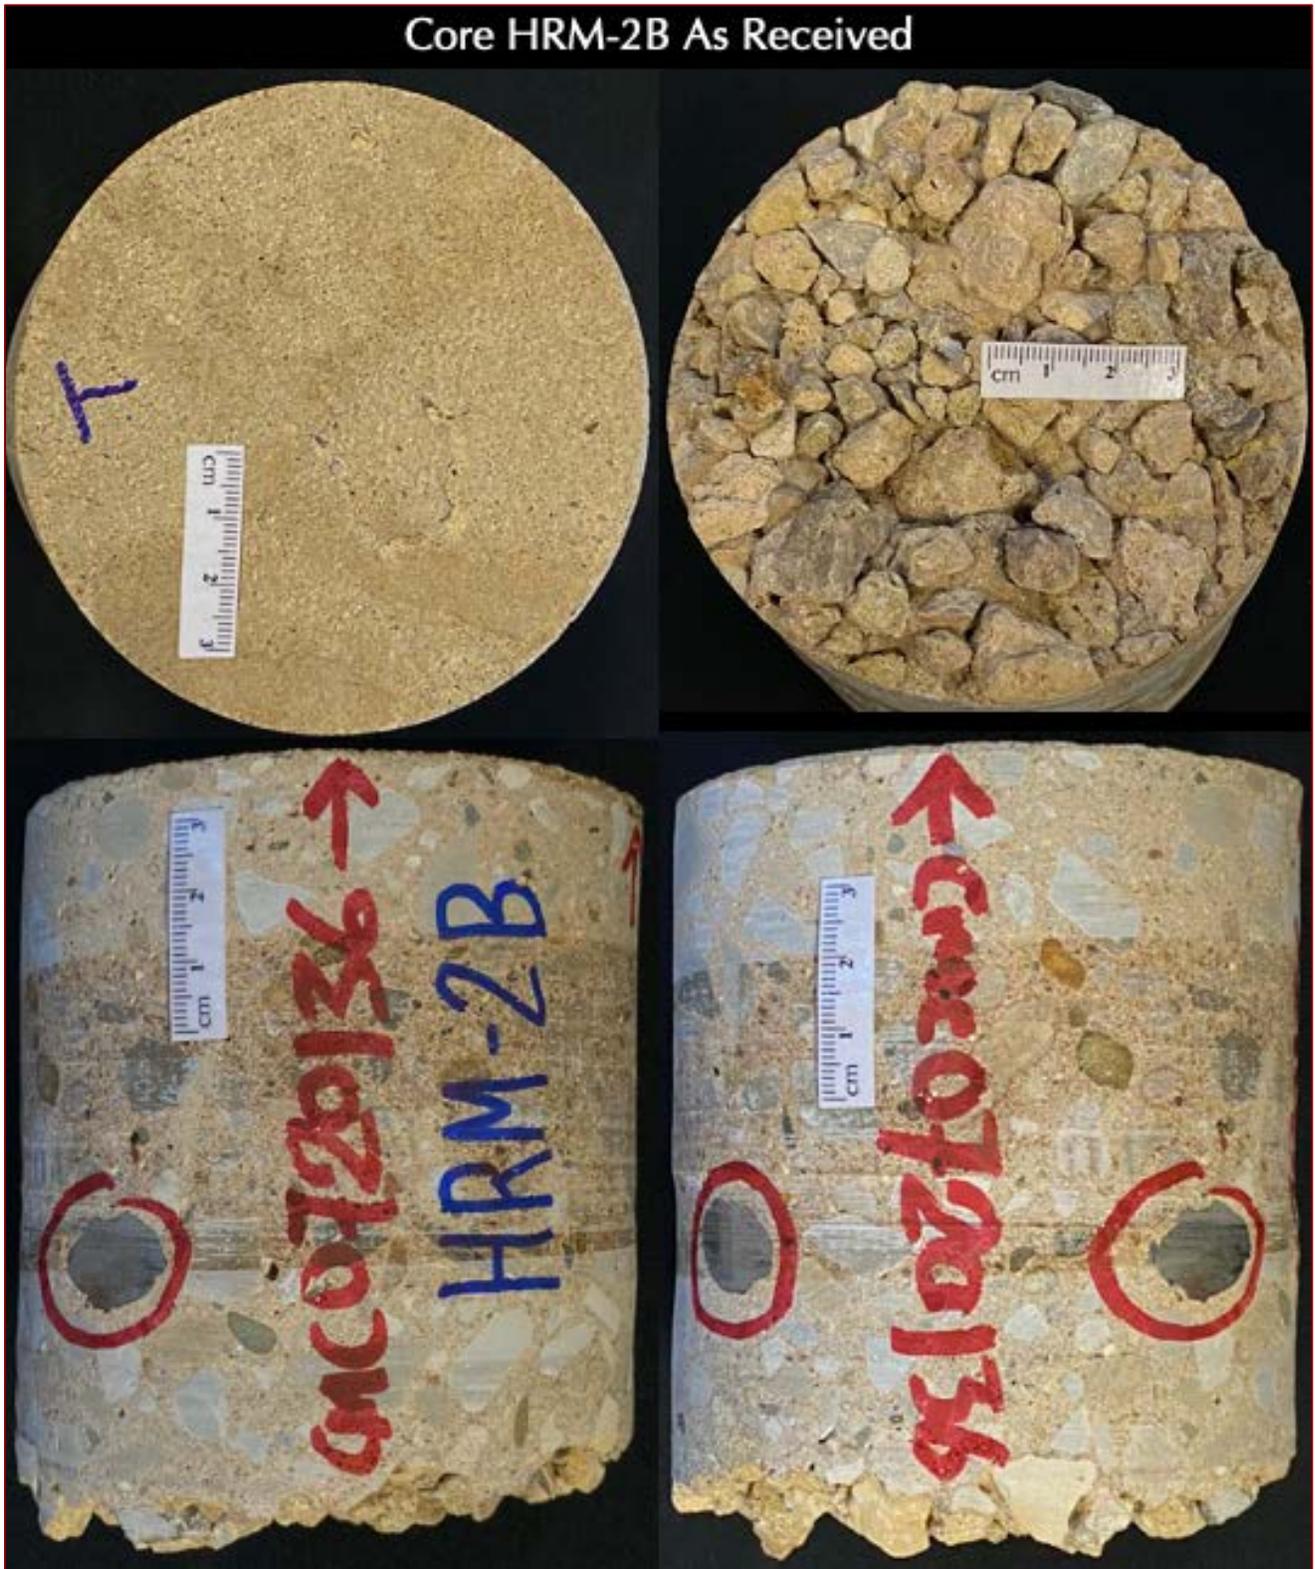
Figure 3 shows the core, as received, which has a diameter of 4 in. (100 mm), and a nominal length of 4¹/₂ in. (110 mm).

The top surface is shiny-finished with an incipient lift-off of a 20 mm area at the center.

The bottom surface shows crushed stone from the subbase, indicating full depth retrieval of the core from the pool deck slab at this location.

The core contains a No. 4 reinforcing steel at a depth of 2¹/₂ in. from the top surface, which is present in sound condition with no evidence of corrosion.

Figure 3: Shown are: (a) the top wearing surface of concrete slab at the top left photo having a central region where the original finished surface has been lifted off, but still loosely adhered to the main body; (b) crushed stone of subbase adhered to the bottom end of core (top right); and (c) side cylindrical views of the core HRM-2B showing a No. 4 reinforcing steel at a depth of 2¹/₂ in. from the top surface, which is present in sound condition with no evidence of corrosion.

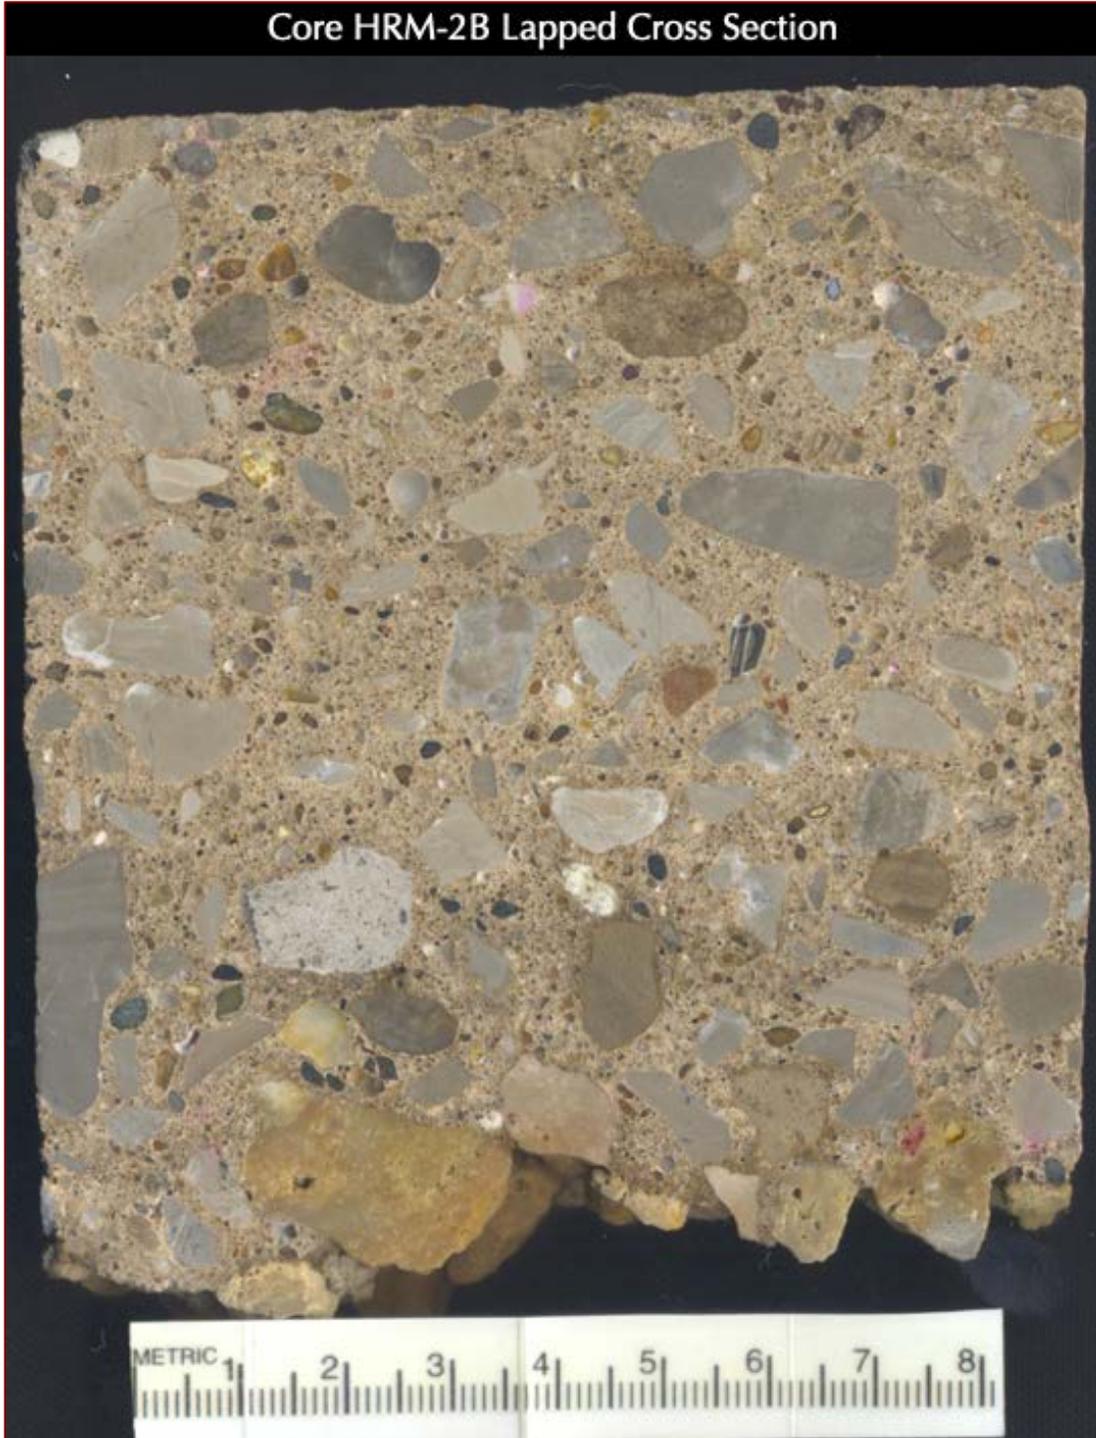
Figure 4: Lapped cross section of core showing: (a) crushed stone coarse aggregate particles that are well-graded and well-distributed; (b) overall dense and well-consolidated nature of concrete without any coarse voids; and (c) beige color tone of paste which is uniform throughout the depth. Crushed stone of subbase indicates full-depth extraction of the core.

The interior concrete is dense and well-consolidated without any coarse voids or honeycombing, indicating adequate consolidation of concrete during placement. There is also no evidence of any segregation of aggregates during placement. There is, therefore, no evidence of any improper consolidation practices of at the location of the received core.

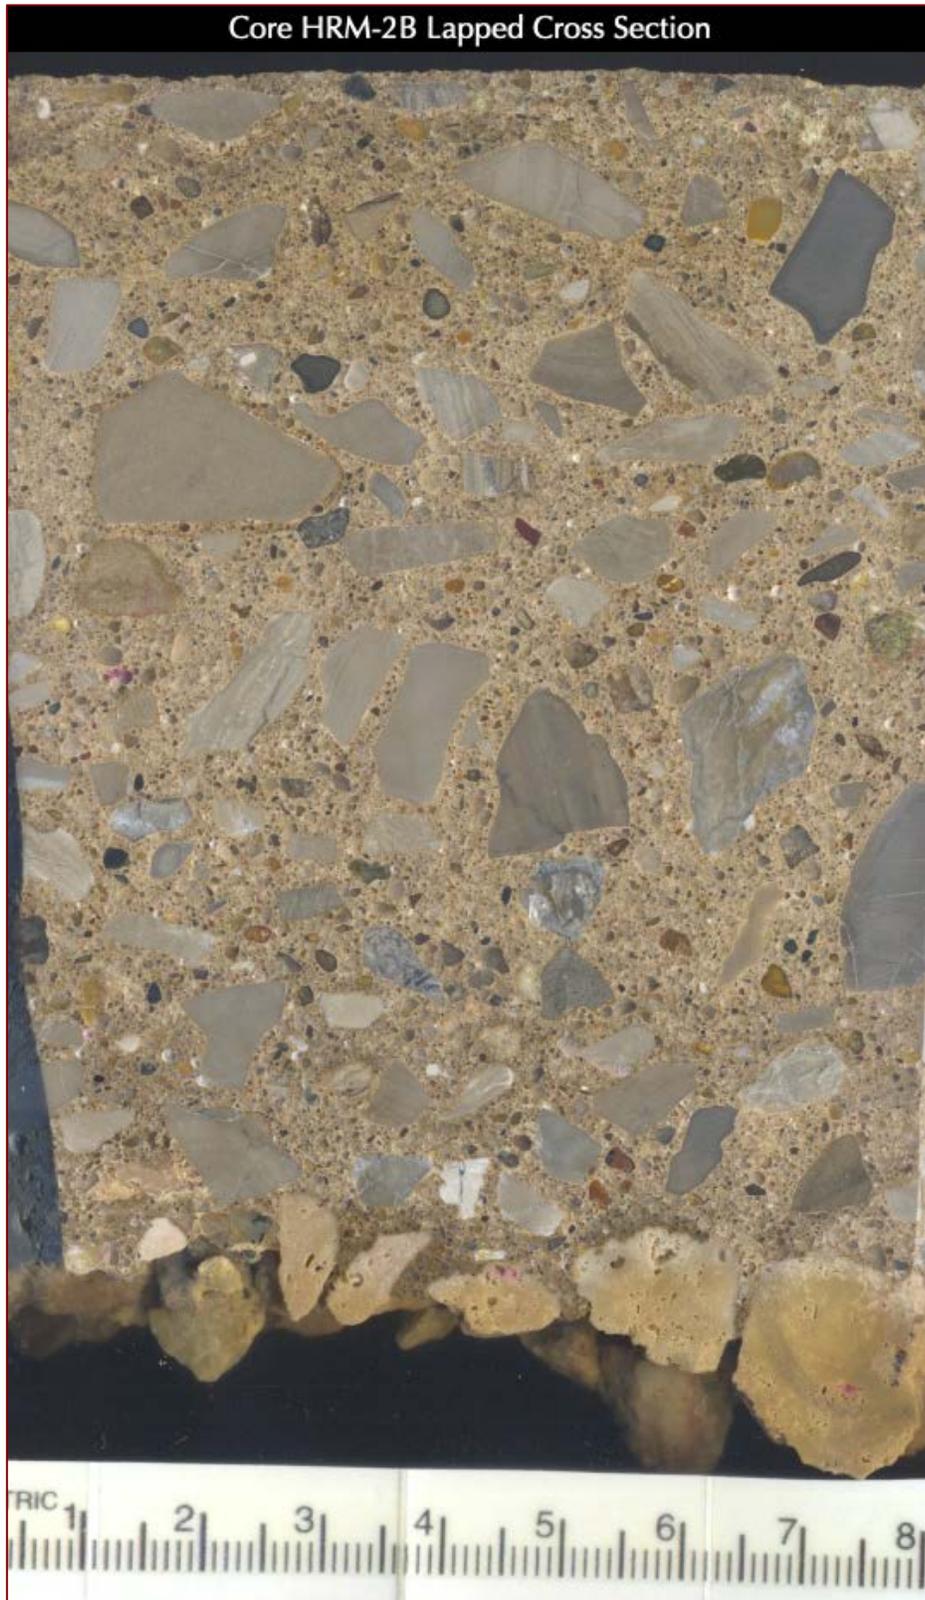
Figure 5: A second lapped cross section of core sectioned parallel to the first one shown in the previous photo showing: (a) crushed stone coarse aggregate particles that are well-graded and well-distributed; (b) overall dense and well-consolidated nature of concrete without any coarse voids; and (c) beige color tone of paste which is uniform throughout the depth. Crushed stone of subbase indicates full-depth extraction of the core.
