Investigation of Concrete Surface Scaling by Laboratory Examinations of Two Concrete Cores

Germantown Mill Lofts
Louisville, Kentucky

Reported herein are the results of detailed laboratory examinations of two (2) hardened concrete cores identified as 'north' and 'south' received from scaled concrete sidewalks at Germantown Mill Lofts located in Louisville, Kentucky.

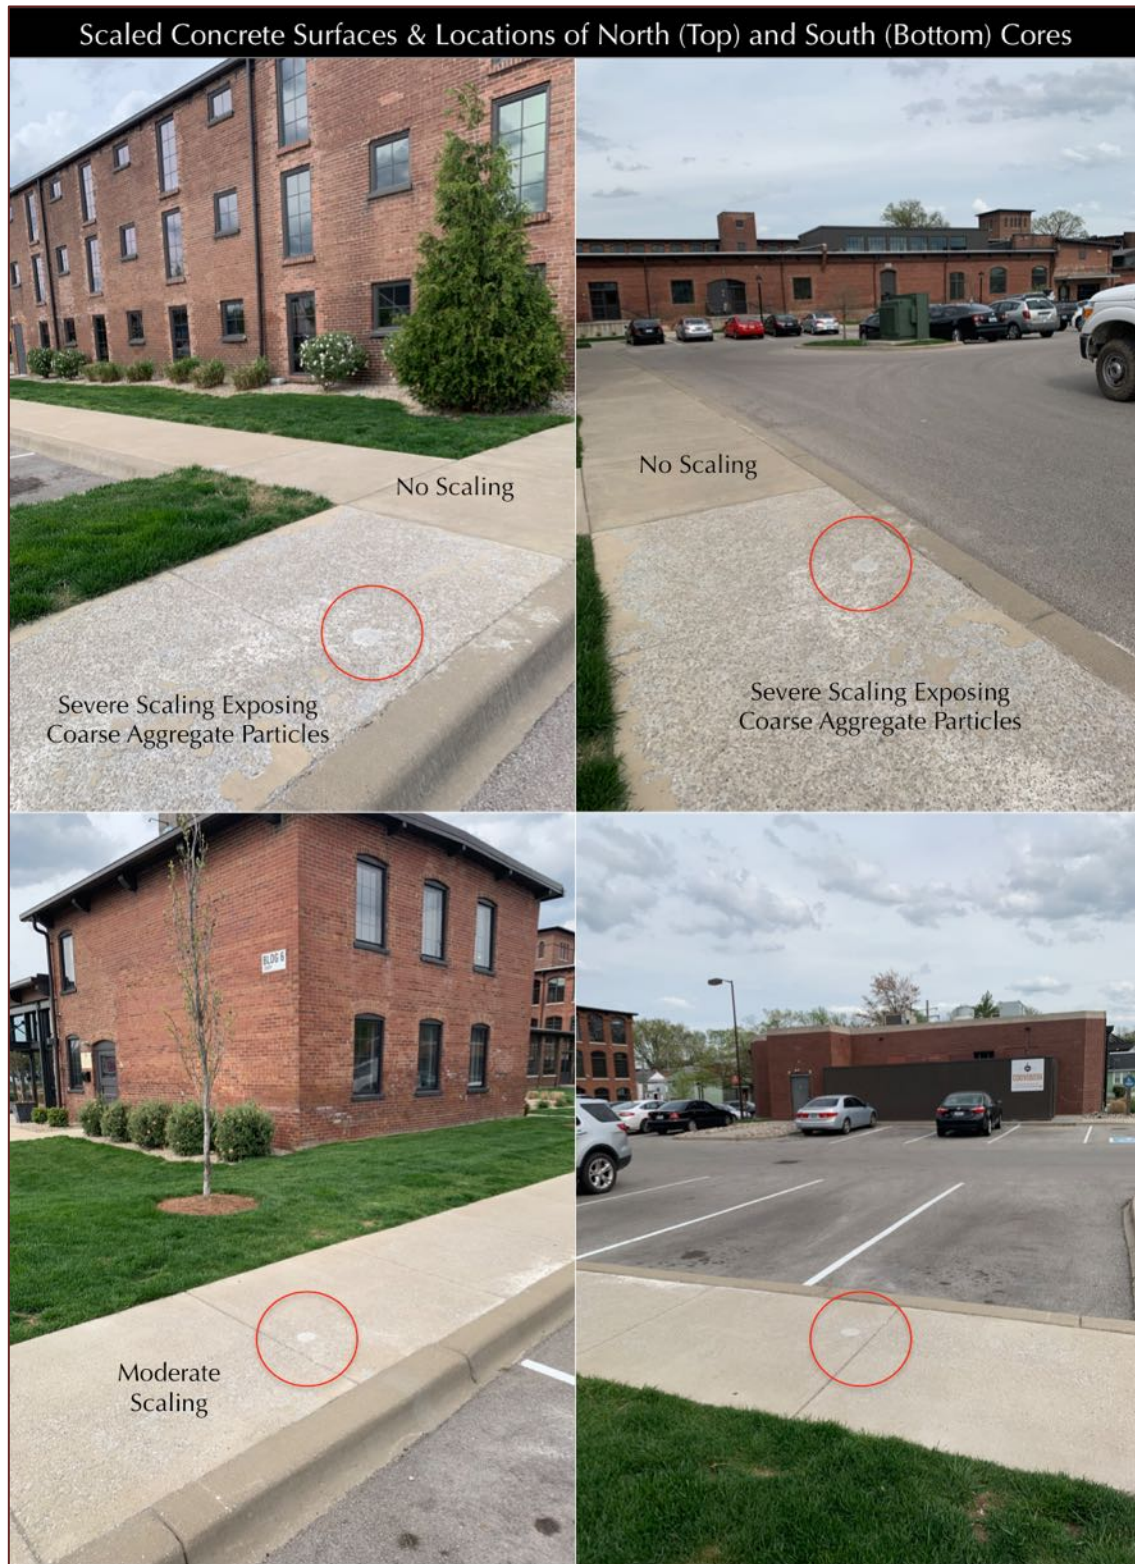
Figure 1 shows field photos of concrete surface distress at the locations of 'north' and 'south' cores. Figure 1 shows:

- a. Severe scaling of concrete surface and exposures of coarse aggregate particles at scaled locations of 'north' core in the top photo,
- b. Relatively lesser degree of surface scaling but exposure of coarse aggregate particles at the scaled location of 'south' core (bottom photo), and,
- c. Noticeably sound concrete slabs adjacent to the scaled ones of this investigation separated by construction joints.

Figure 1: Field photographs of concrete surface scaling at the locations of two cores (circled) marked as 'north' (top photo) and 'south' (bottom photo). Notice: (a) severe scaling of concrete surface and exposures of coarse aggregate particles at scaled locations of 'north' core in the top photo, (b) relatively lesser degree of surface scaling but exposure of coarse aggregate particles at the scaled location of 'south' core (bottom photo), and, (c) noticeably sound concrete slabs adjacent to the scaled ones of this investigation separated by construction joints.

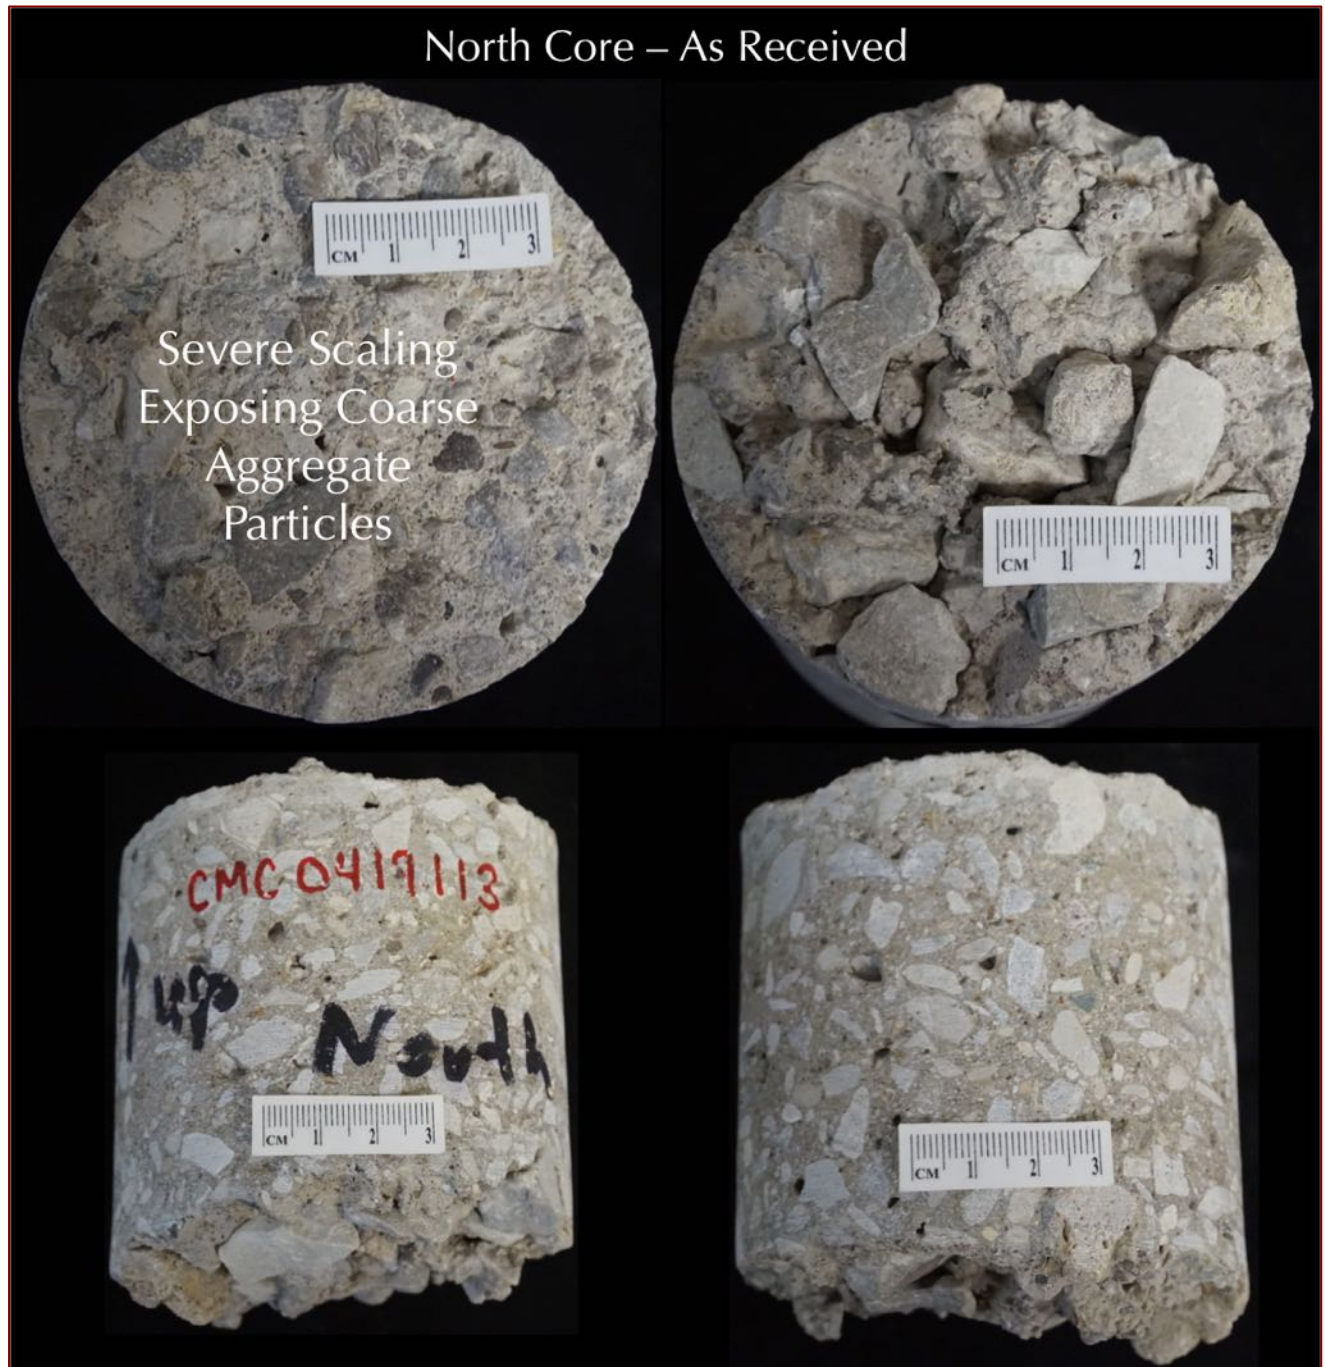
Both cores show scaled surfaces at the exposed top ends and adhered crushed stone of subbase in the bottom ends.

Scaling is more pronounced in the 'north' core with exposures of coarse aggregate particles.

Figure 2: Photographs of North Core as received. Top left – Exposed surface with severe scaling and complete loss of the finished surface with exposed coarse and fine aggregate particles; Top right - bottom surface with adhered stones from subbase; and Bottom row - cylindrical side views of the core with identification.

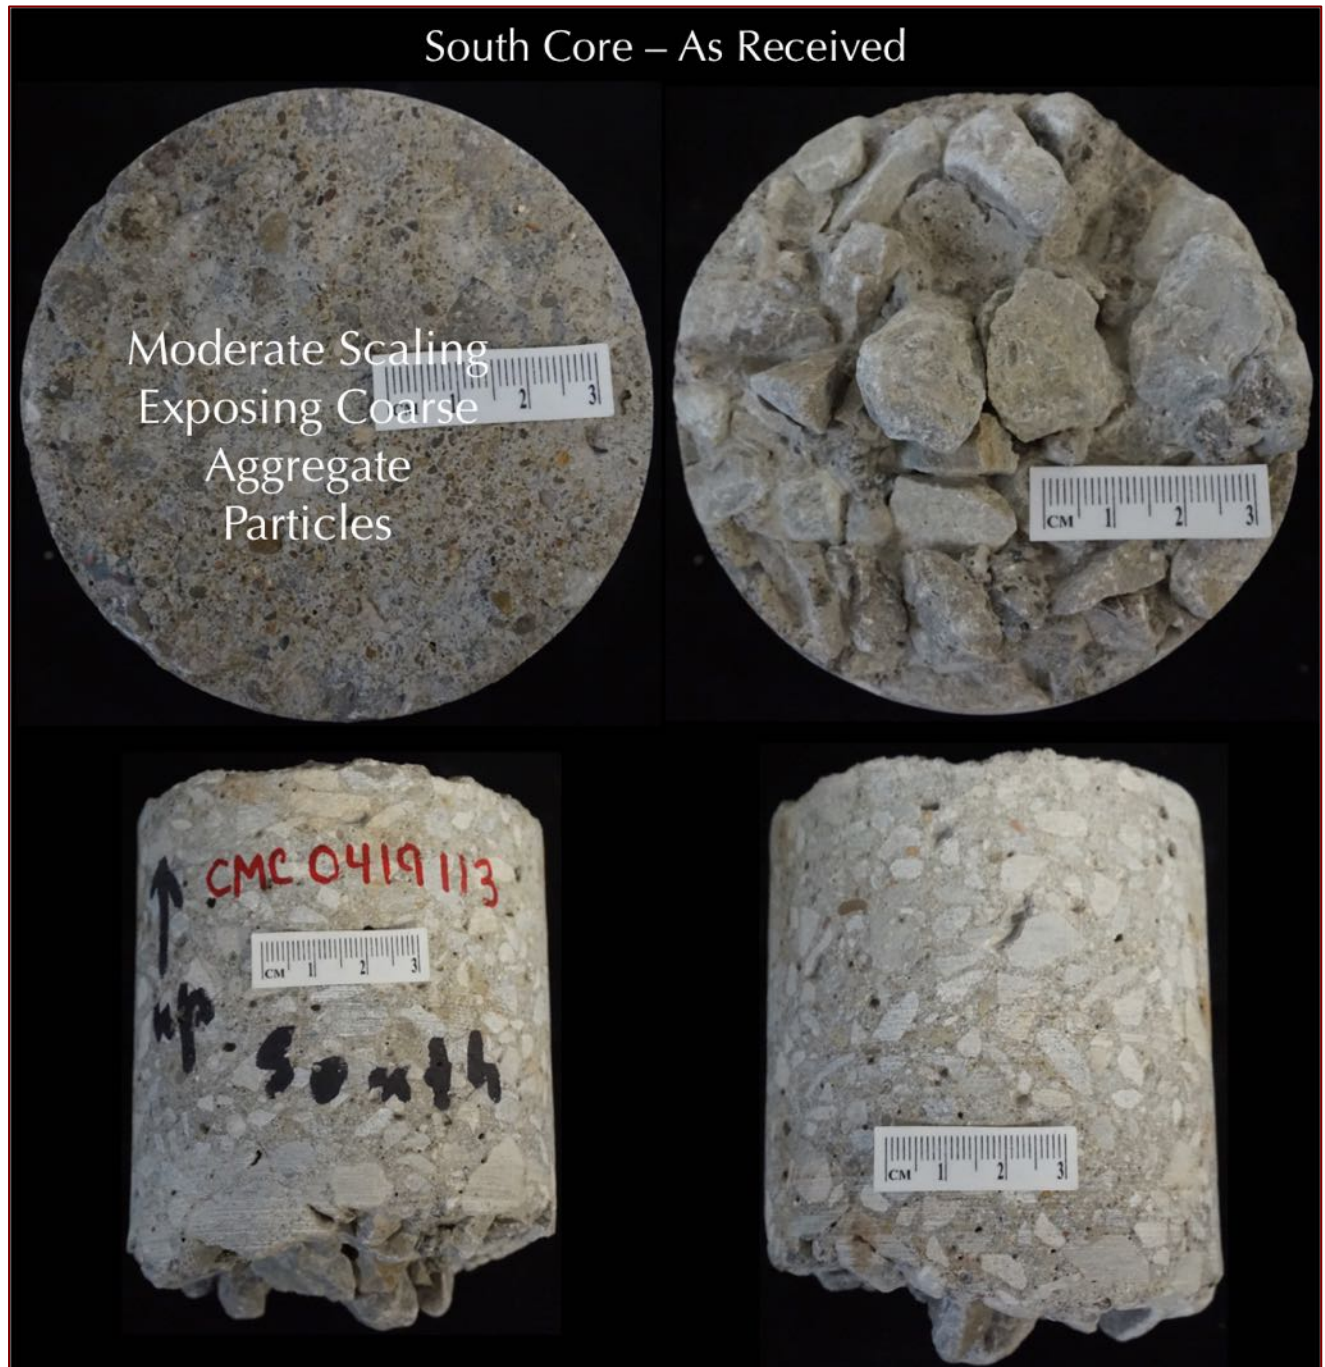
Figure 3: Photographs of South Core as received. Top left – Exposed surface with moderate scaling, loss of the finished surface with exposed coarse and fine aggregate particles; Top right - bottom surface with adhered stones from subbase; and Bottom row - cylindrical side views of the core with identification.

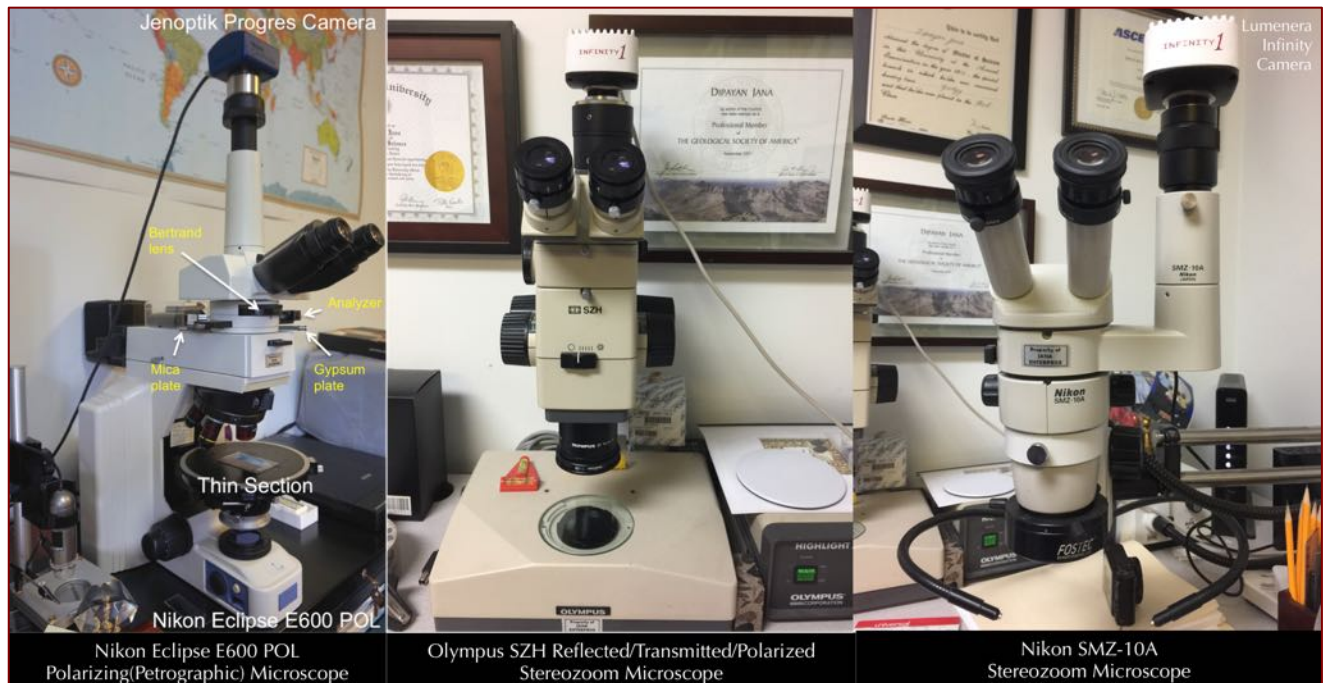
Figure 4: Nikon Eclipse E600POL Petrographic Microscope with Jenoptik Gryphax Camera (left), Olympus SZH (middle), and Nikon SMZ-10A Stereomicroscope (right) used for petrographic examinations.

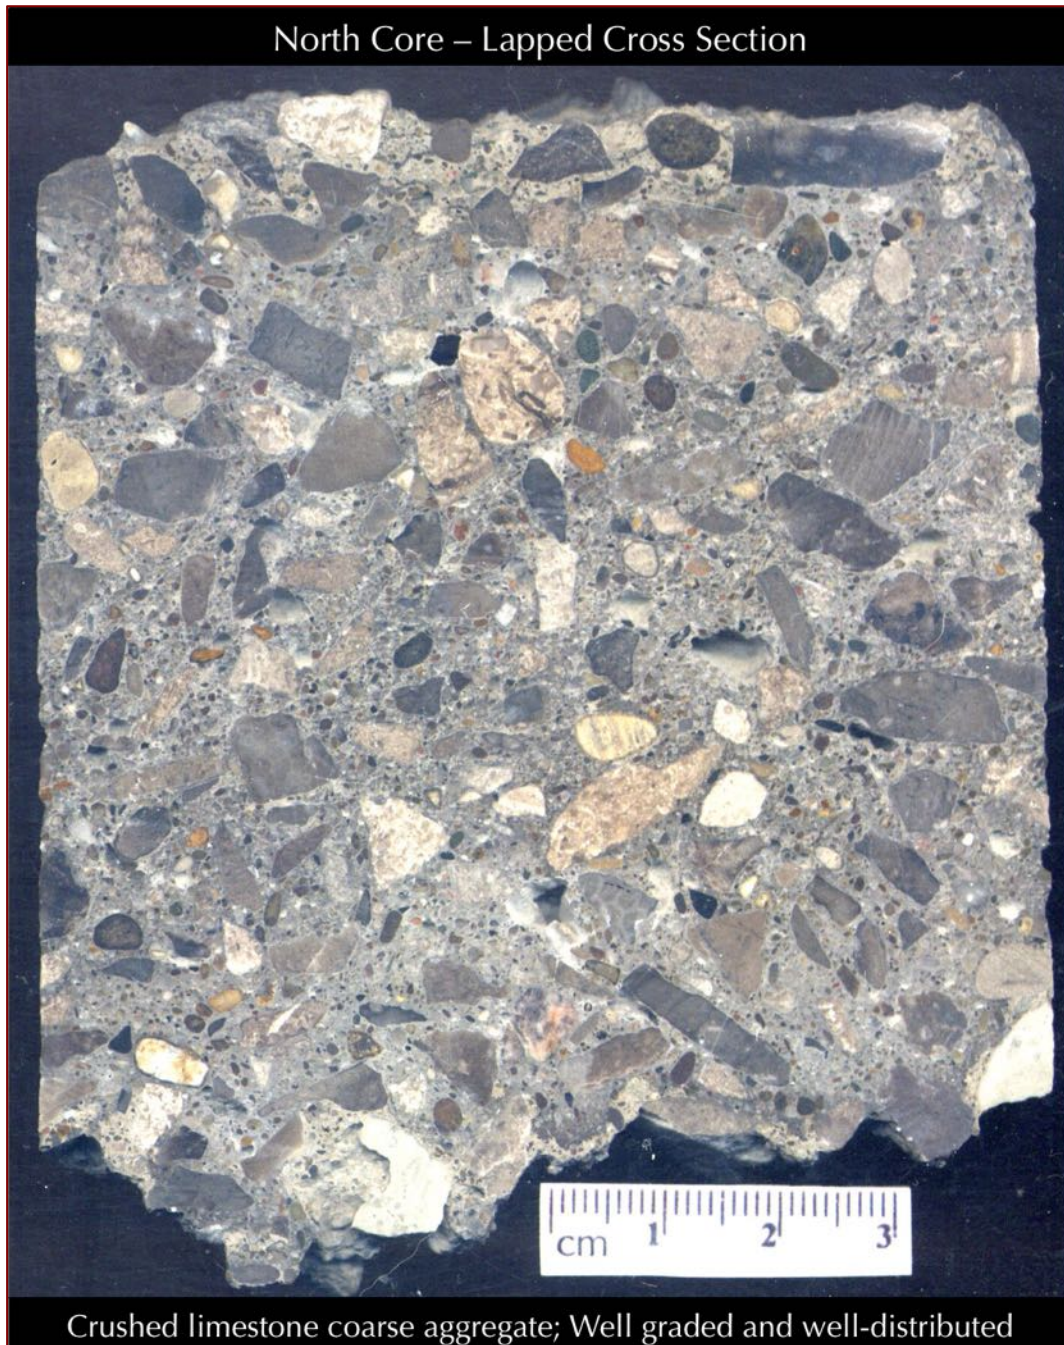
Figure 6: Lapped cross section of North Core showing: (a) severely scaled exposed surface at the top, (b) well-graded, well-distributed crushed limestone coarse aggregate, (c) dense and well-consolidated nature of concrete, (d) uniform color tone of paste in the body, but some lighter color paste at the scaled surface region at the top; and (e) adhered crushed limestone of subbase at the bottom of core.

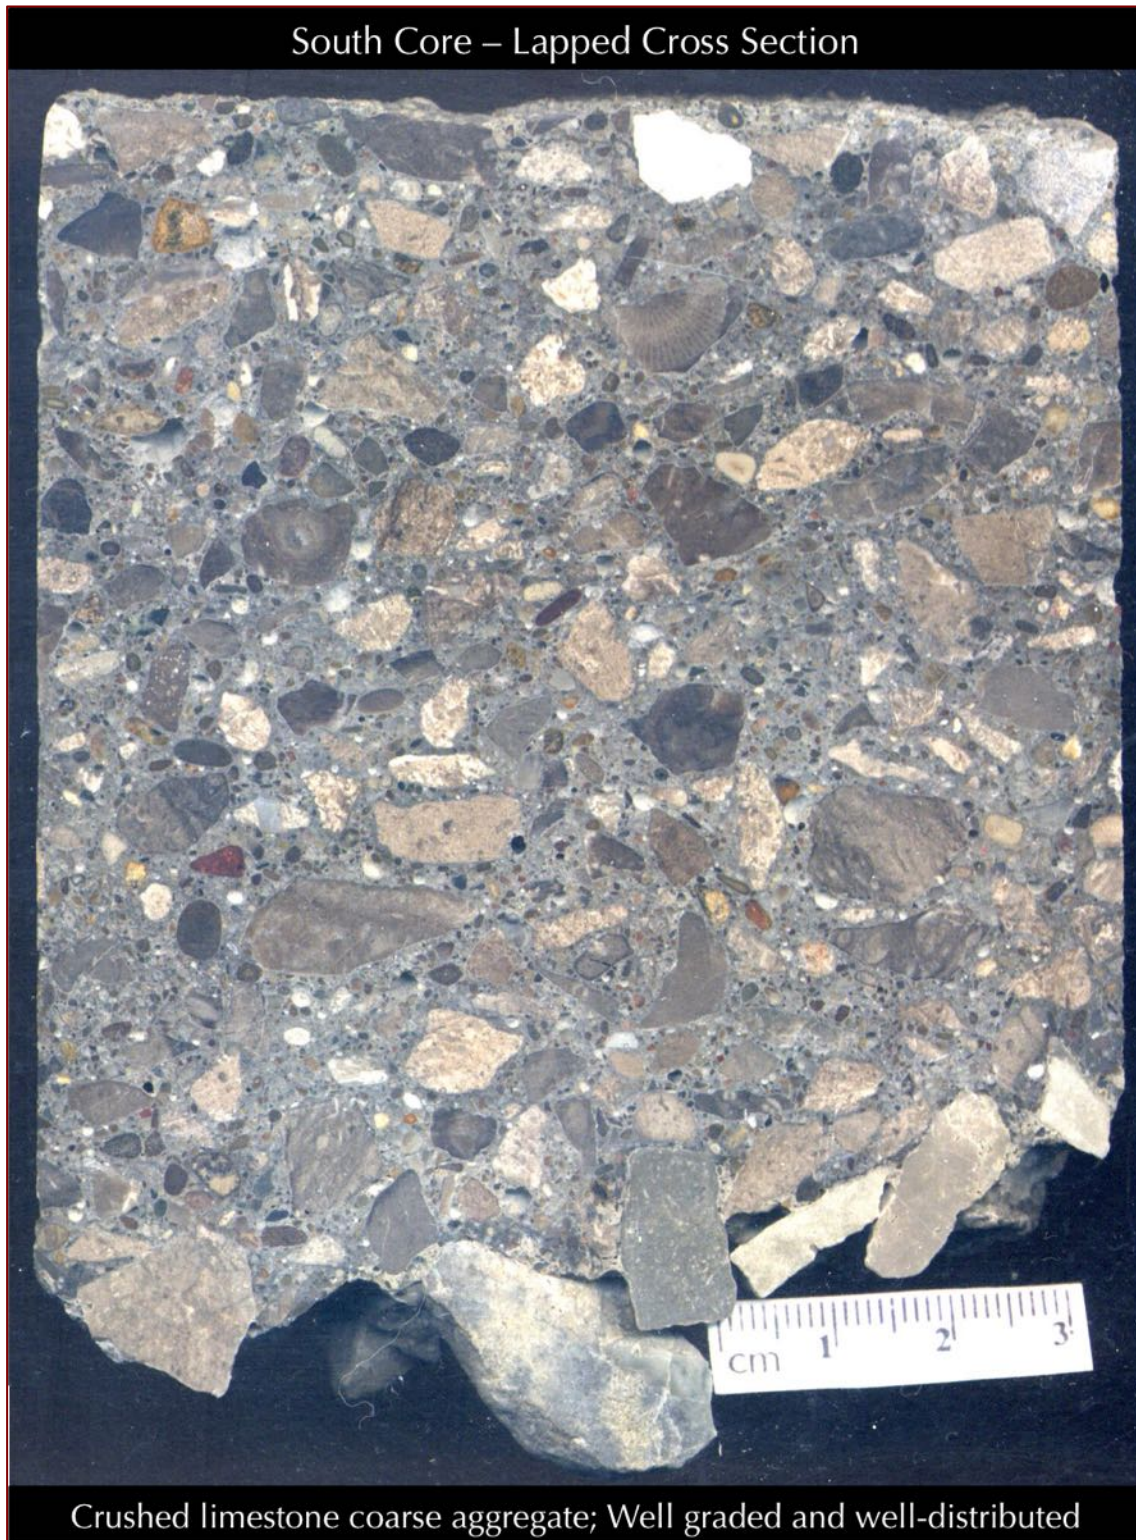
Figure 7: Lapped cross section of South Core showing: (a) severely scaled exposed surface at the top, (b) well-graded, well-distributed crushed limestone coarse aggregate, (c) dense and well-consolidated nature of concrete, (d) uniform color tone of paste in the body, but some lighter color paste at the scaled surface region at the top; and (e) adhered crushed limestone of subbase at the bottom of core.

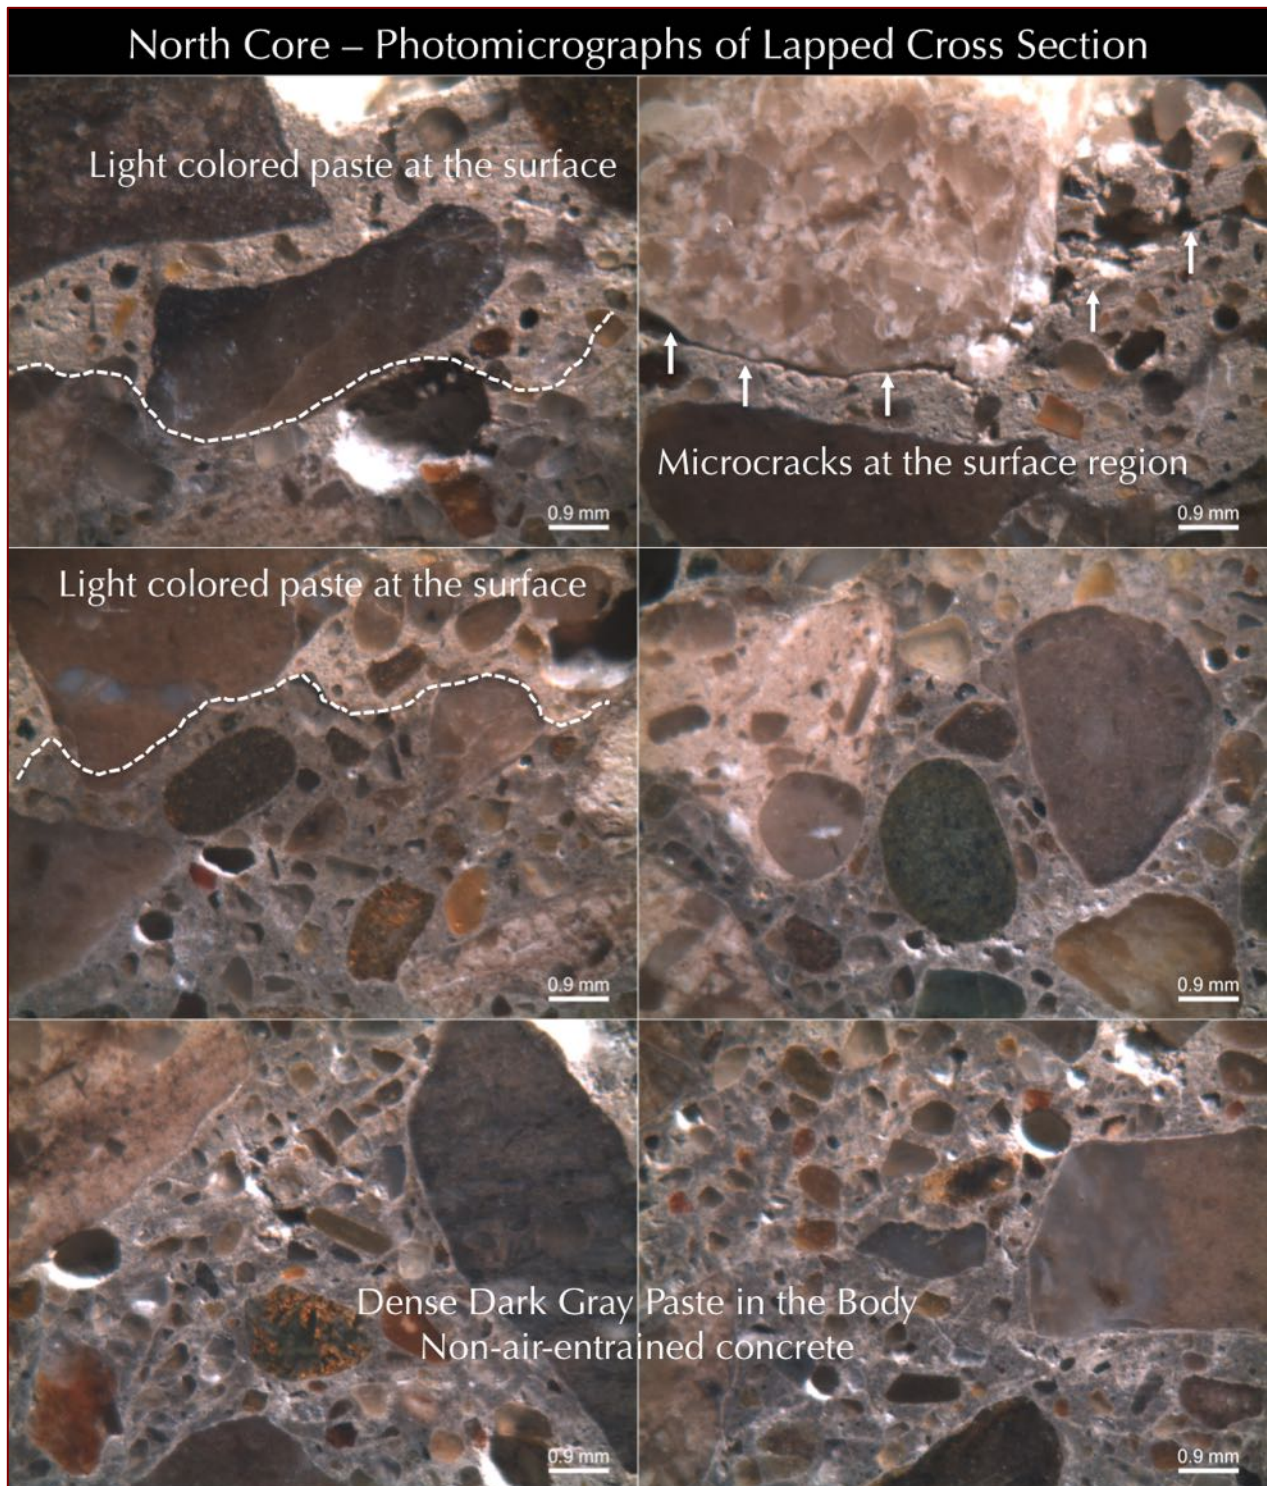
Figure 8: Photomicrographs of lapped cross section of North Core showing: (a) overall non-air-entrained nature of concrete in all photos containing a few coarse near-spherical and irregularly-shaped entrapped air voids; (b) lighter gray tone paste at the top scaled surface region separated from darker gray paste in the body by white dashed lines, and (c) fine, near-surface surface-parallel microcrack at the scaled surface region (marked by arrows in right photo).

Microcracking	None except for some near-surface microcracking that are judged to be related to the scaling distress (Figure 8).
Aggregate-paste Bond	Tight
Bleeding, Tempering	None
Chemical deterioration	None

There is no evidence of any deleterious deposits found in the cores. Carbonation is shallow 1 to 2 mm, which does not represent the true depth due to loss of the original finished surface. Bonds between the coarse and fine aggregate particles and paste are tight. There is no evidence of microcracking due to deleterious reactions, except for some near-surface microcracking that are judged to be related to the scaling distress (Figure 8).

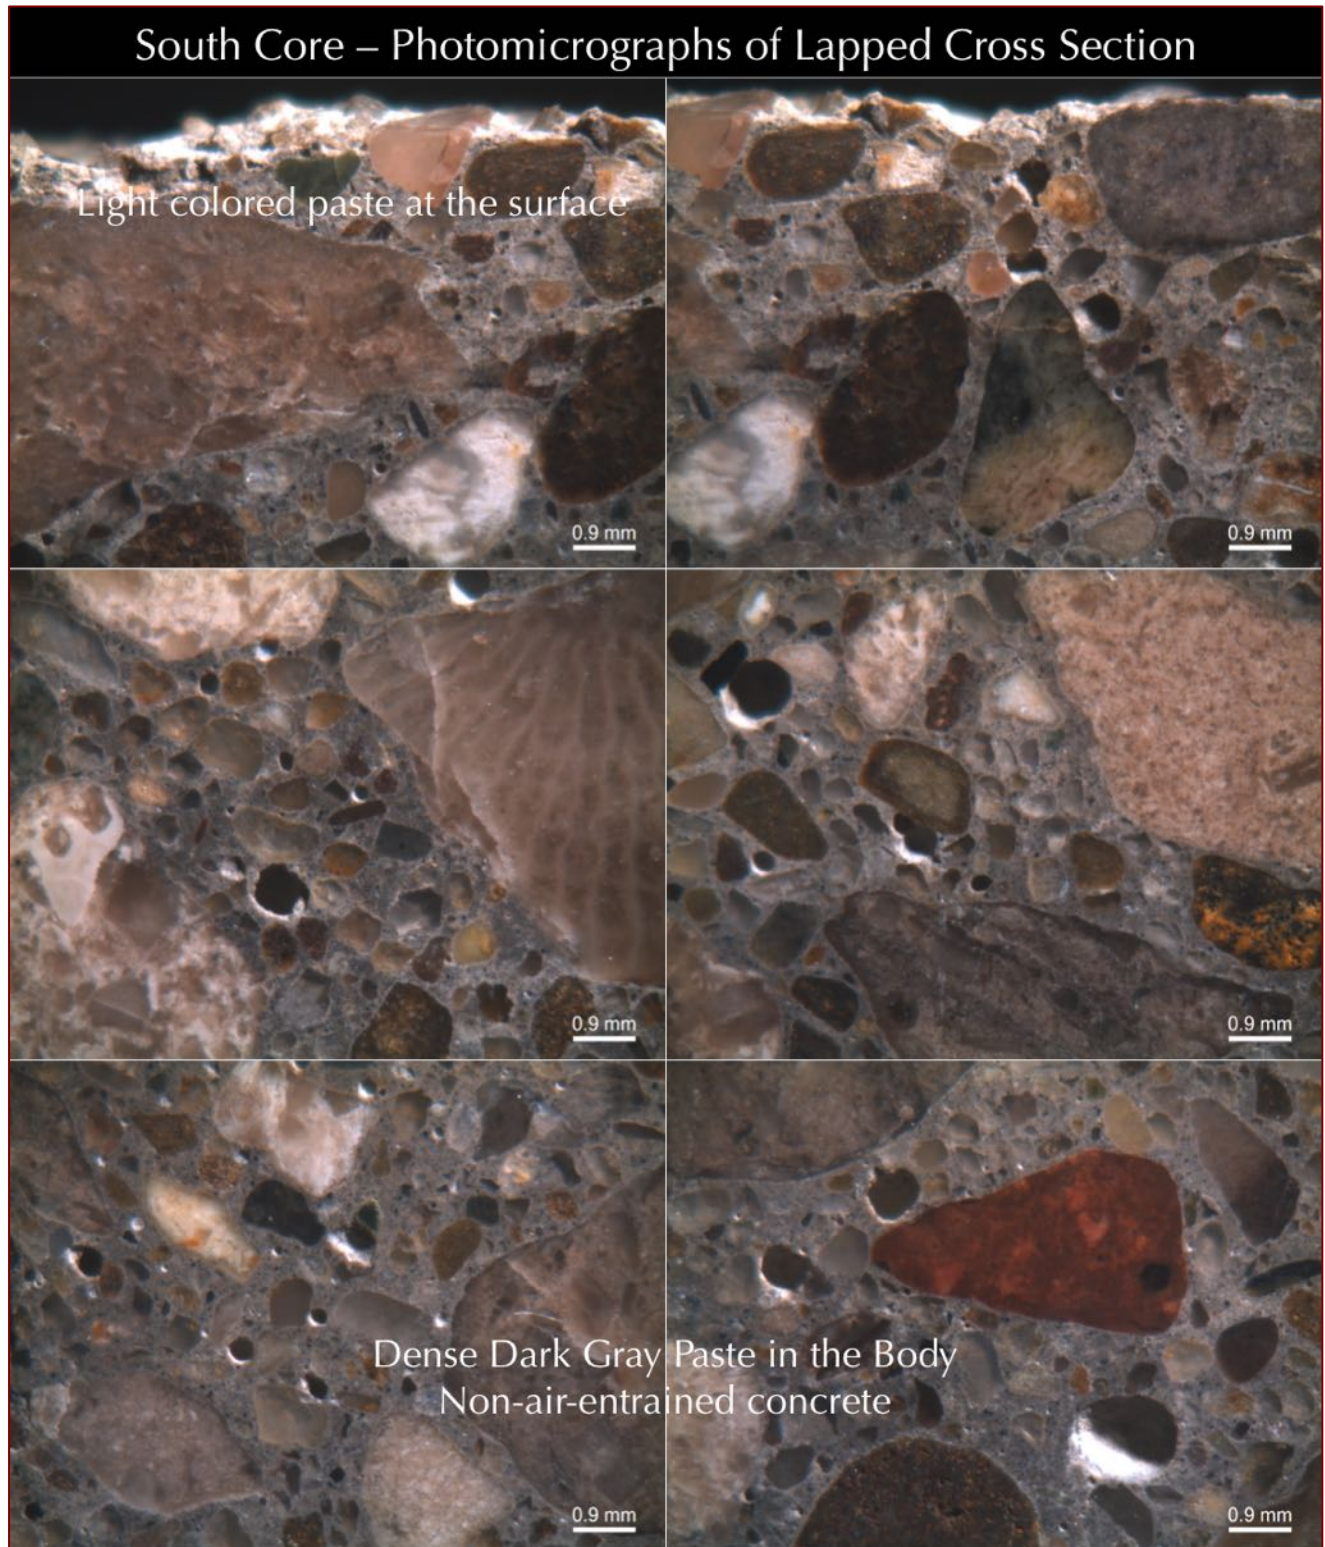
Figure 9: Photomicrographs of lapped cross section of South Core showing: (a) overall non-air-entrained nature of concrete in all photos containing a few coarse near-spherical and irregularly-shaped entrapped air voids; and (b) lighter gray tone paste at the top scaled surface region above the darker gray paste in the body.

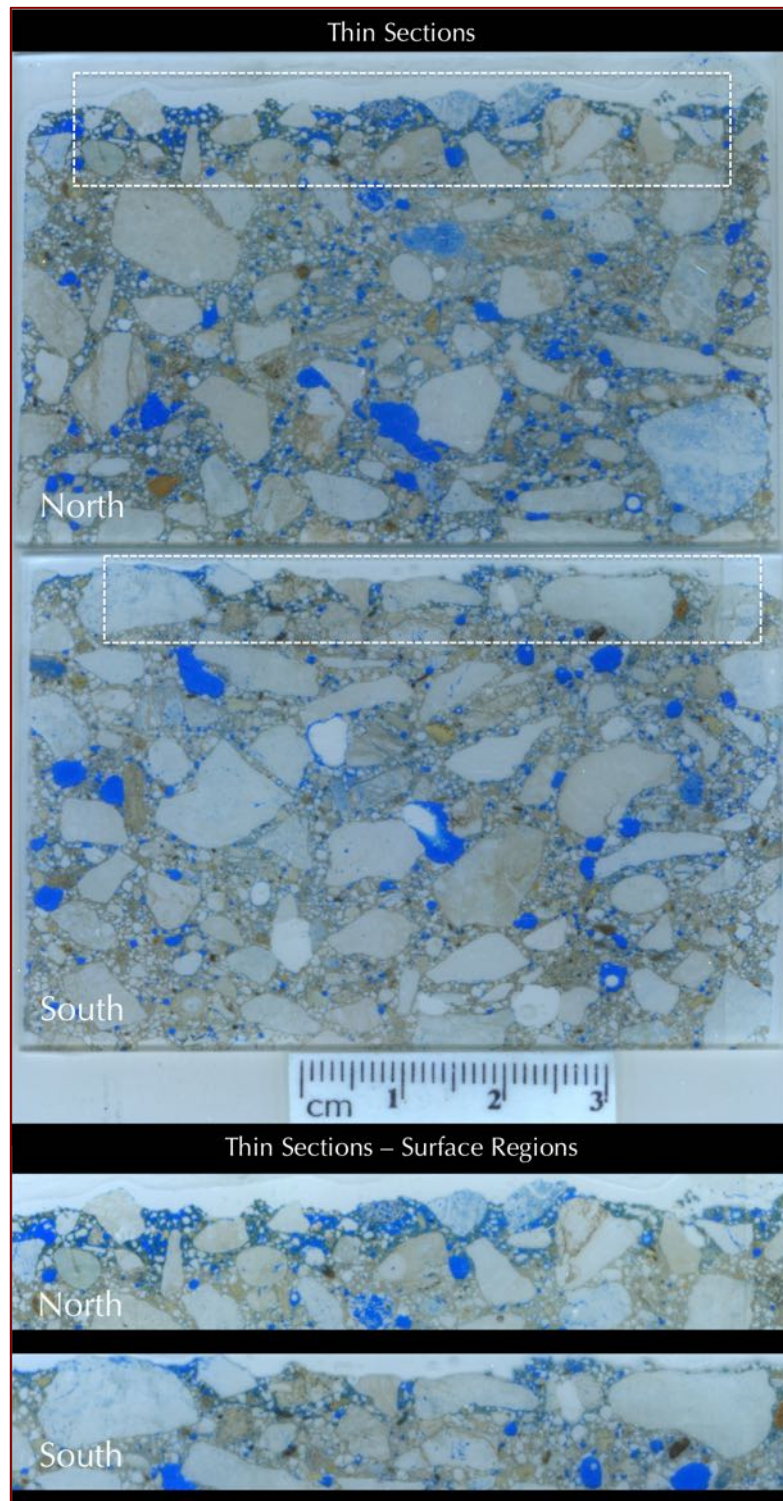
Figure 10: Blue dye-mixed epoxy-impregnated thin sections of 'north' and 'south' cores at the top and middle, respectively and enlarged views of surface regions of these cores at the bottom showing porous paste at the scaled surface regions highlighted by blue epoxy that has been absorbed more in the porous paste compared to denser interior. Blue epoxy has highlighted entrapped air voids and porous areas in concrete.

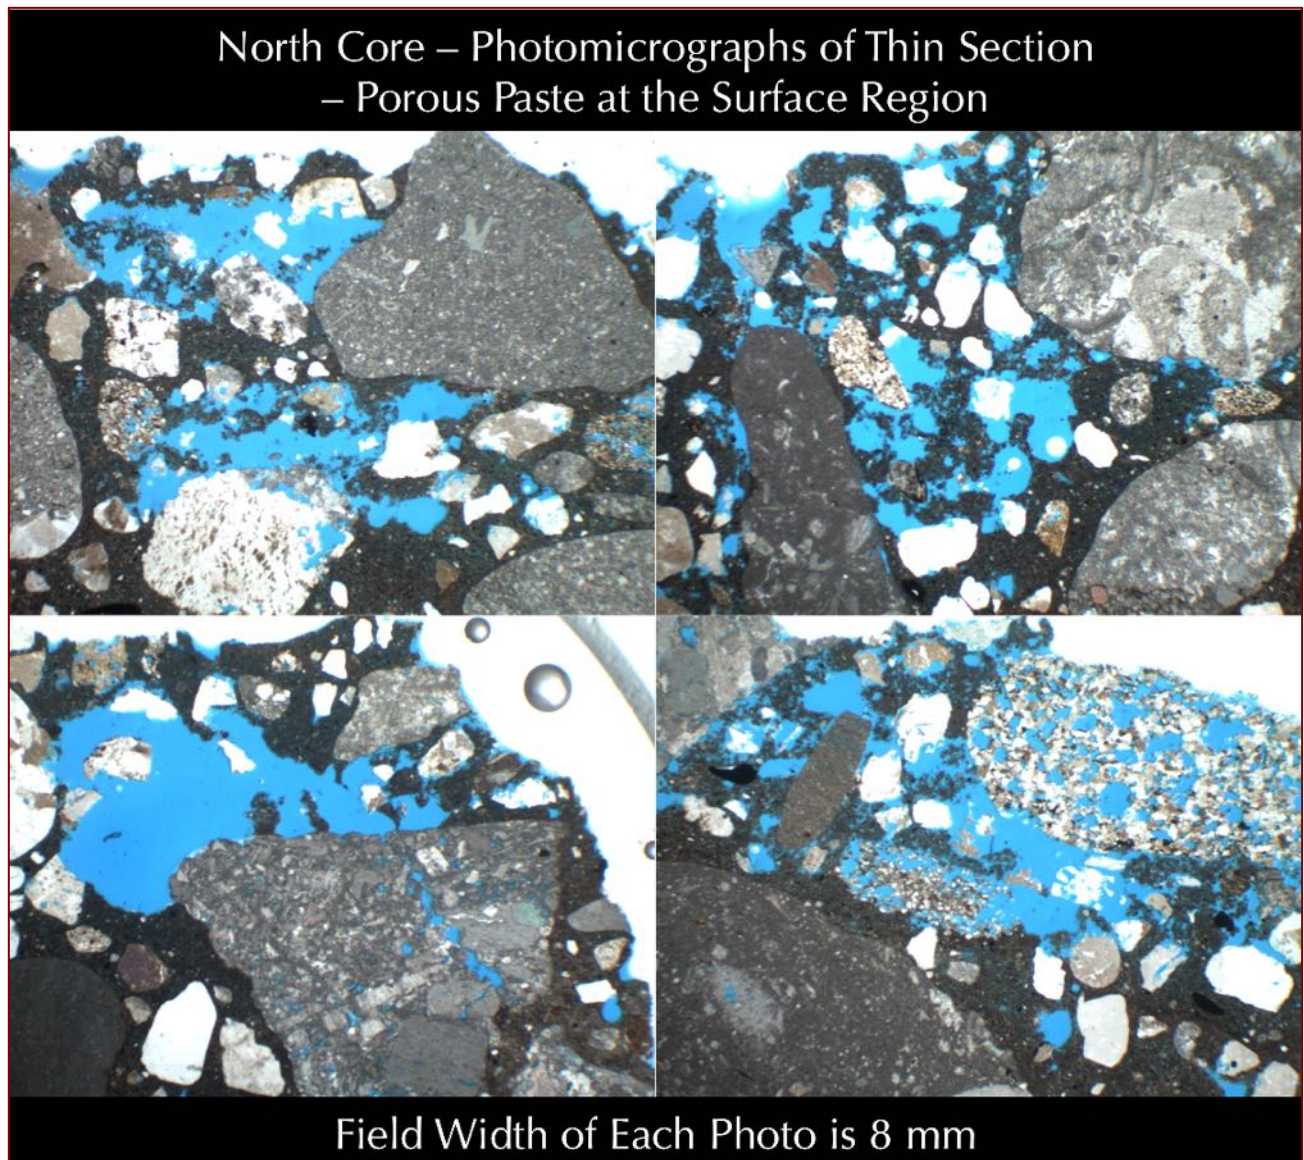
Figure 11: Photomicrographs of blue dye-mixed epoxy-impregnated thin section of concrete in 'north' core taken with a reflected-light Stereozoom microscope showing porous areas of paste at the scaled surface region (which was also shown in Figure 10), which is responsible for the lighter gray tone paste at the surface shown in Figure 8.

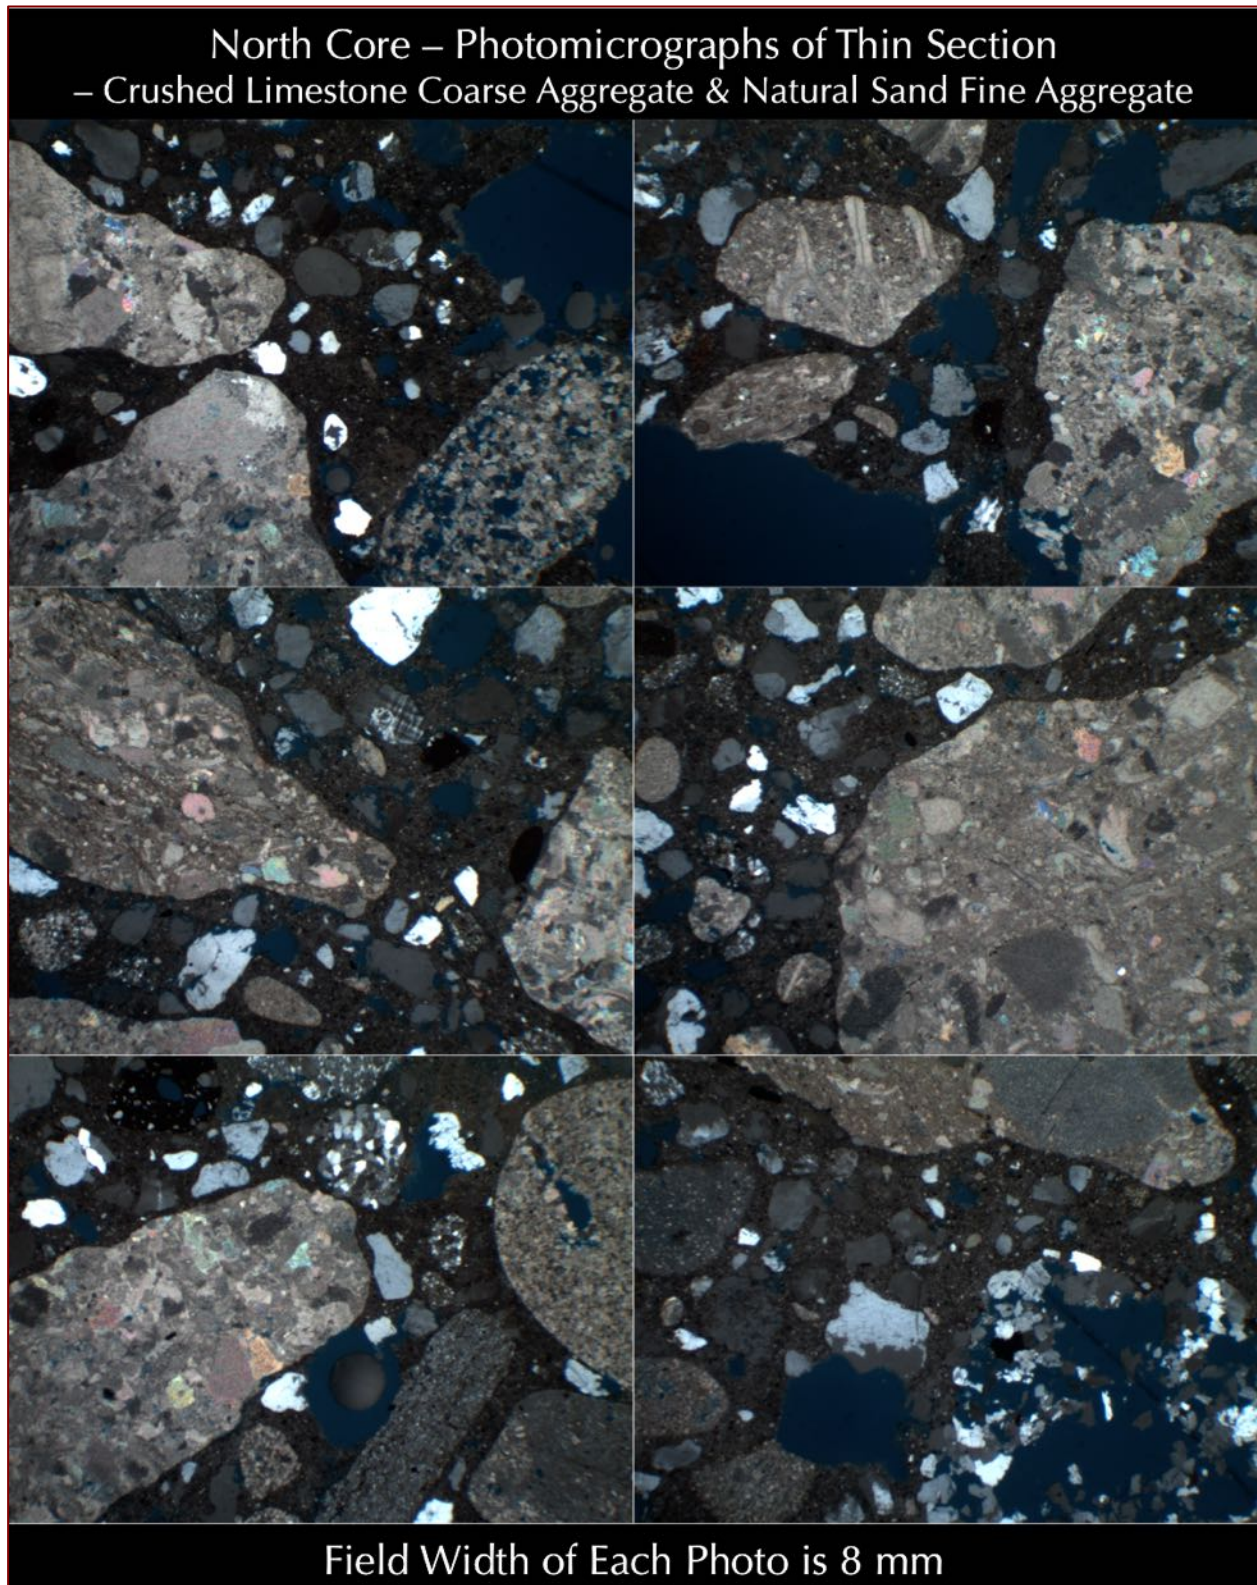
Figure 12: Photomicrographs of blue dye-mixed epoxy-impregnated thin section of concrete in 'north' core taken with a reflected-light Stereozoom microscope showing crushed limestone coarse aggregate and natural siliceous-calcareous sand fine aggregate containing quartz, quartzite, feldspar, sandstone, shale, limestone, and dolomite particles in fine aggregate.

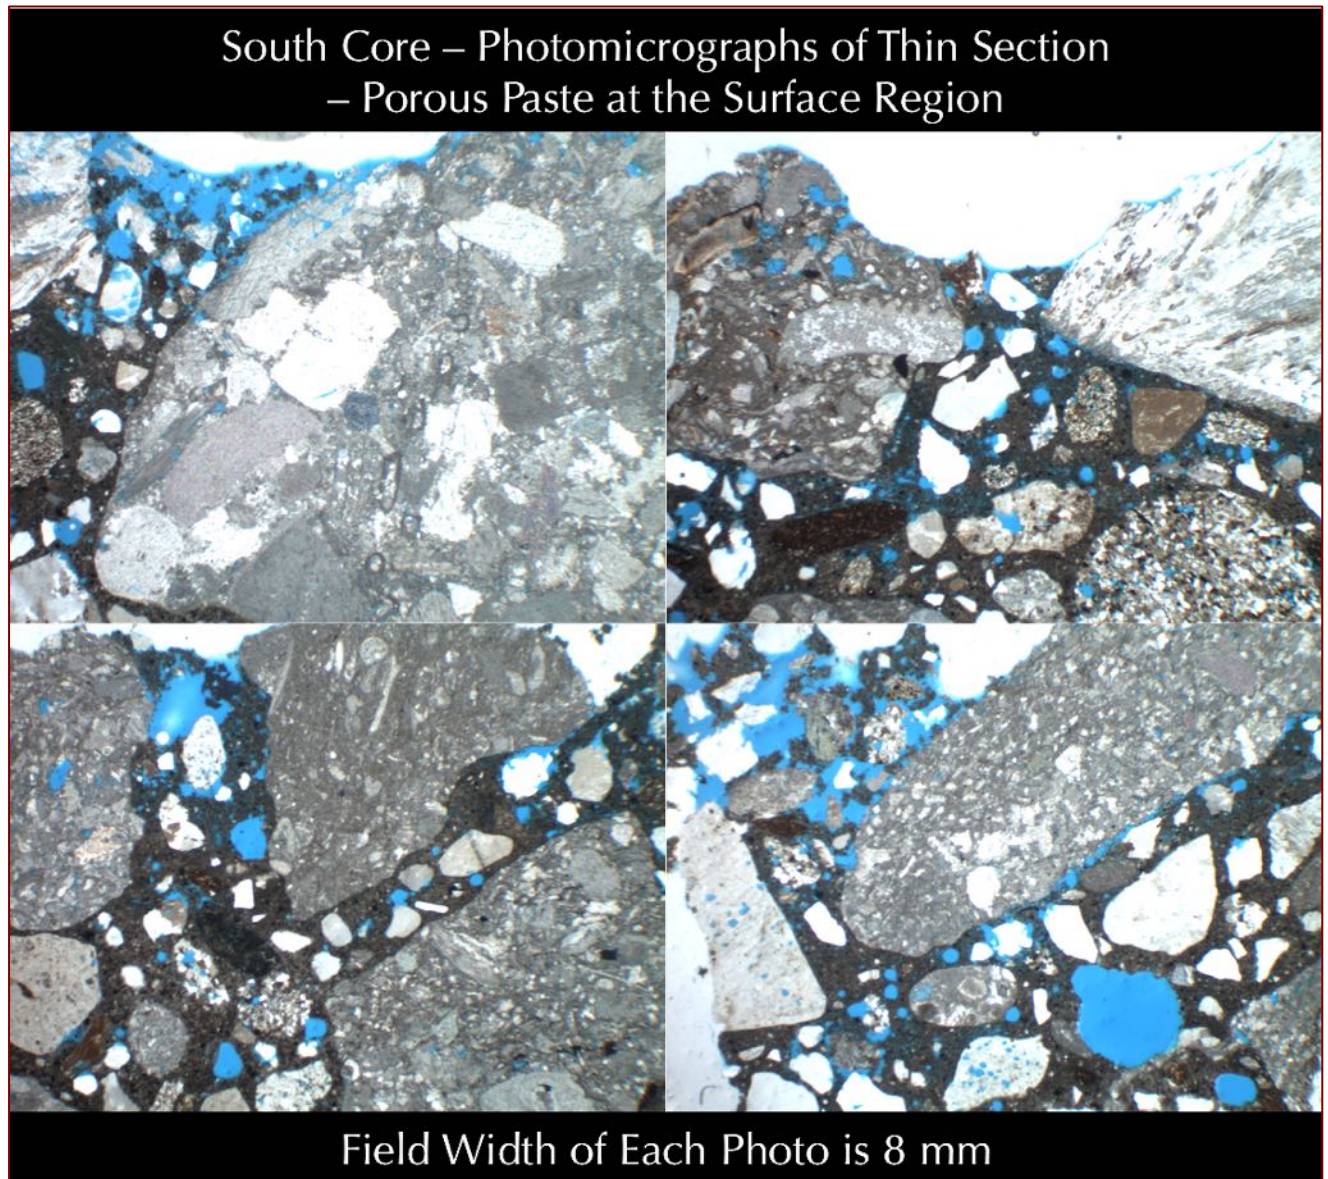
Figure 13: Photomicrographs of blue dye-mixed epoxy-impregnated thin section of concrete in 'south' core taken with a reflected-light Stereozoom microscope showing porous areas of paste at the scaled surface region (which was also shown in Figure 10), which is responsible for the lighter gray tone paste at the surface shown in Figure 9.
