Investigation of Concrete Surface Scaling by Laboratory Examinations of Two Concrete Cores

Germantown Mill Lofts
Louisville, Kentucky

Reported herein are the results of detailed laboratory examinations of two (2) hardened concrete cores identified as 'north' and 'south' received from scaled concrete sidewalks at Germantown Mill Lofts located in Louisville, Kentucky.

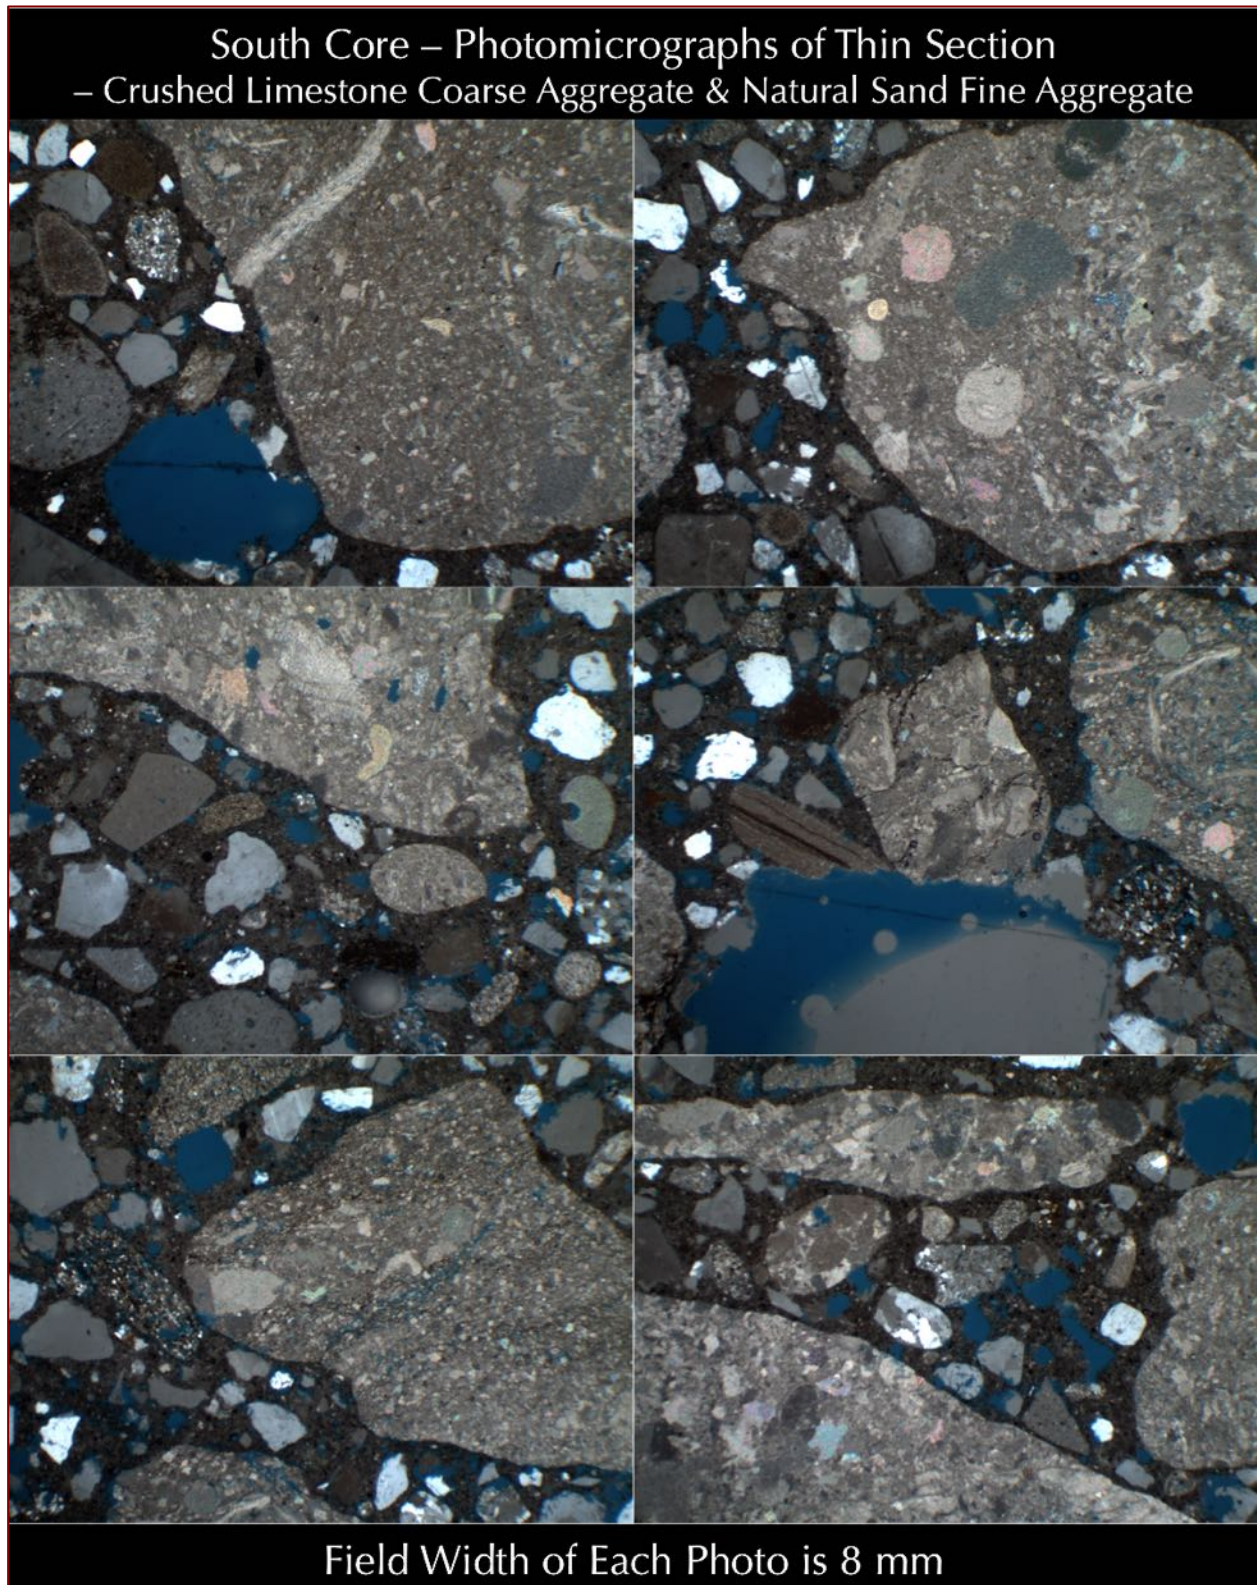
Figure 14: Photomicrographs of blue dye-mixed epoxy-impregnated thin section of concrete in 'south' core taken with a reflected-light Stereozoom microscope showing crushed limestone coarse aggregate and natural siliceous-calcareous sand fine aggregate containing quartz, quartzite, feldspar, sandstone, shale, limestone, and dolomite particles in fine aggregate.

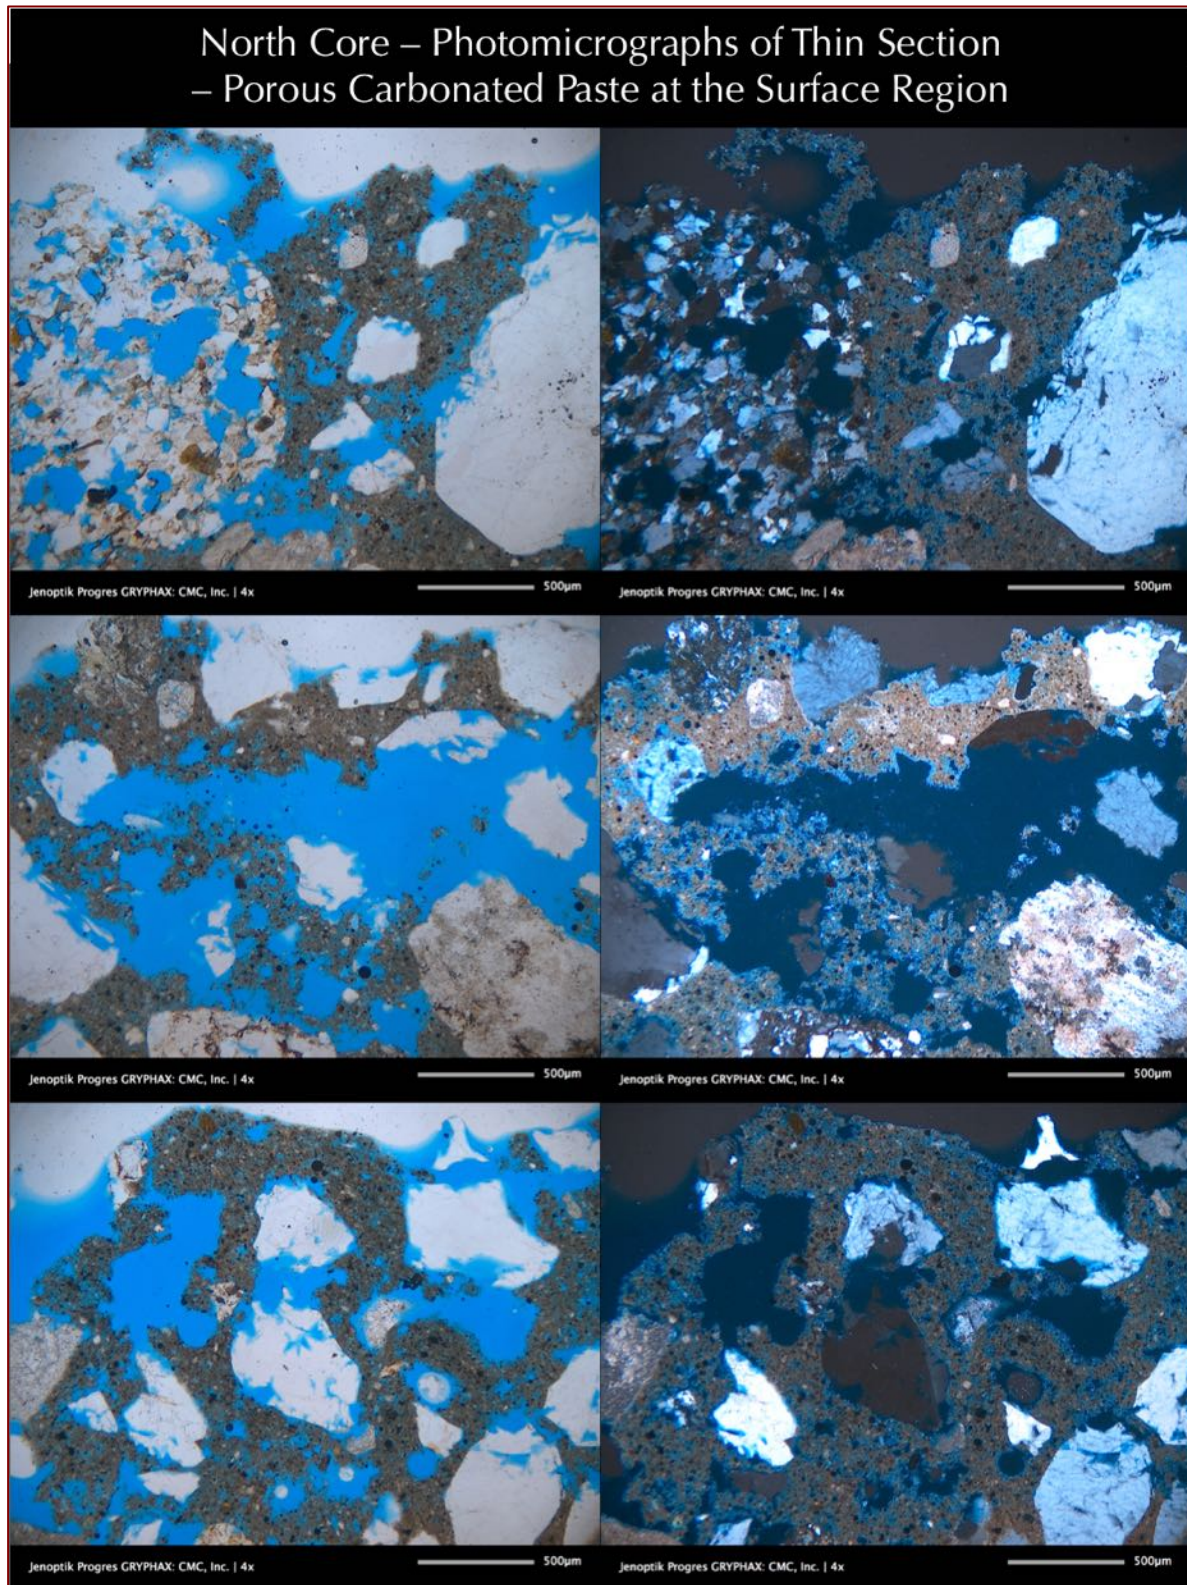
Figure 15: Photomicrographs of blue dye-mixed epoxy-impregnated thin section of concrete in 'north' core taken with a petrographic microscope showing porous, carbonated paste at the scaled surface region.

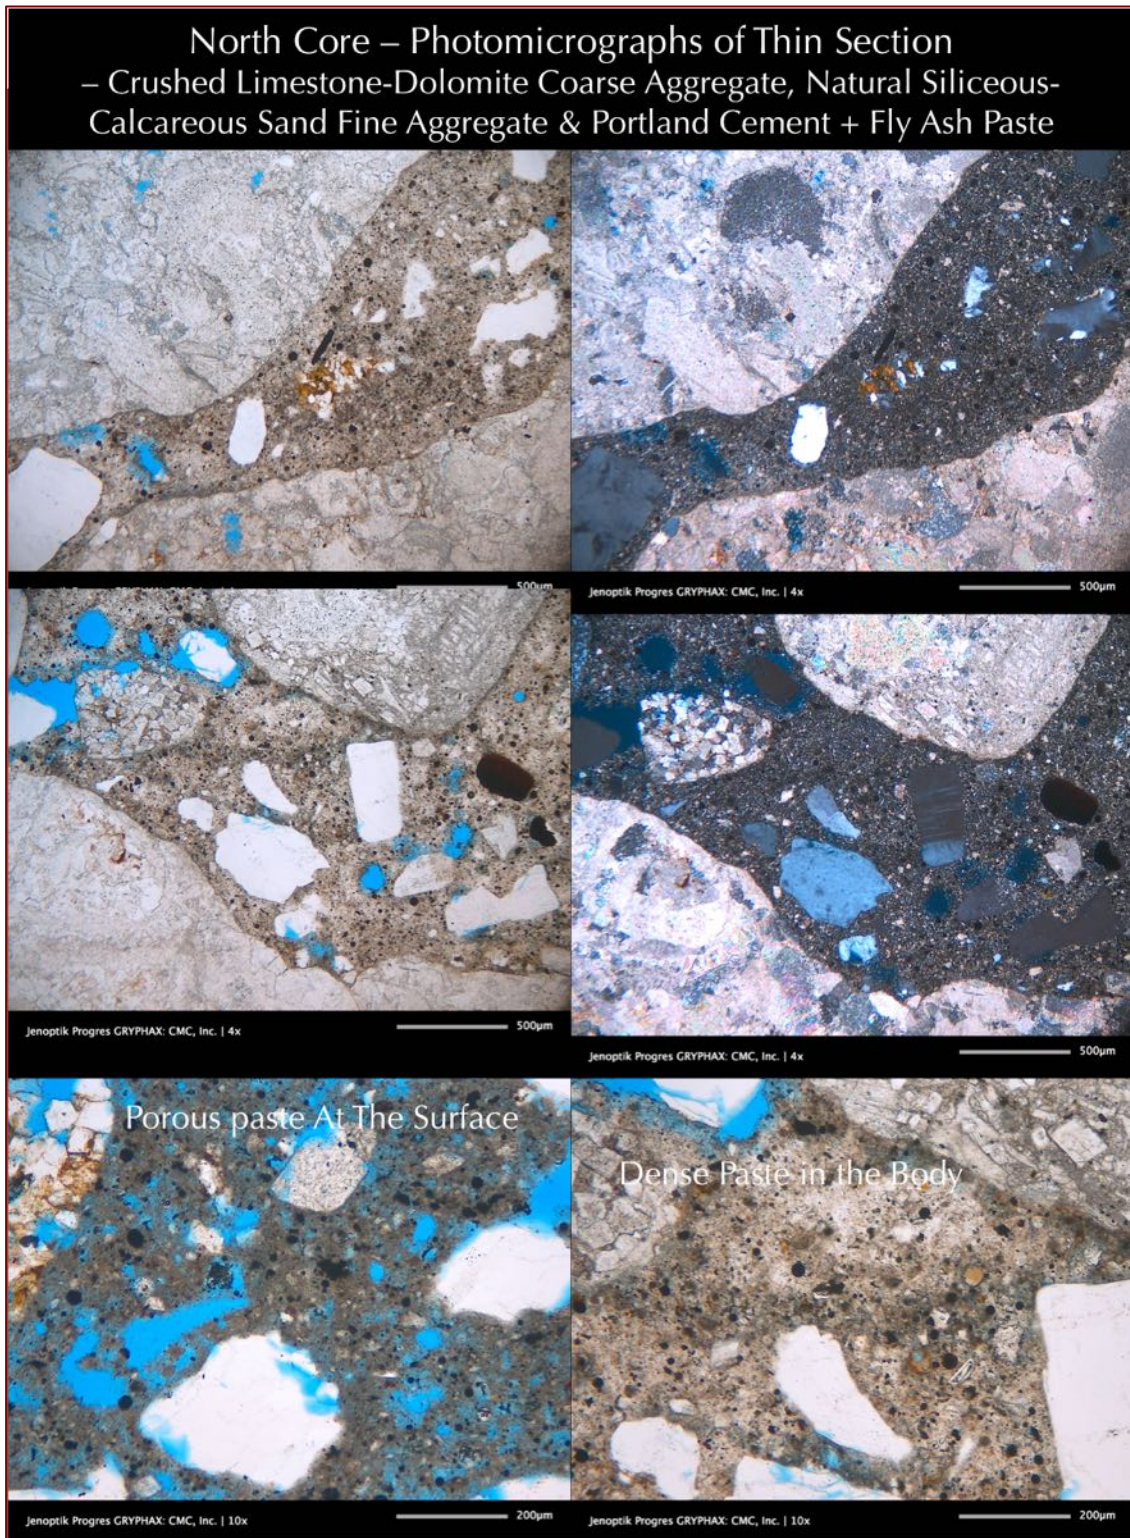
Figure 16: Photomicrographs of blue dye-mixed epoxy-impregnated thin section of concrete in 'north' core taken with a petrographic microscope showing crushed limestone coarse aggregate, natural siliceous-calcareous sand fine aggregate, and non-air-entrained concrete (top and middle rows), dense paste in the body (top and middle row), and contrasting paste porosities between porous paste at the surface versus denser paste in the body (bottom row). Notice spherical fly ash particles in paste (bottom right photo).

Properties and composition of hardened cement paste are summarized in Table 2. Paste in both cores is light gray and noticeably porous at the top 1 to 2 mm of scaled surface (Figures 8 to 11, 13, 15, and 17) but medium to dark gray and denser in the interior bodies (Figures 8, 9, 16, and 18). Paste is dense and hard; freshly fractured surfaces of interior paste have subvitreous lusters and subconchoidal textures. Residual and relict Portland cement particles are present and estimated to constitute 6 to 8 percent of the paste volumes. Hydration of Portland cement is normal. Distributed throughout the paste are fine, clear to dark brown spherical glassy particles of fly ash having the fineness of Portland cement (Figures 16 and 18).

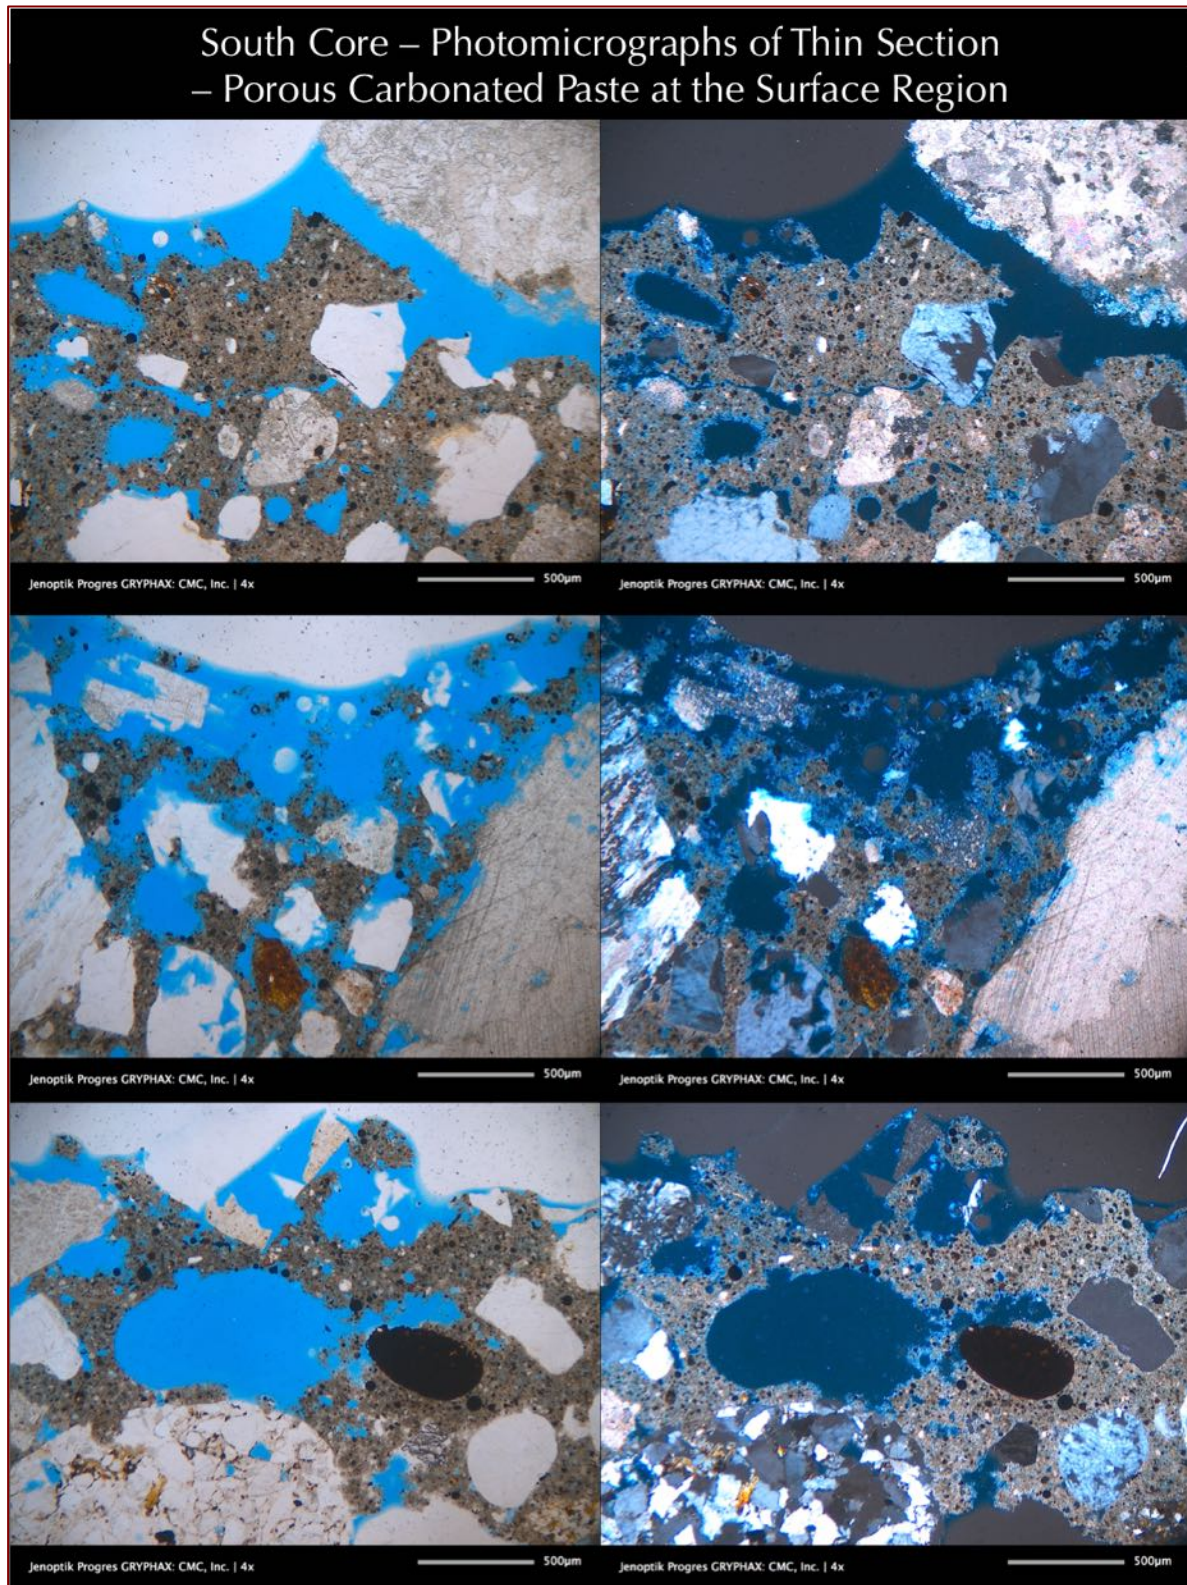
Figure 17: Photomicrographs of blue dye-mixed epoxy-impregnated thin section of concrete in 'south' core taken with a petrographic microscope showing porous, carbonated paste at the scaled surface region.

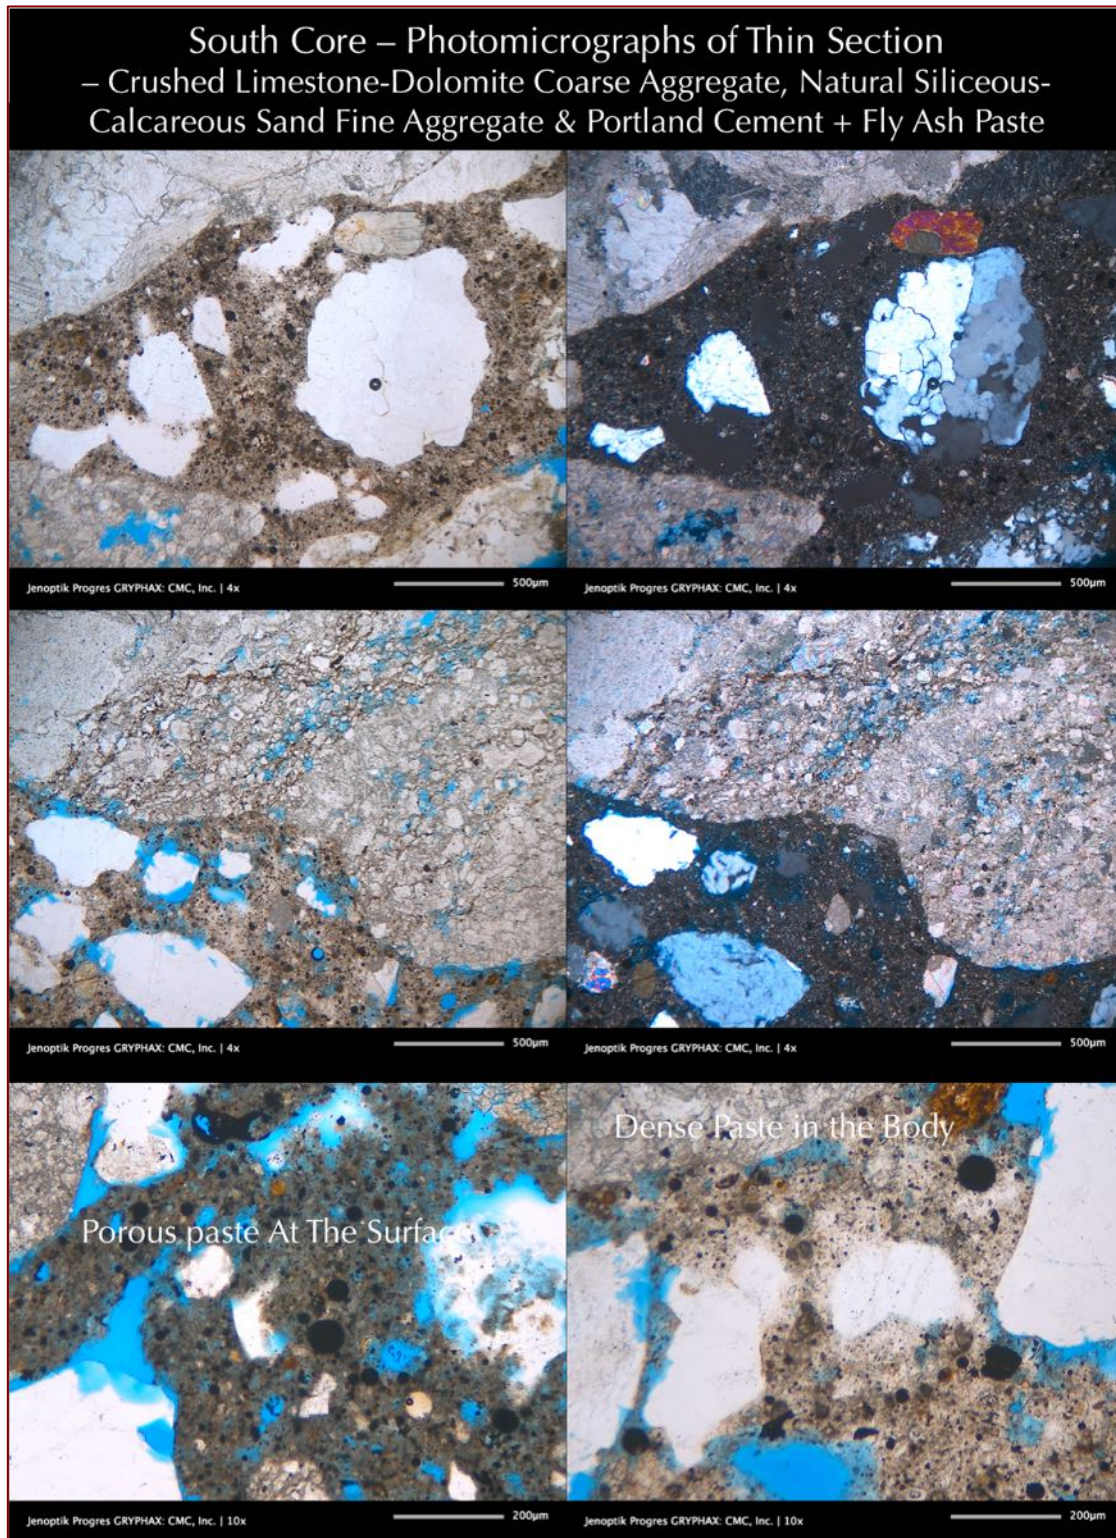
Figure 18: Photomicrographs of blue dye-mixed epoxy-impregnated thin section of concrete in 'south' core taken with a petrographic microscope showing crushed limestone coarse aggregate, natural siliceous-calcareous sand fine aggregate, and non-air-entrained concrete (top and middle rows), dense paste in the body (top and middle row), and contrasting paste porosities between porous paste at the surface versus denser paste in the body (bottom row). Notice spherical fly ash particles in paste (bottom right photo).

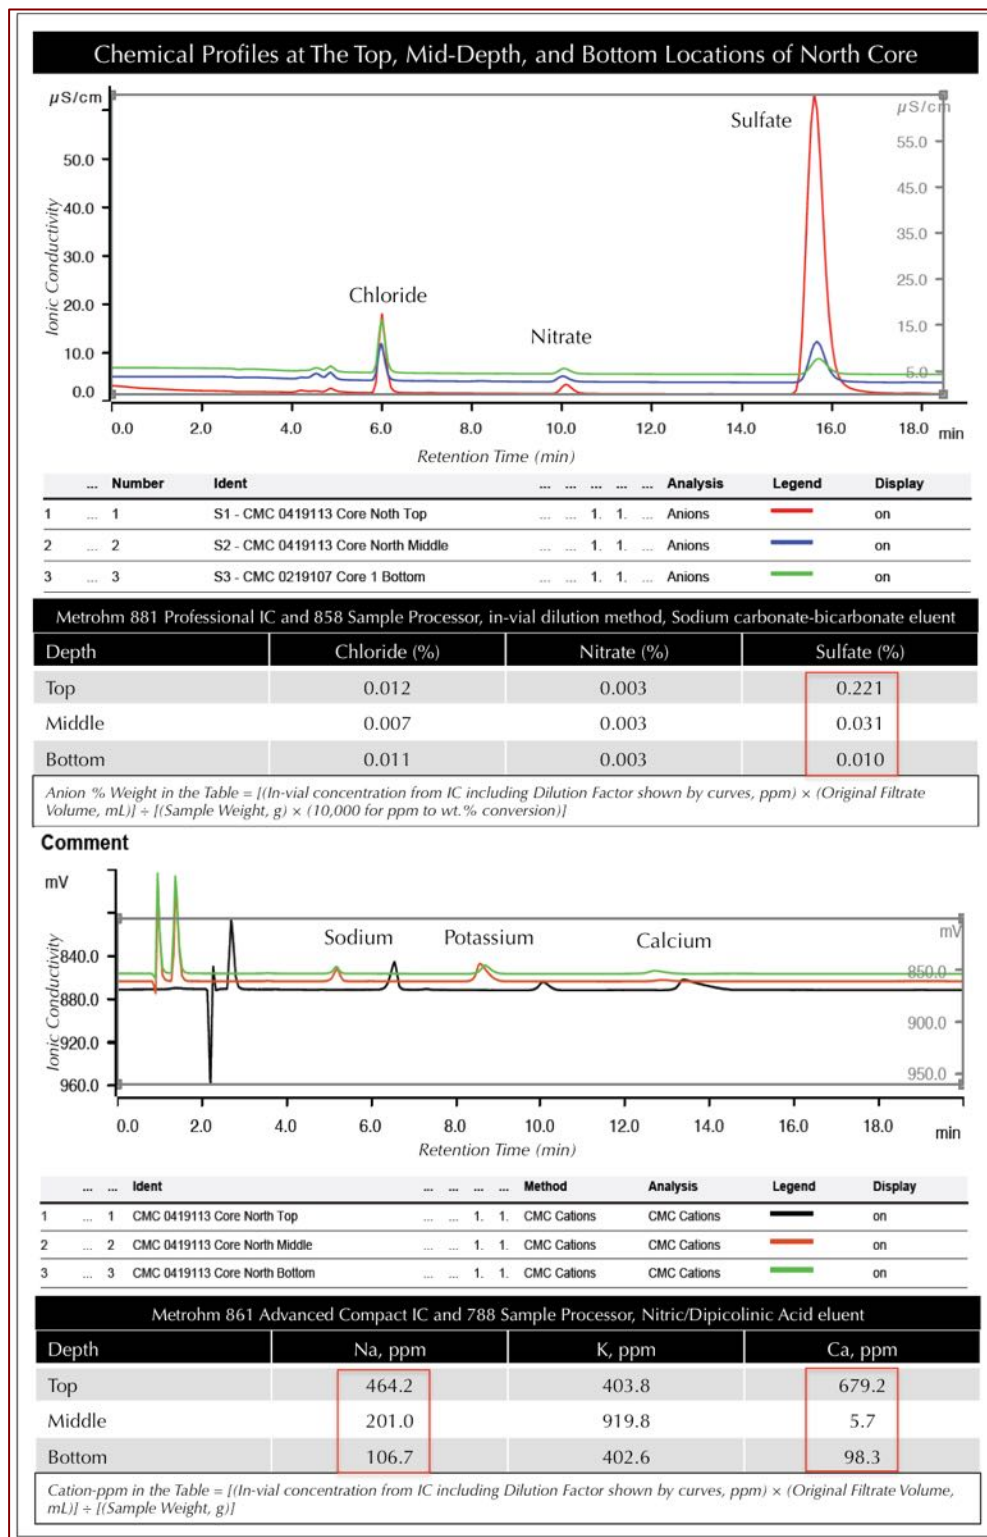
Figure 21: Results of ion chromatography of water-soluble anions (chloride, nitrate, sulfate) at the top, and, water-soluble cations (sodium, potassium, and calcium) at the bottom of deionized water-digested pulverized concrete from the top, mid-depth, and bottom locations of 'north' core showing noticeable enrichment of sulfate, sodium and calcium at the scaled surface region compared to interior. Tables beneath ion chromatograms show results as percent by mass of concrete for anions and ppm-concentration by mass of concrete for cations.

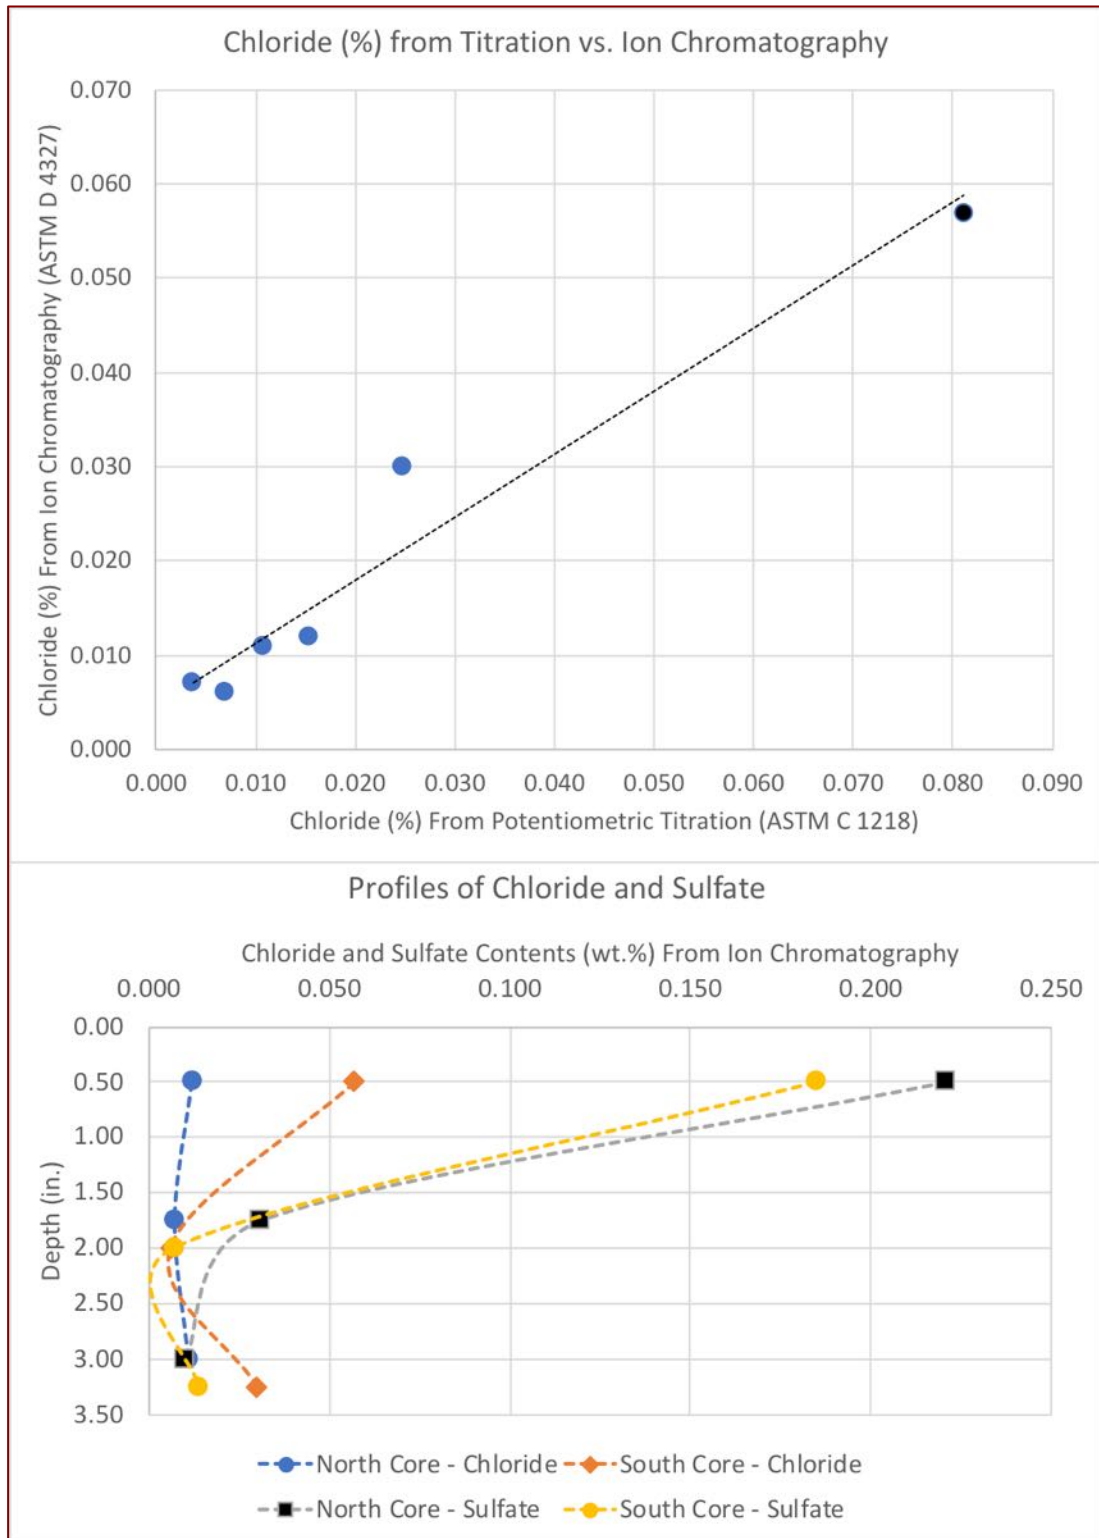
Figure 23: Top: Correlations between chloride contents from potentiometric titration (ASTM C 1218) and ion chromatography (ASTM D 4327) from the top, mid-depth, and bottom locations of 'north' and 'south' cores. Bottom: Profiles of chloride and sulfate from top, mid-depth, and bottom locations of 'north' and 'south' cores as obtained from ion chromatography.
