Investigation of Reinforcing Steel Corrosion-Related Spalling of Balconies in Two 22-Story 1970s Highrise Buildings in an Oceanfront Environment in Luquillo, Puerto Rico

Sandy Hills
Luquillo, PR 00773

August 21, 2020
CMC 0720138

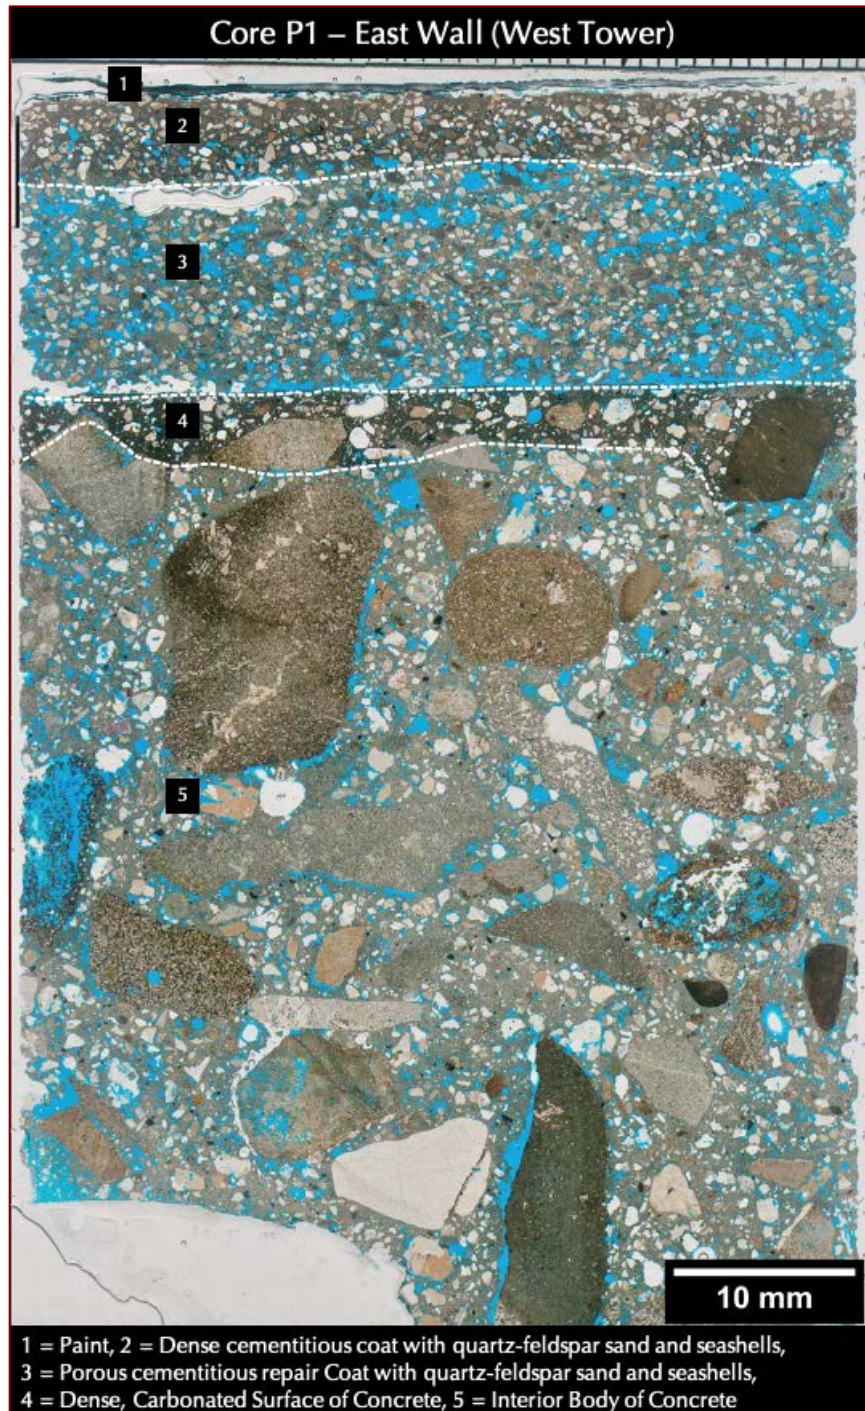
Figure 13: Blue dye-mixed epoxy-impregnated thin section of Core P-1 from West Wall seen in PPL mode scanned with a transmitted-light stereozoom microscope with polarizing light facilities showing:

(A) The **paint coat** consisting of: a thin, dark gray, acrylic paint coat at the very top marked as #1 having a nominal thickness of <0.5 mm; and,

(B) The **mortar topping** consisting of: (B1) a dense, carbonated cementitious coat of Portland cement and mixed seashells and silica sand of <1 mm size in a layer marked as #2 having a nominal thickness of 5 mm; and, (B2) the porous main body of the repair coat marked as #3 consisting of mixed seashells and silica sand and porous Portland cement paste, having a nominal thickness of 12 mm;

(C) The paint and mortar topping protective layers were applied over the **main concrete body**, which has (C1) a thin dense dark gray, carbonated finished surface region, marked as #4 having a nominal thickness of 5 mm, above (C2) the main concrete body marked as #5, of 150 mm recovered length, containing crushed gravel coarse aggregate, natural siliceous sand fine aggregate, Portland cement paste, and many interstitial voids where pore spaces and voids are highlighted by blue epoxy.

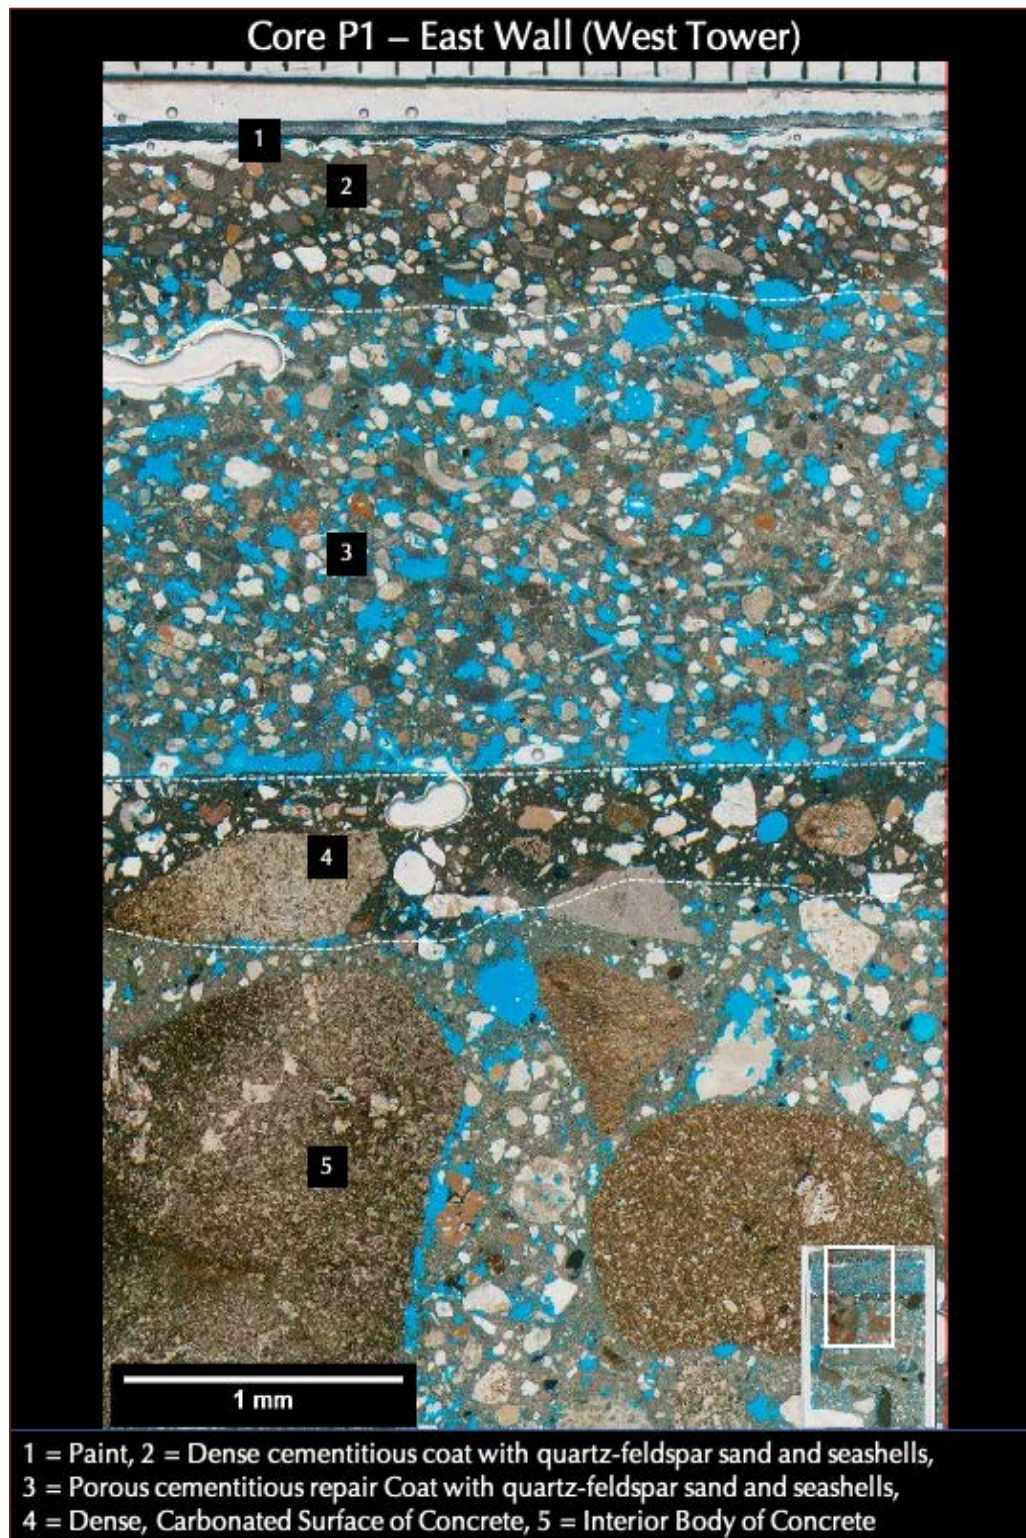
Figure 14: Blue dye-mixed epoxy-impregnated thin section of Core P-1 from West Wall seen in PPL mode scanned with a transmitted-light stereozoom microscope with polarizing light facilities showing:

(A) The **paint coat** consisting of a thin, dark gray, acrylic paint coat at the very top marked as #1 having a nominal thickness of <0.5 mm; and,

(B) The **mortar topping** consisting of:
(B1) a dense, carbonated cementitious coat of Portland cement and mixed seashell and silica sand of <1 mm size in a layer marked as #2 having a nominal thickness of 5 mm; and, (B2) the porous main body of the repair coat marked as #3 consisting of mixed sea shell and silica sand and porous Portland cement paste, having a nominal thickness of 12 mm;

(C) The paint and mortar topping protective layers were applied over the **main concrete body**, which

has (C1) a thin dense dark gray, carbonated finished surface region, marked as #4 having a nominal thickness of 5 mm, above (C2) the main concrete body marked as # 5, of 150 mm recovered length, containing crushed gravel coarse aggregate, natural siliceous sand fine aggregate, Portland cement paste, and many interstitial voids where pore spaces and voids are highlighted by blue epoxy.

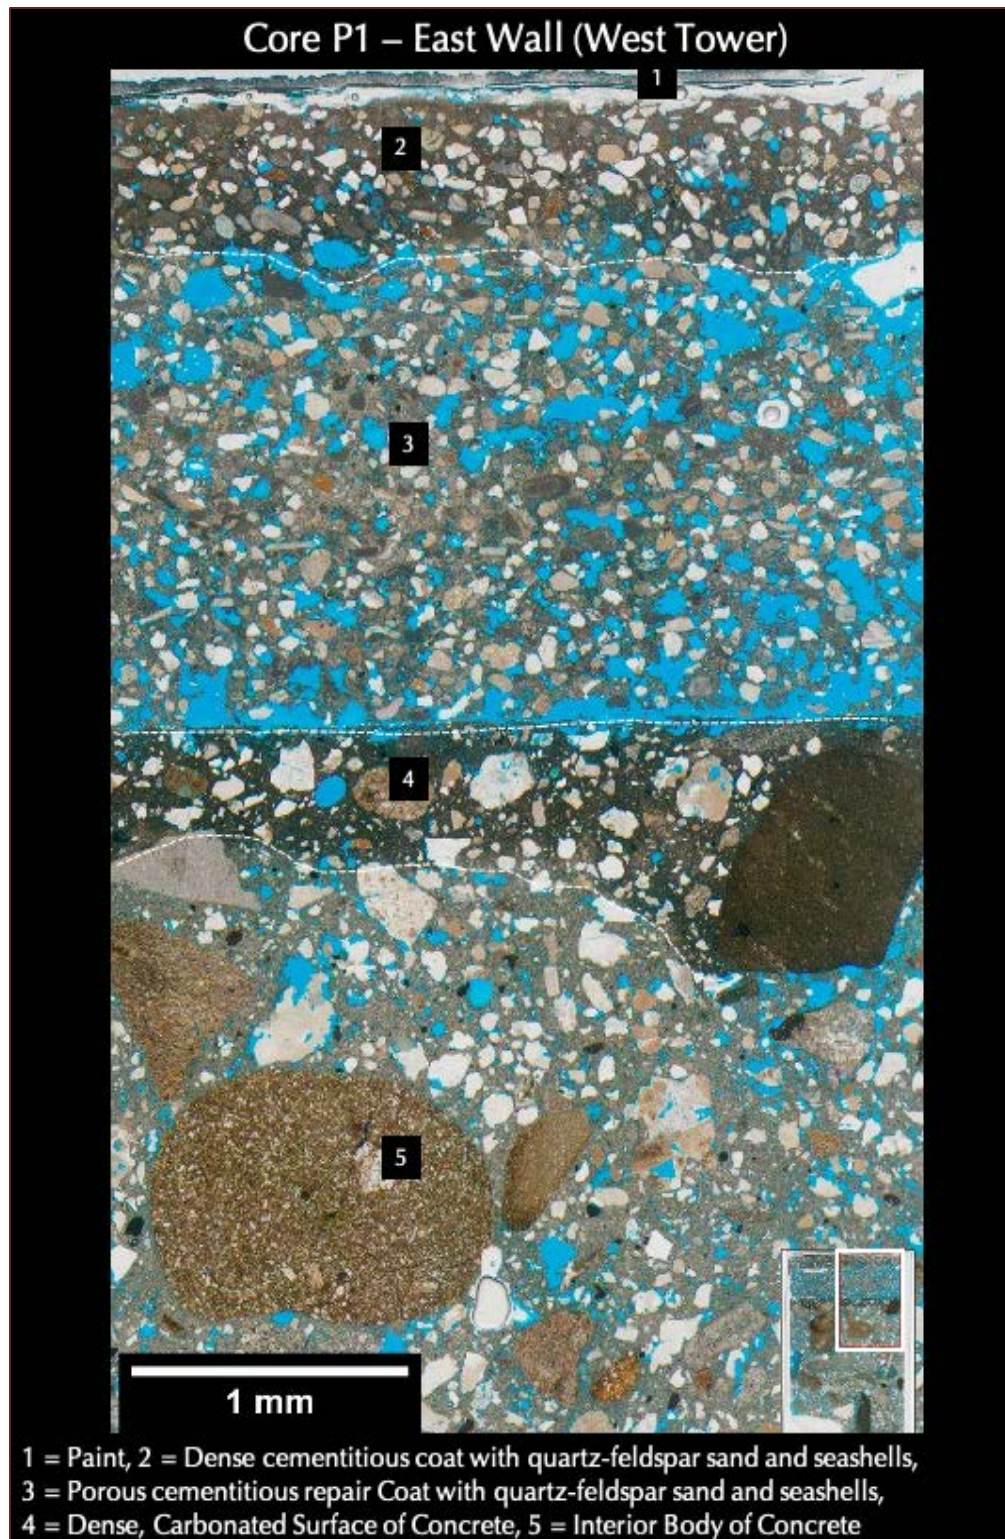
Figure 15: Blue dye-mixed epoxy-impregnated thin section of Core P-1 from West Wall seen in PPL mode scanned with a transmitted-light stereozoom microscope with polarizing light facilities showing:

(A) The **paint coat** consisting of: a thin, dark gray, acrylic paint coat at the very top marked as #1 having a nominal thickness of <0.5 mm; and,

(B) The **mortar topping** consisting of: (B1) a dense, carbonated cementitious coat of Portland cement and mixed seashells and silica sand of <1 mm size in a layer marked as #2 having a nominal thickness of 5 mm; and, (B2) the porous main body of the repair coat marked as #3 consisting of mixed seashells and silica sand and porous Portland cement paste, having a nominal thickness of 12 mm;

(C) The paint and mortar topping protective layers were applied over the **main concrete body**, which has (C1) a thin dense dark gray, carbonated finished surface region, marked as #4 having a nominal

thickness of 5 mm, above (C2) the main concrete body marked as #5, of 150 mm recovered length, containing crushed gravel coarse aggregate, natural siliceous sand fine aggregate, Portland cement paste, and many interstitial voids where pore spaces and voids are highlighted by blue epoxy.

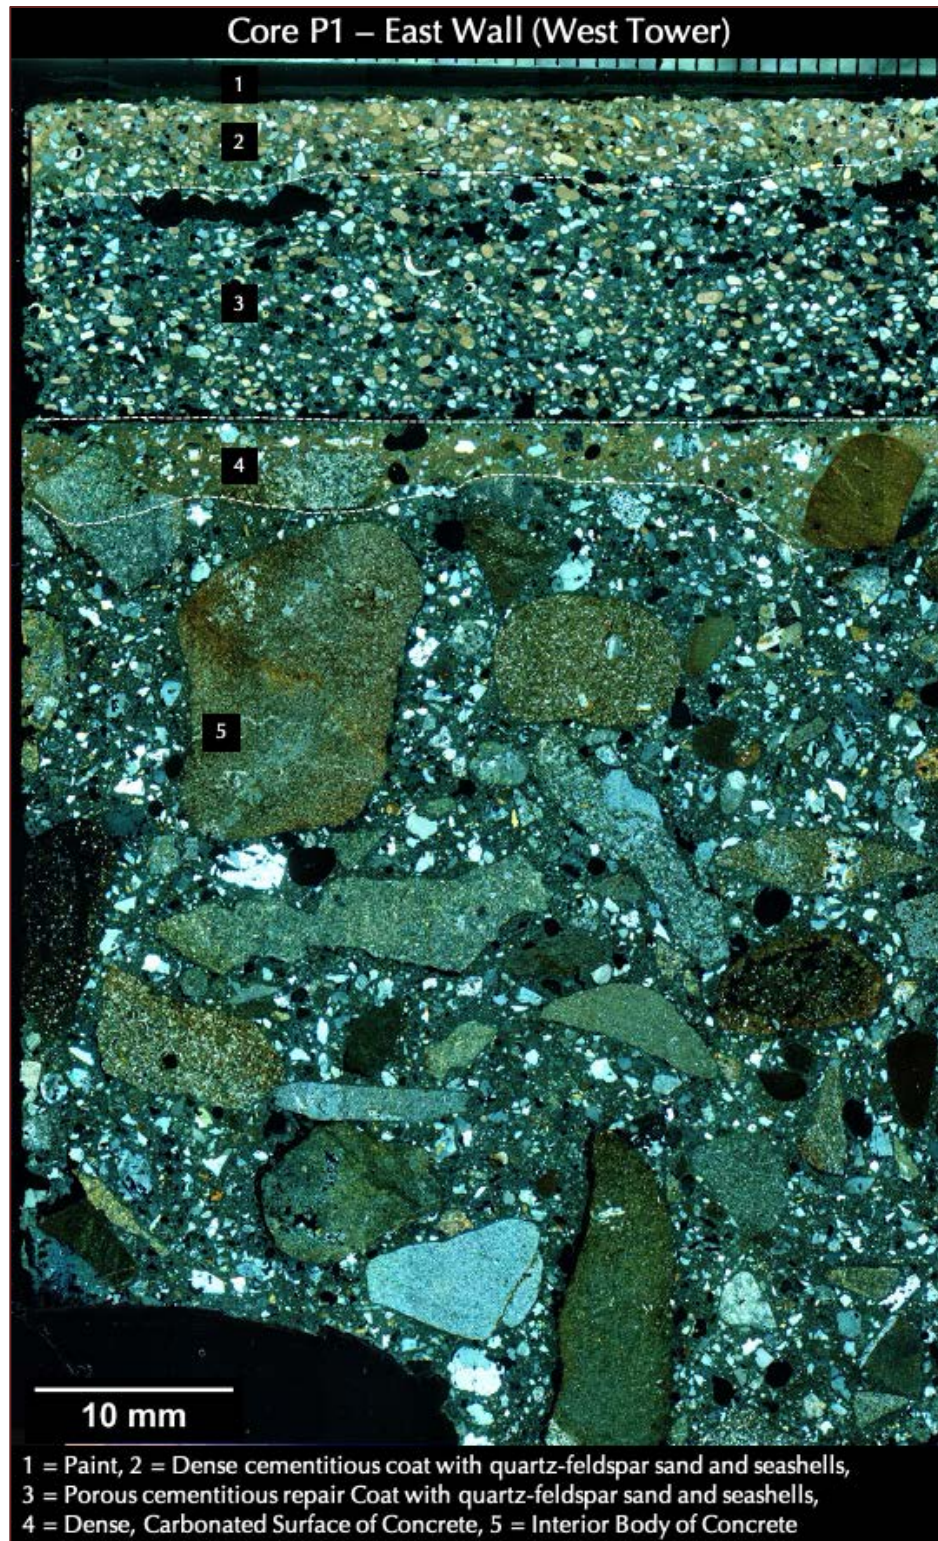
Figure 16: Blue dye-mixed epoxy-impregnated thin section of Core P-1 from West Wall seen in XPL mode scanned with a transmitted-light stereozoom microscope with polarizing light facilities showing:

(A) The **paint coat** consisting of: a thin, dark gray, acrylic paint coat at the very top marked as #1 having a nominal thickness of <0.5 mm; and,

(B) The **mortar topping** consisting of: (B1) a dense, carbonated cementitious coat of Portland cement and mixed seashells and silica sand of <1 mm size in a layer marked as #2 having a nominal thickness of 5 mm; and, (B2) the porous main body of the repair coat marked as #3 consisting of mixed seashells and silica sand and porous Portland cement paste, having a nominal thickness of 12 mm;

(C) The paint and mortar topping protective layers were applied over the **main concrete body**, which has (C1) a thin dense dark gray, carbonated finished surface region, marked as #4 having a nominal thickness of 5 mm, above (C2) the main concrete body marked as #5, of 150 mm recovered length, containing crushed gravel coarse aggregate, natural siliceous sand fine aggregate, Portland cement paste, and many interstitial voids where pore spaces and voids are highlighted by blue epoxy.

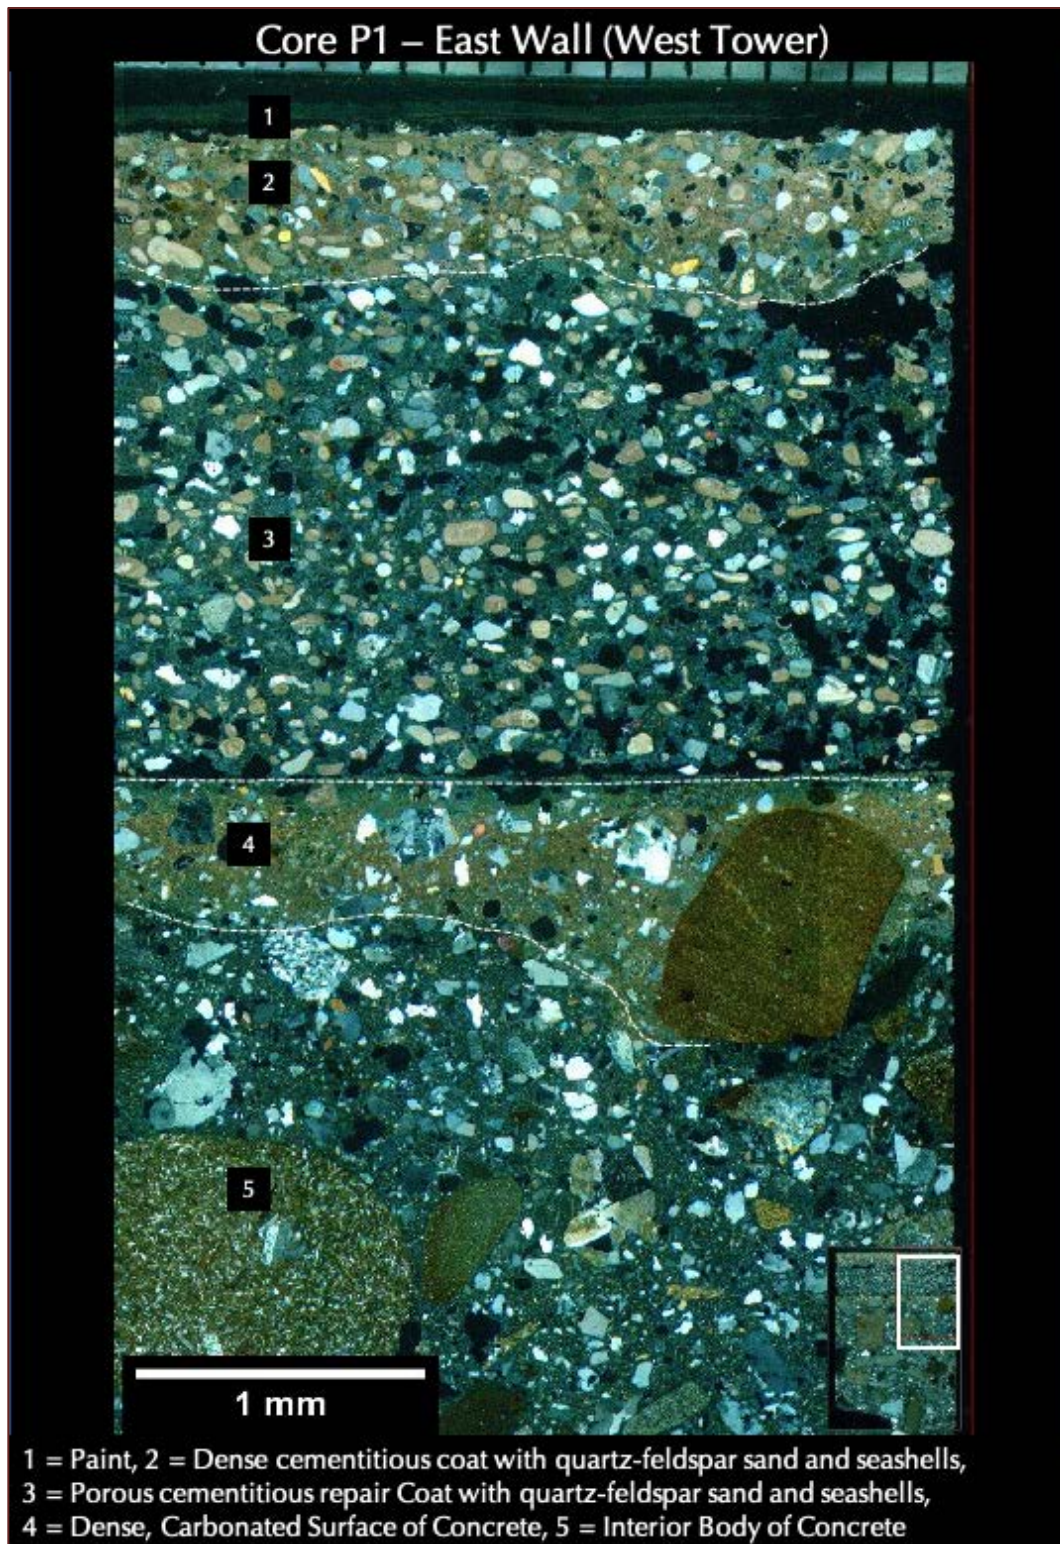
Figure 17: Blue dye-mixed epoxy-impregnated thin section of Core P-1 from West Wall seen in XPL mode scanned with a transmitted-light stereozoom microscope with polarizing light facilities showing:

(A) The **paint coat** consisting of: a thin, dark gray, acrylic paint coat at the very top marked as #1 having a nominal thickness of <0.5 mm; and,

(B) The **mortar topping** consisting of: (B1) a dense, carbonated cementitious coat of Portland cement and mixed seashells and silica sand of <1 mm size in a layer marked as #2 having a nominal thickness of 5 mm; and, (B2) the porous main body of the repair coat marked as #3 consisting of mixed seashells and silica sand and porous Portland cement paste, having a nominal thickness of 12 mm;

(C) The paint and mortar topping protective layers were applied over the **main concrete body**, which has (C1) a thin dense dark gray, carbonated finished surface region,

marked as #4 having a nominal thickness of 5 mm, above (C2) the main concrete body marked as #5, of 150 mm recovered length, containing crushed gravel coarse aggregate, natural siliceous sand fine aggregate, Portland cement paste, and many interstitial voids where pore spaces and voids are highlighted by blue epoxy.

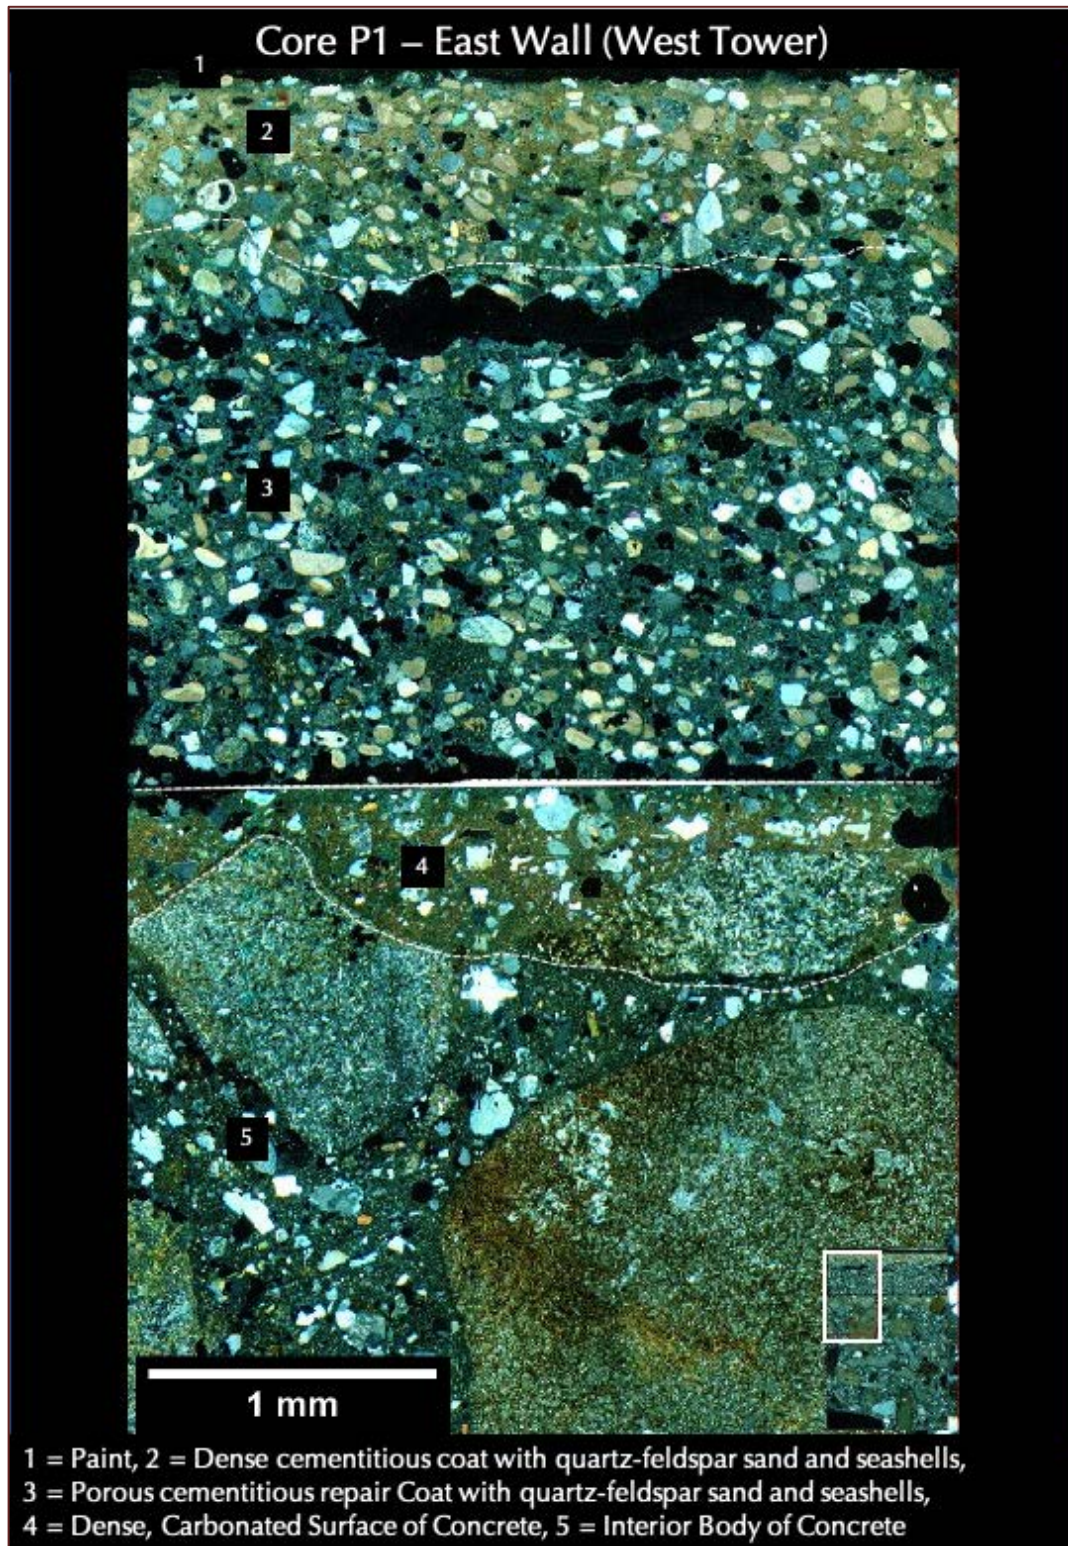
Figure 18: Blue dye-mixed epoxy-impregnated thin section of Core P-1 from West Wall seen in XPL mode scanned with a transmitted-light stereozoom microscope with polarizing light facilities showing:

(A) The **paint coat** consisting of: a thin, dark gray, acrylic paint coat at the very top marked as #1 having a nominal thickness of <0.5 mm; and,

(B) The **mortar topping** consisting of: (B1) a dense, carbonated cementitious coat of Portland cement and mixed seashells and silica sand of <1 mm size in a layer marked as #2 having a nominal thickness of 5 mm; and, (B2) the porous main body of the repair coat marked as #3 consisting of mixed seashells and silica sand and porous Portland cement paste, having a nominal thickness of 12 mm;

(C) The paint and mortar topping protective layers were applied over the **main concrete body**, which

has (C1) a thin dense dark gray, carbonated finished surface region, marked as #4 having a nominal thickness of 5 mm, above (C2) the main concrete body marked as #5, of 150 mm recovered length, containing crushed gravel coarse aggregate, natural siliceous sand fine aggregate, Portland cement paste, and many interstitial voids where pore spaces and voids are highlighted by blue epoxy.

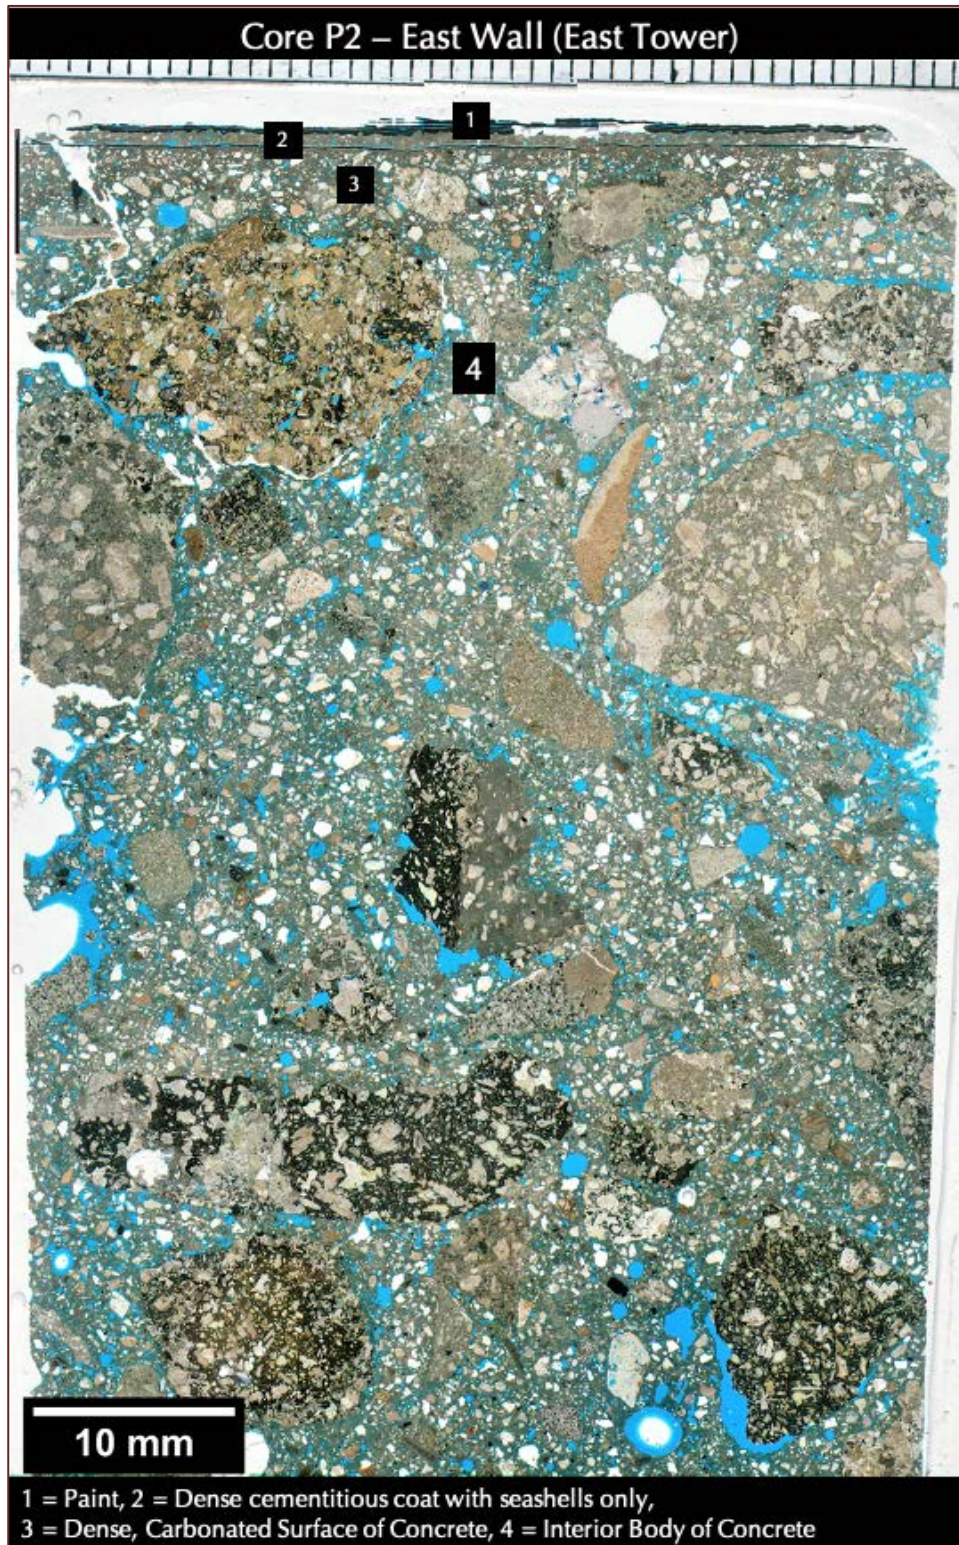
Figure 19: Blue dye-mixed epoxy-impregnated thin section of Core P-2 from East Wall seen in PPL mode scanned with a transmitted-light stereozoom microscope with polarizing light facilities showing:

(A) The top **protective coating** consisting of alternating layers of: (A1) **paint coats** (marked as #1) and (A2) a middle dense, carbonated **cementitious coat** (marked as #2) of Portland cement paste and seashells (<1 mm size) where the cementitious seashell-cement paste coat is sandwiched between two paint coats, altogether applied over

(B) The **main concrete body**. The concrete contains dark gray crushed stone coarse aggregate which is very different from crushed gravel found in Core P-1 from West Wall, natural siliceous sand fine aggregate, Portland cement paste, and some spherical entrained air voids highlighted by blue epoxy indicating marginally air-entrained nature as opposed to non-air-entrained nature of concrete in Core P-1 from West Wall, and overall dense and well-consolidated nature of concrete. Therefore, the concrete used in the East Wall at the core location is from a different mix having different crushed stone coarse aggregate and some air-entraining agent compared to the concrete used in the West Wall at the location of Core P-1. Notice no mortar

topping as seen in P-1 at this P-2 location, but a dense dark gray, carbonated finished top surface region of concrete (marked as #3) as also seen in Core P-1 of the main concrete body (#4).

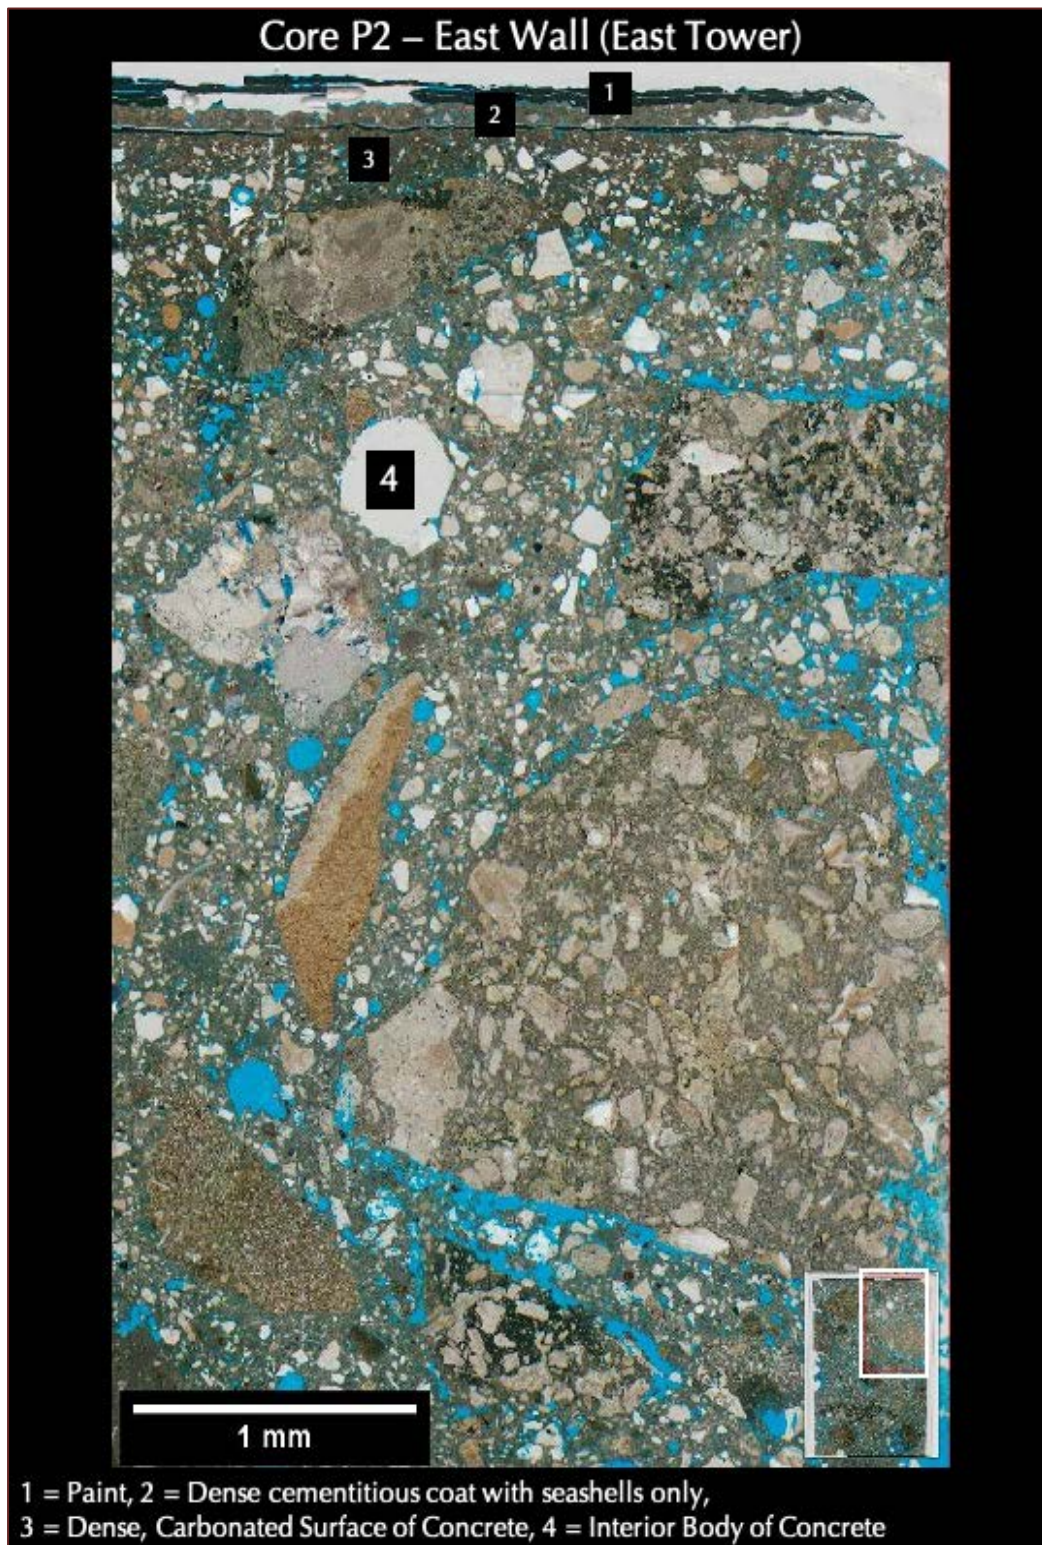
Figure 20: Blue dye-mixed epoxy-impregnated thin section of Core P-2 from East Wall seen in PPL mode scanned with a transmitted-light stereozoom microscope with polarizing light facilities showing:

(A) The top **protective coating** consisting of alternating layers of: (A1) **paint coats** (marked as #1) and (A2) a middle dense, carbonated **cementitious coat** (marked as #2) of Portland cement paste and seashells (<1 mm size) where the cementitious seashell-cement paste coat is sandwiched between two paint coats, altogether applied over

(B) The **main concrete body**. The concrete contains dark gray crushed stone coarse aggregate which is very different from crushed gravel found in Core P-1 from West Wall, natural siliceous sand fine aggregate, Portland cement paste, and some spherical entrained air voids highlighted by blue epoxy indicating marginally air-entrained nature as opposed to non-air-entrained nature of concrete in Core P-1 from West Wall, and overall

dense and well-consolidated nature of concrete. Therefore, the concrete used in the East Wall at the core location is from a different mix having different crushed stone coarse aggregate and some air-entraining agent compared to the concrete used in the West Wall at the location of Core P-1. Notice no mortar topping as seen in P-1 at this P-2 location, but a dense dark gray, carbonated finished top surface region of concrete (marked as #3) as also seen in Core P-1 of the main concrete body (#4).

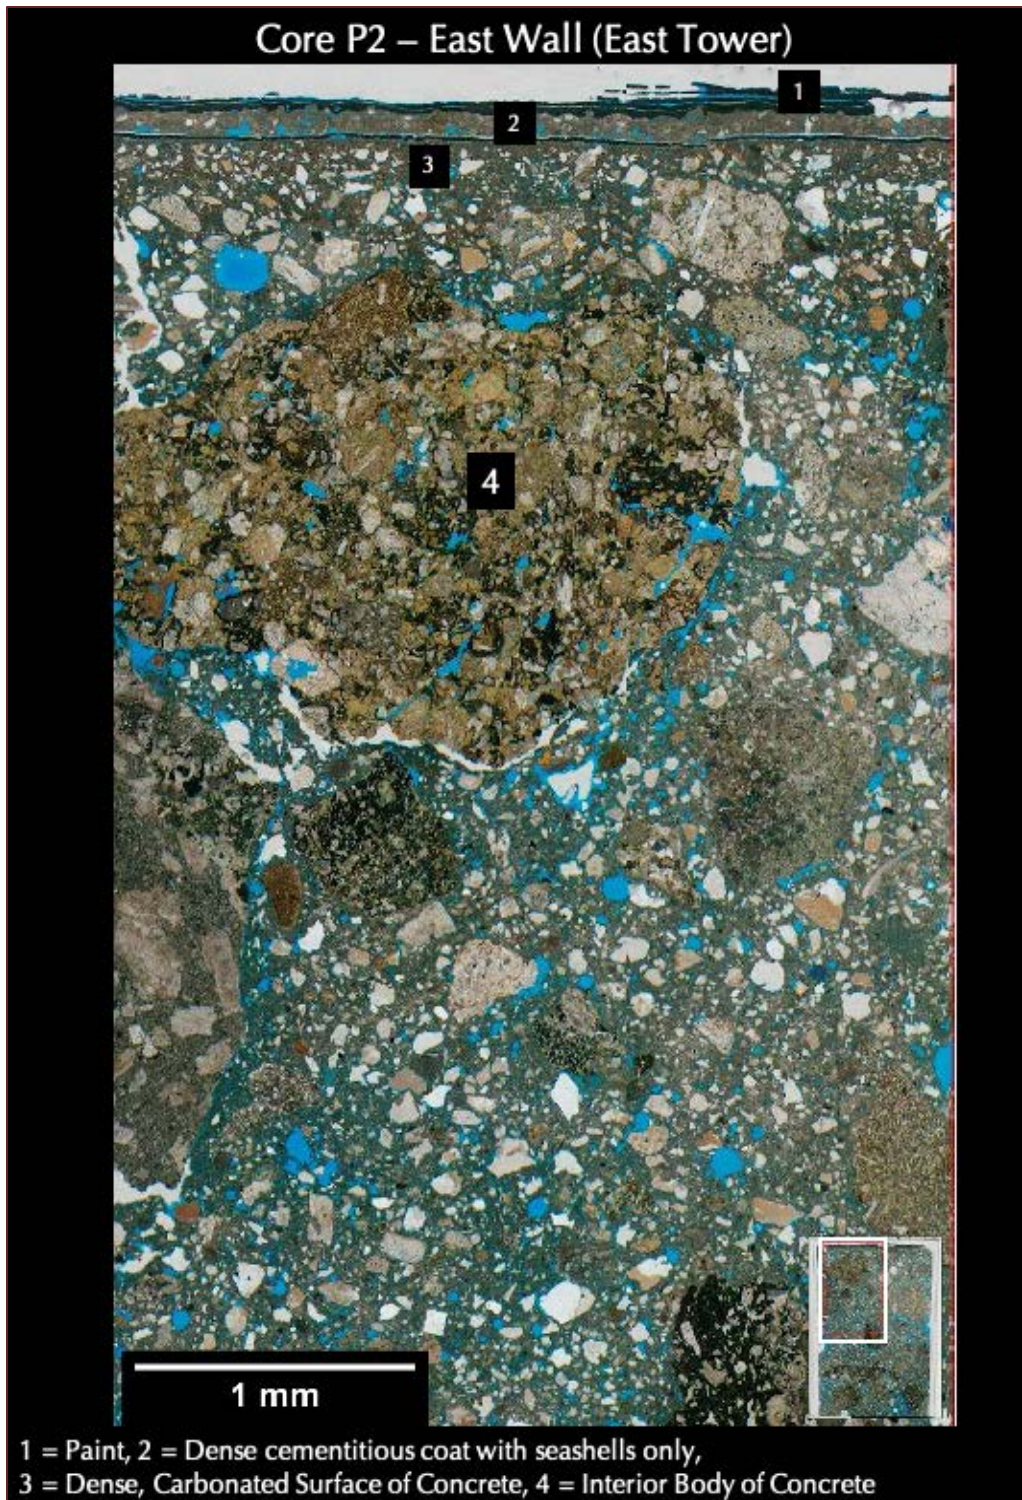
Figure 21: Blue dye-mixed epoxy-impregnated thin section of Core P-2 from East Wall seen in PPL mode scanned with a transmitted-light stereozoom microscope with polarizing light facilities showing:

(A) The top **protective coating** consisting of alternating layers of: (A1) **paint coats** (marked as #1) and a (A2) middle dense, carbonated **cementitious coat** (marked as #2) of Portland cement paste and seashells (<1 mm size) where the cementitious seashell-cement paste coat is sandwiched between two paint coats, altogether applied over

(B) The **main concrete body**. The concrete contains dark gray crushed stone coarse aggregate which is very different from crushed gravel found in Core P-1 from West Wall, natural siliceous sand fine aggregate, Portland cement paste, and some spherical entrained air voids highlighted by blue epoxy indicating marginally air-entrained nature as opposed to non-air-entrained nature of concrete in Core P-1 from West Wall, and overall

dense and well-consolidated nature of concrete. Therefore, the concrete used in the East Wall at the core location is from a different mix having different crushed stone coarse aggregate and some air-entraining agent compared to the concrete used in the West Wall at the location of Core P-1. Notice no mortar topping as seen in P-1 at this P-2 location, but a dense dark gray, carbonated finished top surface region of concrete (marked as #3) as also seen in Core P-1 of the main concrete body (#4).

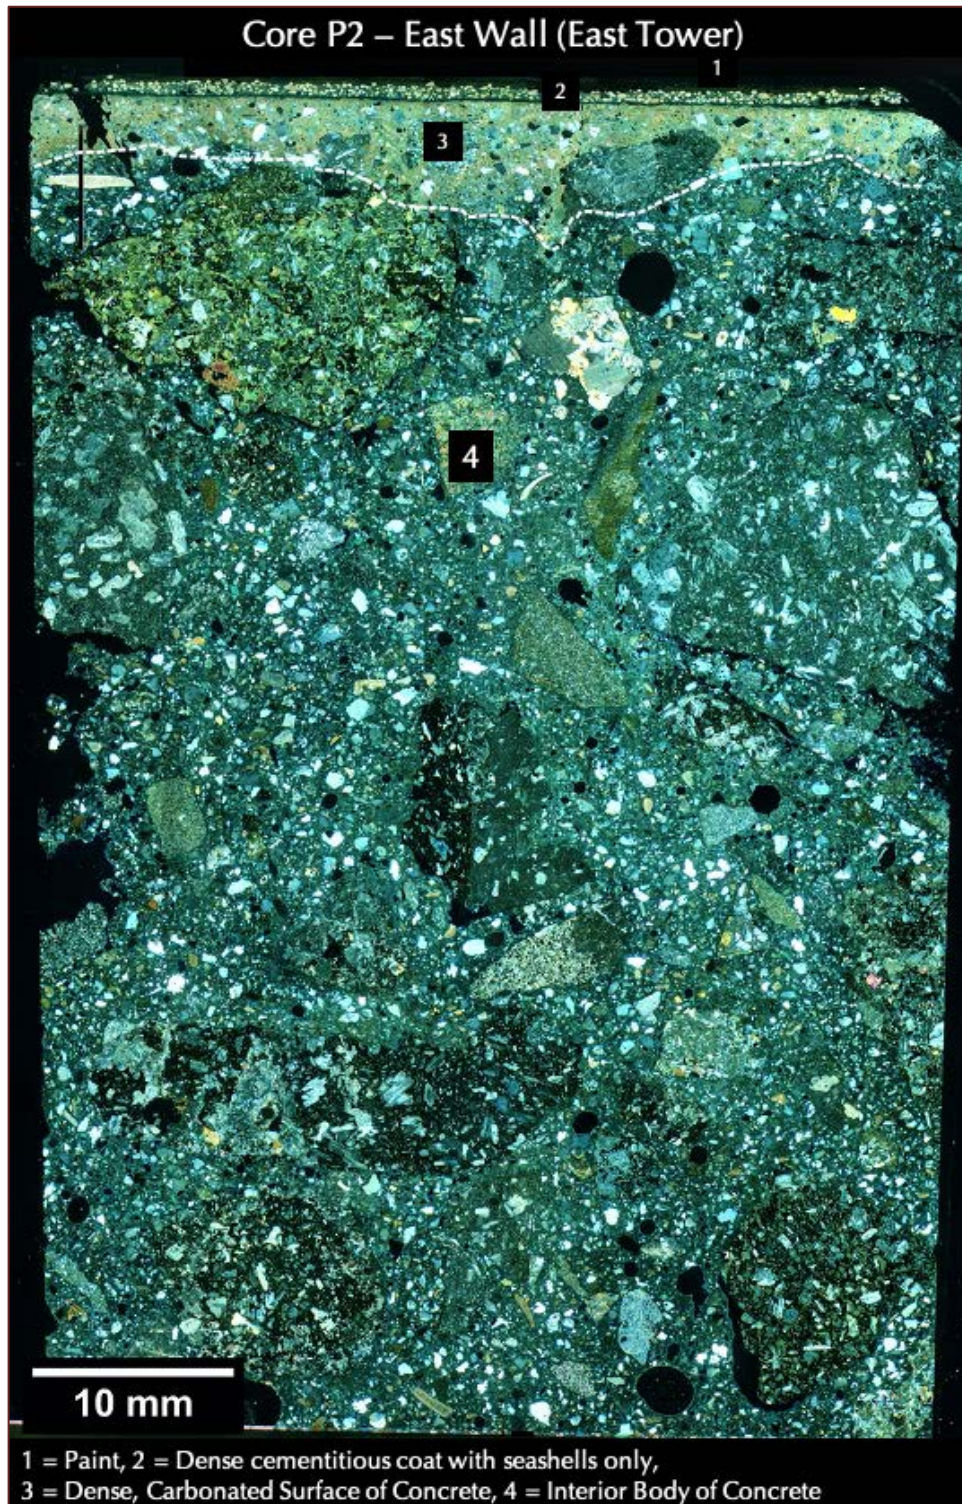
Figure 22: Blue dye-mixed epoxy-impregnated thin section of Core P-2 from East Wall seen in XPL mode scanned with a transmitted-light stereozoom microscope with polarizing light facilities showing:

(A) The top **protective coating** consisting of alternating layers of: (A1) **paint coats** (marked as #1) and (A2) a middle dense, carbonated **cementitious coat** (marked as #2) of Portland cement paste and seashells (<1 mm size) where the cementitious seashell-cement paste coat is sandwiched between two paint coats, altogether applied over

(B) The **main concrete body**. The concrete contains dark gray crushed stone coarse aggregate which is very different from crushed gravel found in Core P-1 from West Wall, natural siliceous sand fine aggregate, Portland cement paste, and some spherical entrained air voids highlighted by blue epoxy indicating marginally air-entrained nature as opposed to non-air-entrained nature of concrete in Core P-1 from West Wall, and overall dense and well-consolidated nature of

concrete. Therefore, the concrete used in the East Wall at the core location is from a different mix having different crushed stone coarse aggregate and some air-entraining agent compared to the concrete used in the West Wall at the location of Core P-1. Notice no mortar topping as seen in P-1 at this P-2 location, but a dense dark gray, carbonated finished top surface region of concrete (marked as #3) as also seen in Core P-1 of the main concrete body (#4).

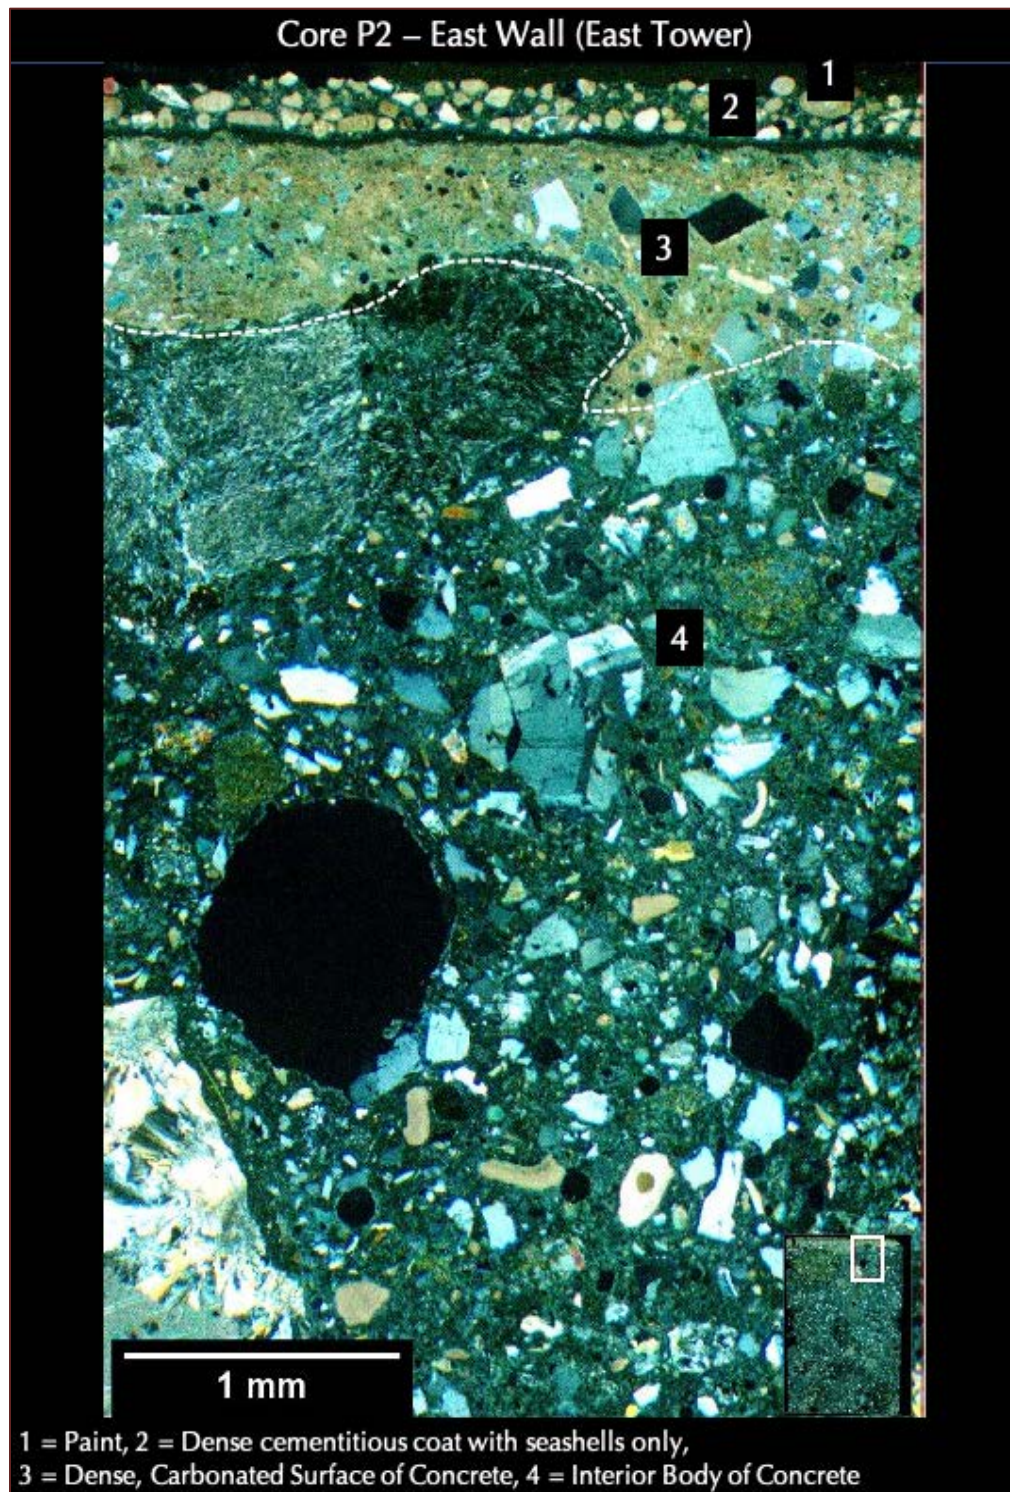
Figure 23: Blue dye-mixed epoxy-impregnated thin section of Core P-2 from East Wall seen in XPL mode scanned with a transmitted-light stereozoom microscope with polarizing light facilities showing:

(A) The top **protective coating** consisting of alternating layers of: (A1) **paint coats** (marked as #1) and (A2) a middle dense, carbonated **cementitious coat** (marked as #2) of Portland cement paste and seashells (<1 mm size) where the cementitious seashell-cement paste coat is sandwiched between two paint coats, altogether applied over

(B) The **main concrete body**. The concrete contains dark gray crushed stone coarse aggregate which is very different from crushed gravel found in Core P-1 from West Wall, natural siliceous sand fine aggregate, Portland cement paste, and some spherical entrained air voids highlighted by blue epoxy indicating marginally air-entrained nature as opposed to

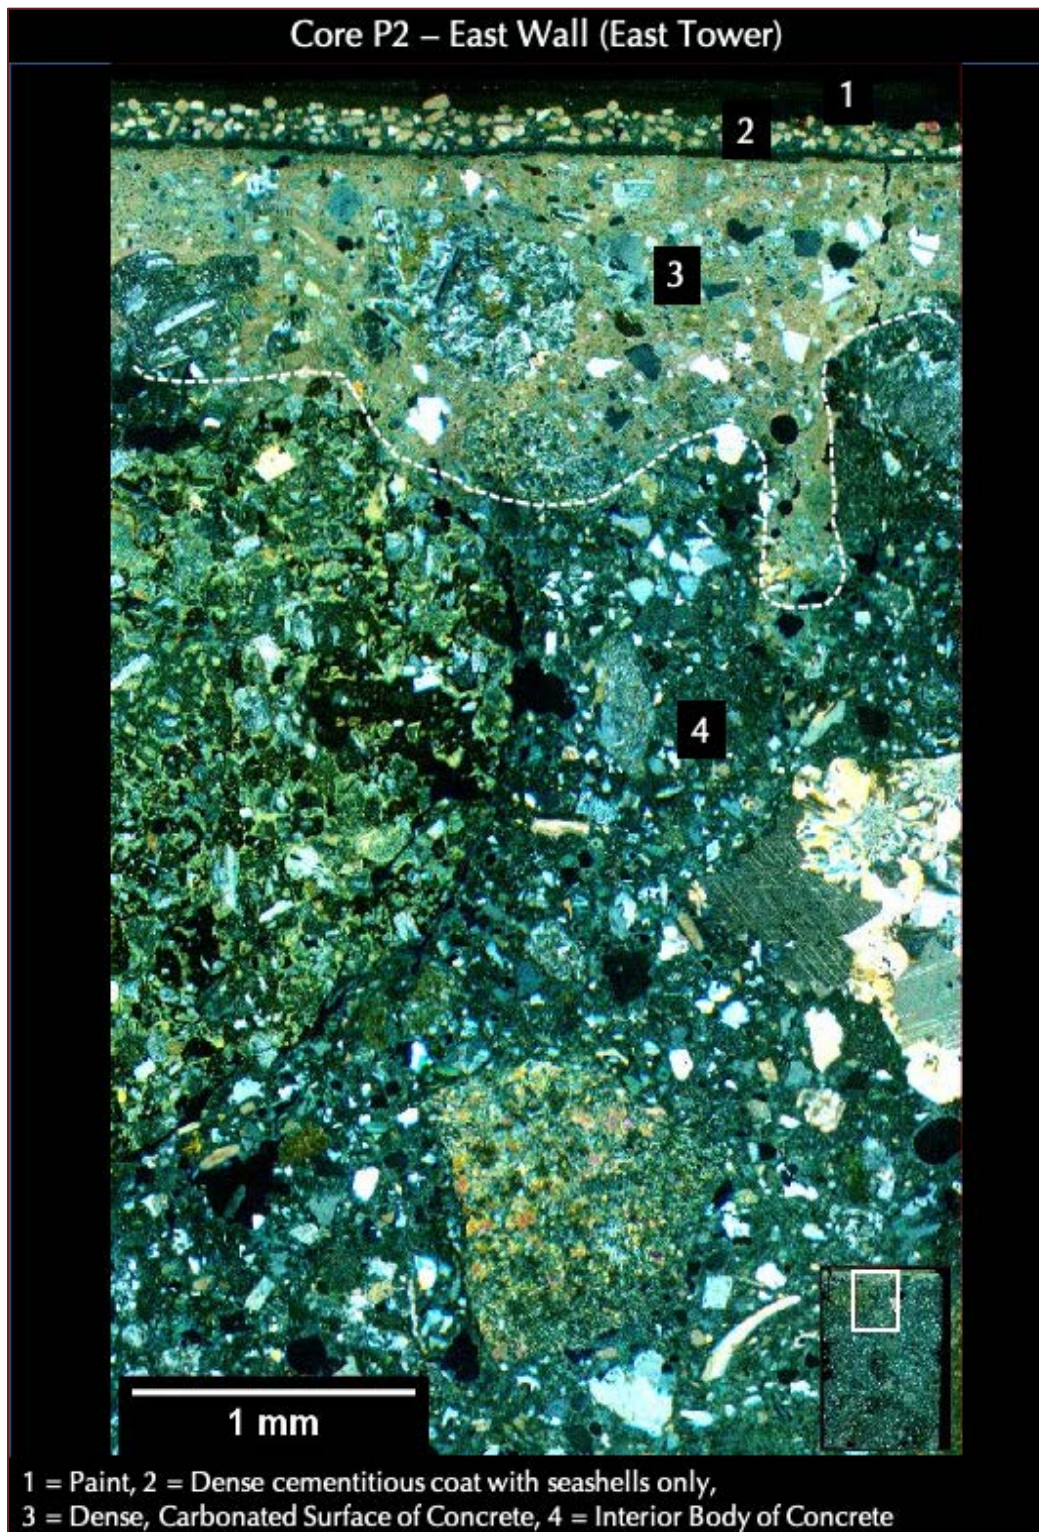
Figure 24: Blue dye-mixed epoxy-impregnated thin section of Core P-2 from East Wall seen in XPL mode scanned with a transmitted-light stereozoom microscope with polarizing light facilities showing:

(A) The top **protective coating** consisting of alternating layers of: (A1) **paint coats** (marked as #1) and (A2) a middle dense, carbonated **cementitious coat** (marked as #2) of Portland cement paste and seashells (<1 mm size) where the cementitious seashell-cement paste coat is sandwiched between two paint coats, altogether applied over

(B) The **main concrete body**. The concrete contains dark gray crushed stone coarse aggregate which is very different from crushed gravel found in Core P-1 from West Wall, natural siliceous sand fine aggregate, Portland cement paste, and some spherical entrained air voids highlighted by blue epoxy indicating marginally air-entrained nature as opposed to

non-air-entrained nature of concrete in Core P-1 from West Wall, and overall dense and well-consolidated nature of concrete. Therefore, the concrete used in the East Wall at the core location is from a different mix having different crushed stone coarse aggregate and some air-entraining agent compared to the concrete used in the West Wall at the location of Core P-1. Notice no mortar topping as seen in P-1 at this P-2 location, but a dense dark gray, carbonated finished top surface region of concrete (marked as #3) as also seen in Core P-1 of the main concrete body (#4).
