Investigation of Reinforcing Steel Corrosion-Related Spalling of Balconies in Two 22-Story 1970s Highrise Buildings in an Oceanfront Environment in Luquillo, Puerto Rico

Sandy Hills
Luquillo, PR 00773

August 21, 2020
CMC 0720138

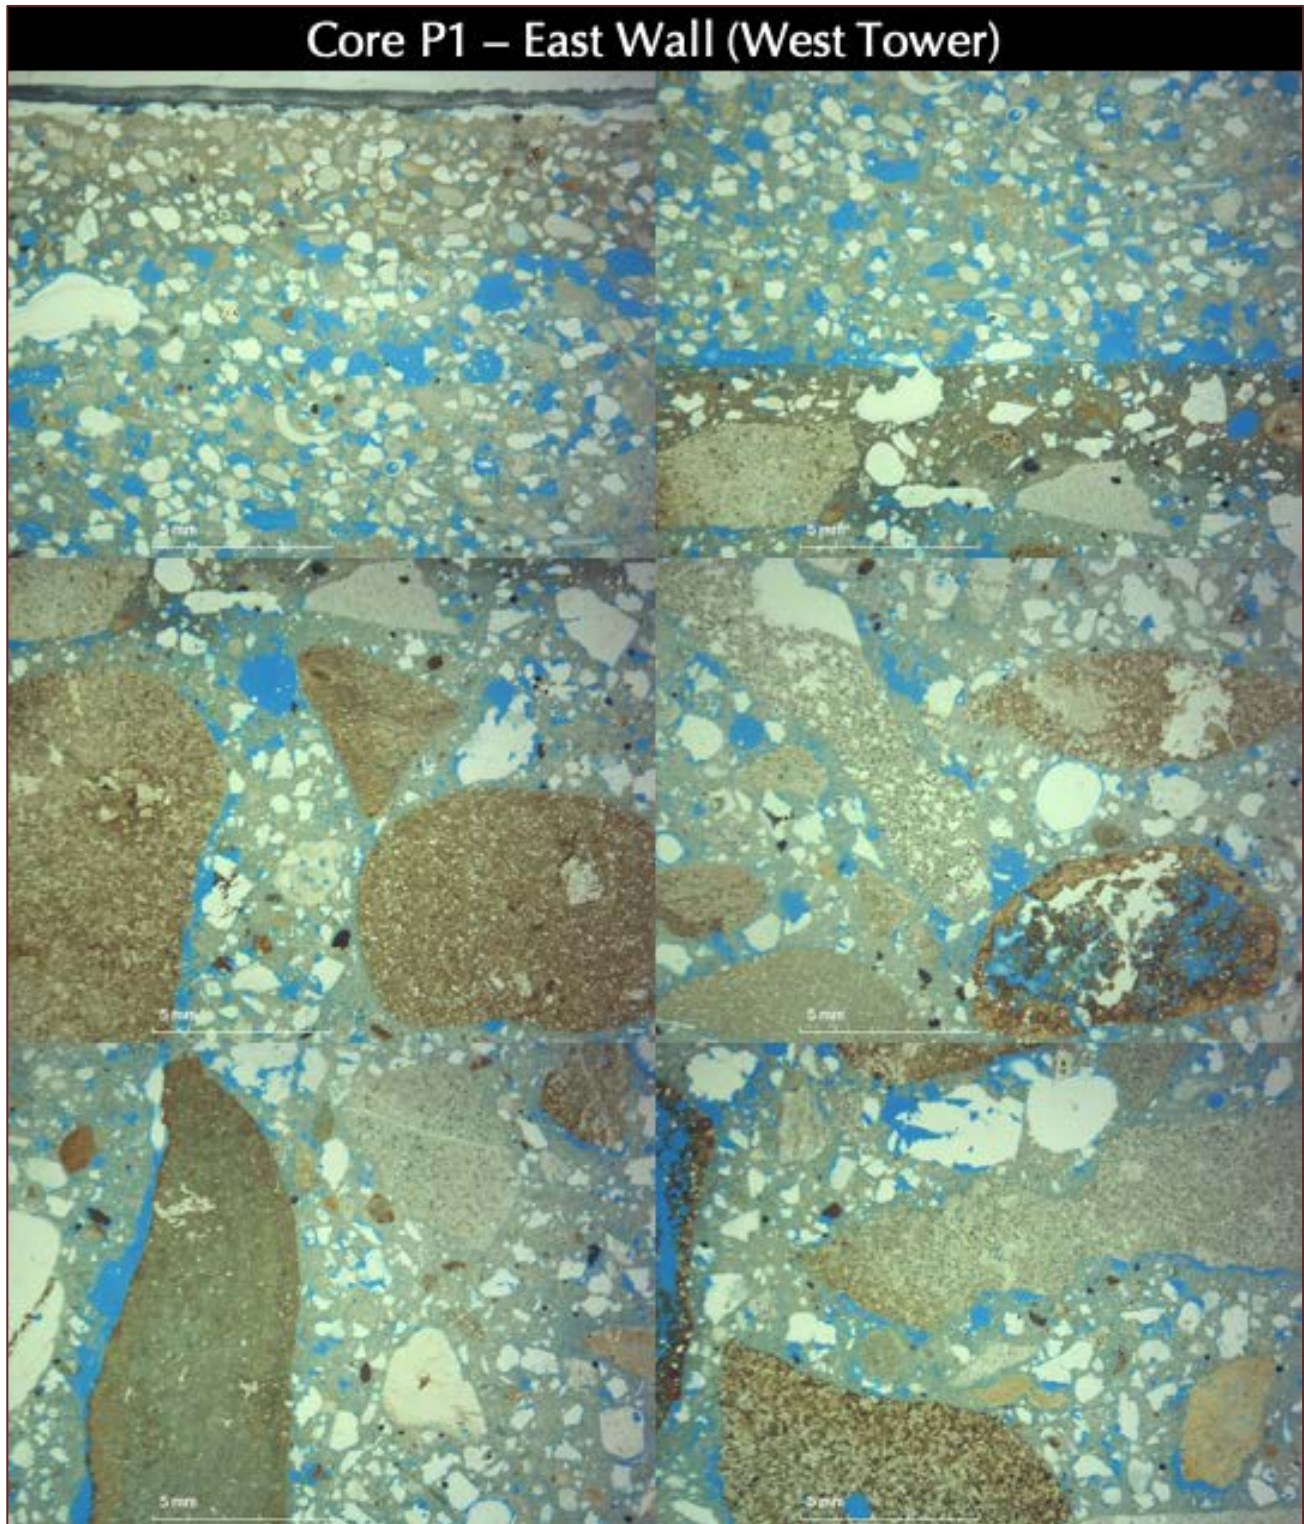
Figure 25: Micrographs of thin section of Core P-1 from West Wall showing the acrylic paint coat, the dense, cementitious coat, the porous repair mortar topping, the densified finished surface region of the main concrete body containing crushed gravel coarse aggregate particles, many of which show the typical volcanic texture and mineralogy of basalt-andesite-trachyte-dacite clan.

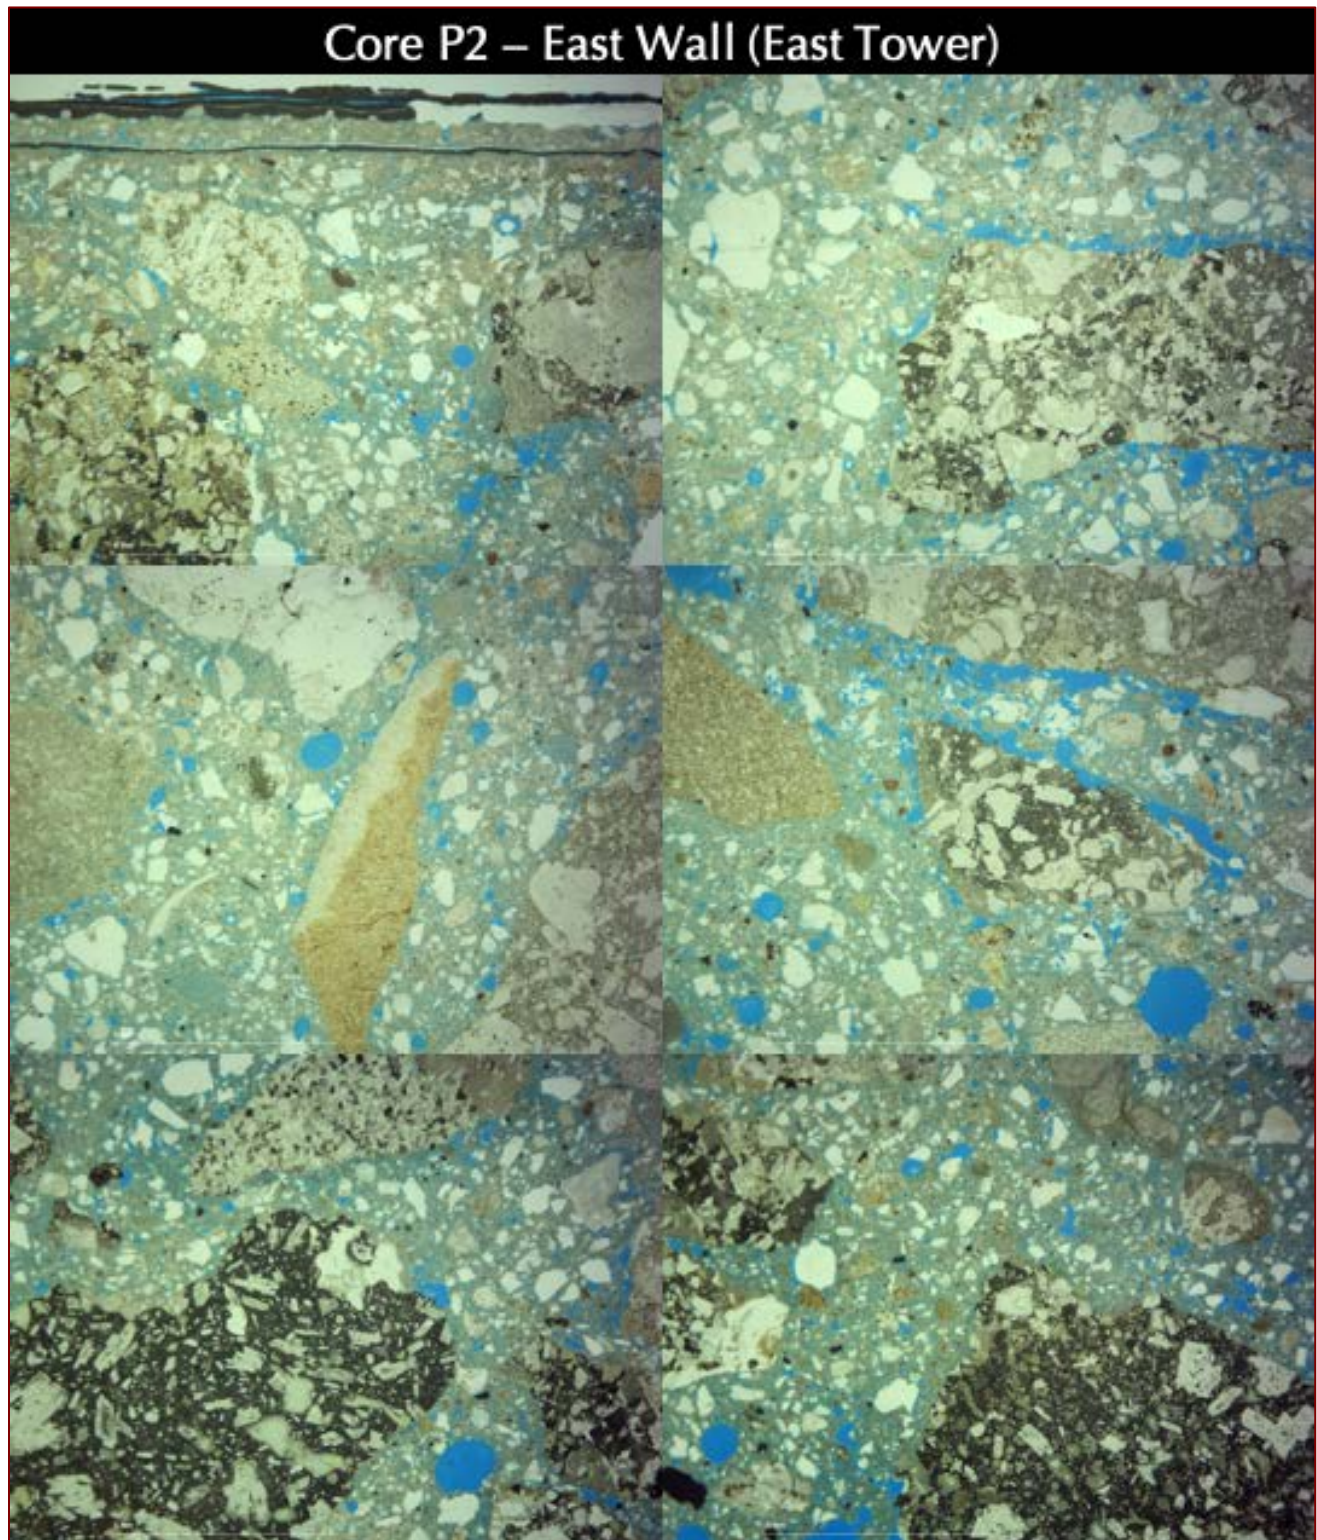
Figure 26: Micrographs of thin section of Core P-2 from East Wall showing the acrylic paint coat, the dense, cementitious coat, the densified finished surface region of the main concrete body containing crushed gravel coarse aggregate particles, many of which show the typical volcanic texture and mineralogy of basalt-andesite-trachyte-dacite clan.

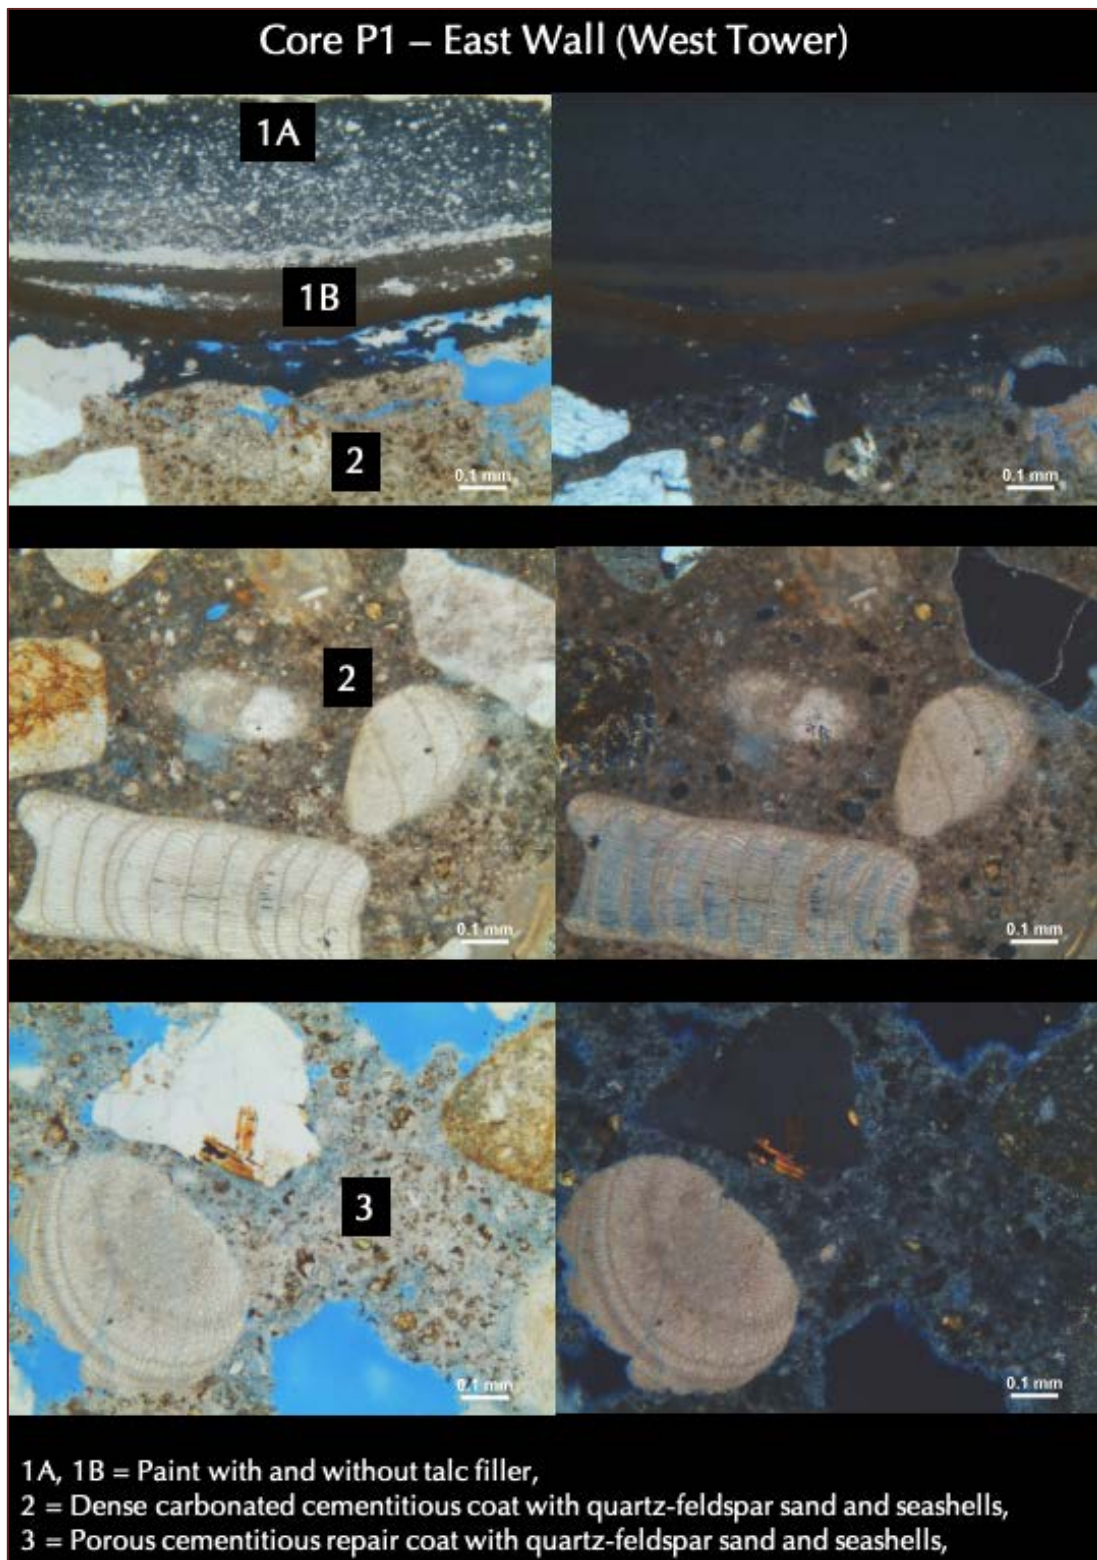
Figure 27:
Micrographs of thin section of Core P-1 from West Wall showing:

(A) The **paint coat** consisting of a thin, dark gray, acrylic paint coat at the very top marked as #1 having a nominal thickness of <0.5 mm, which comprises two different paint coats with (#1A) and without (#1B) talc filler; and,

(B) The **mortar topping** consisting of: (B1) a dense, carbonated cementitious coat of Portland cement and mixed seashells and silica sand of <1 mm size in a layer marked as #2 having a nominal thickness of 5 mm; and, (B2) the porous main body of the repair coat marked as #3 consisting of mixed seashells and silica sand and porous Portland cement paste, having a nominal thickness of 12 mm;

(C) The paint and mortar topping protective layers were applied over the **main concrete body**, which has

(C1) a thin dense dark gray, carbonated finished surface region, marked as #4 having a nominal thickness of 5 mm, above (C2) the main concrete body marked as #5, of 150 mm recovered length, containing crushed gravel coarse aggregate, natural siliceous sand fine aggregate, Portland cement paste, and many interstitial voids where pore spaces and voids are highlighted by blue epoxy. Left and right column photos were taken in PPL and corresponding XPL modes, respectively.

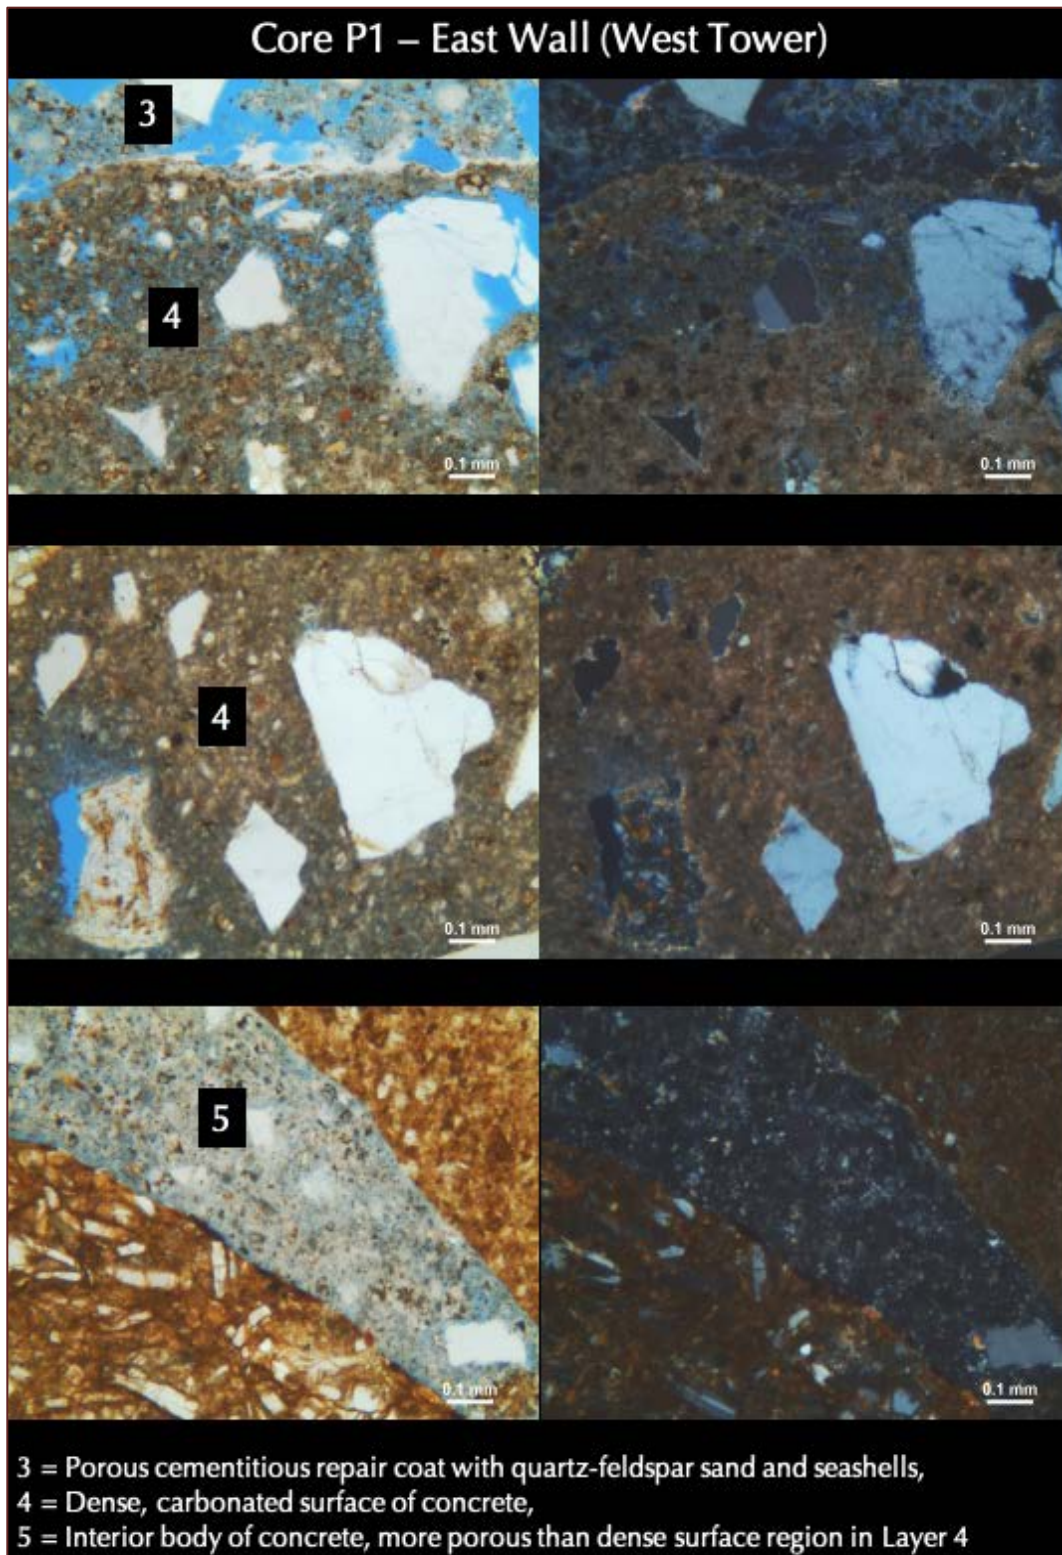
Figure 28: Micrographs of thin section of Core P-1 from West Wall showing:

(A) The **paint coat** consisting of a thin, dark gray, acrylic paint coat at the very top marked as #1 having a nominal thickness of <0.5 mm, which comprises two different paint coats with (#1A) and without (#1B) talc filler; and,

(B) The **mortar topping** consisting of: (B1) a dense, carbonated cementitious coat of Portland cement and mixed seashells and silica sand of <1 mm size in a layer marked as #2 having a nominal thickness of 5 mm; and, (B2) the porous main body of the repair coat marked as #3 consisting of mixed seashells and silica sand and porous Portland cement paste, having a nominal thickness of 12 mm;

(C) The paint and mortar topping protective layers were applied over the **main concrete body**, which has (C1) a thin dense dark gray, carbonated finished surface region, marked as #4 having a nominal thickness of 5 mm, above (C2) the main concrete body marked as #5, of 150 mm recovered length,

containing crushed gravel coarse aggregate, which shows the typical volcanic texture and mineralogy of basalt-andesite-trachyte-dacite clan, natural siliceous sand fine aggregate, Portland cement paste, and many interstitial voids where pore spaces and voids are highlighted by blue epoxy. Left and right column photos were taken in PPL and corresponding XPL modes, respectively.

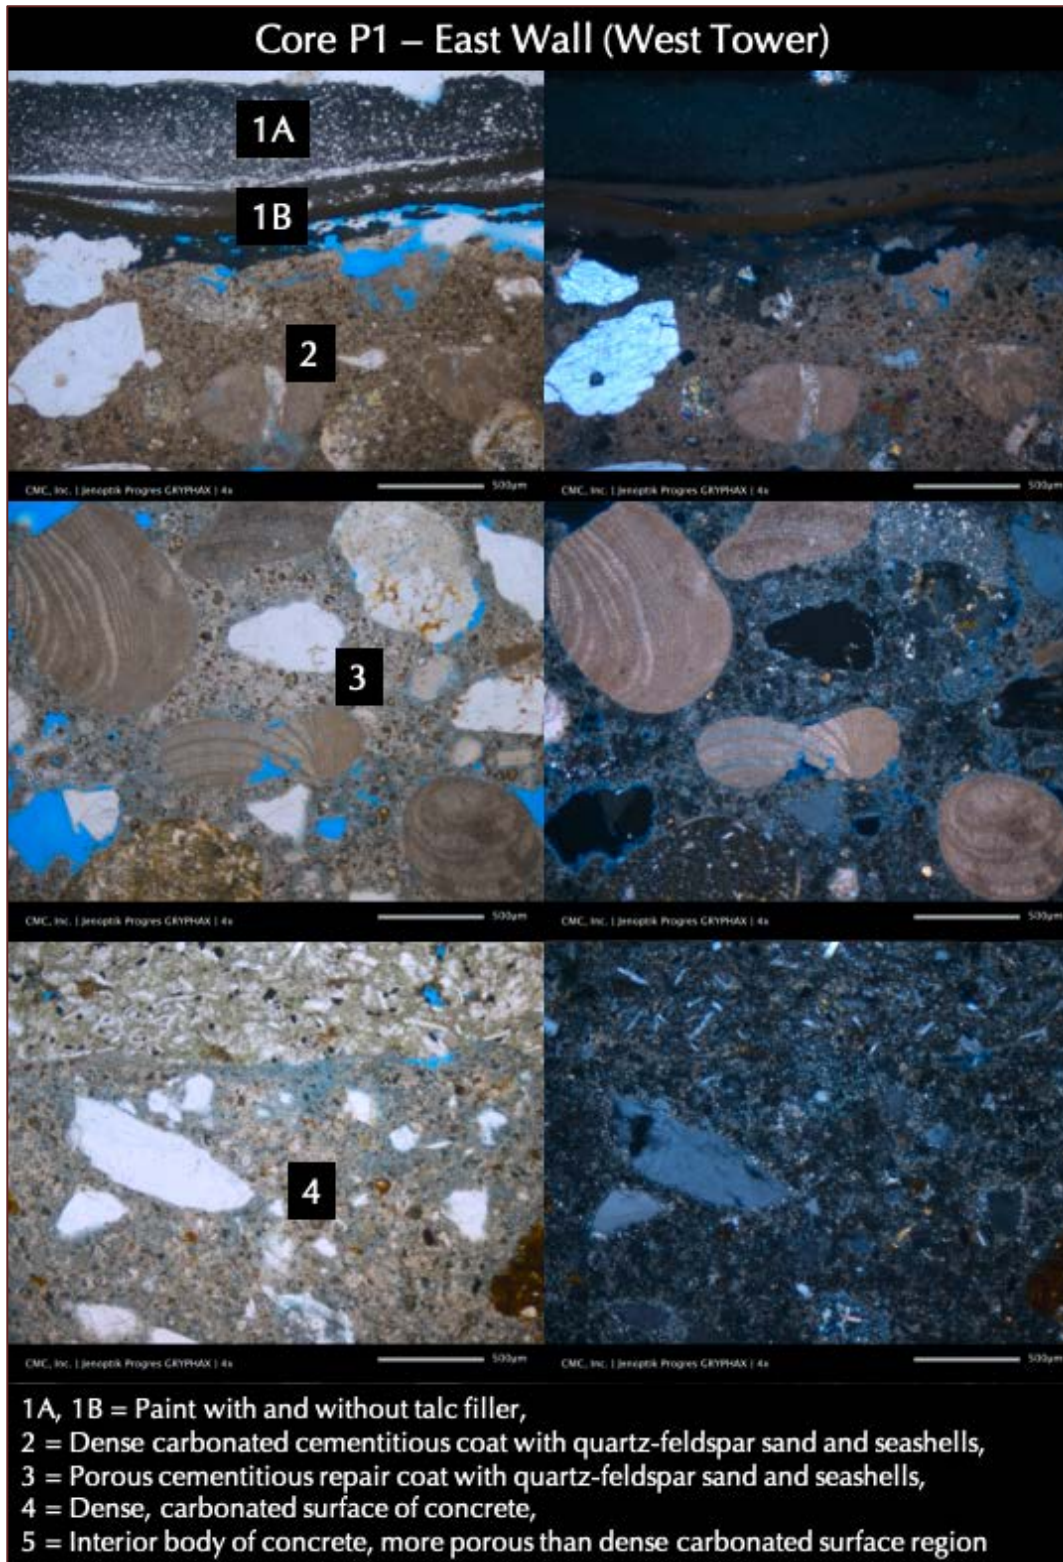
Figure 29: Micrographs of thin section of Core P-1 from West Wall showing:

(A) The **paint coat** consisting of a thin, dark gray, acrylic paint coat at the very top marked as #1 having a nominal thickness of <0.5 mm, which comprises two different paint coats with (#1A) and without (#1B) talc filler; and,

(B) The **mortar topping** consisting of: (B1) a dense, carbonated cementitious coat of Portland cement and mixed seashells and silica sand of <1 mm size in a layer marked as #2 having a nominal thickness of 5 mm; and, (B2) the porous main body of the repair coat marked as #3 consisting of mixed seashells and silica sand and porous Portland cement paste, having a nominal thickness of 12 mm;

(C) The paint and mortar topping protective layers were applied over the **main concrete body**, which has (C1) a thin dense dark gray, carbonated finished surface region, marked as #4 having a nominal thickness of 5 mm, above (C2) the main concrete body marked as #5, of 150 mm recovered length,

containing crushed gravel coarse aggregate, natural siliceous sand fine aggregate, Portland cement paste, and many interstitial voids where pore spaces and voids are highlighted by blue epoxy. Left and right column photos were taken in PPL and corresponding XPL modes, respectively.

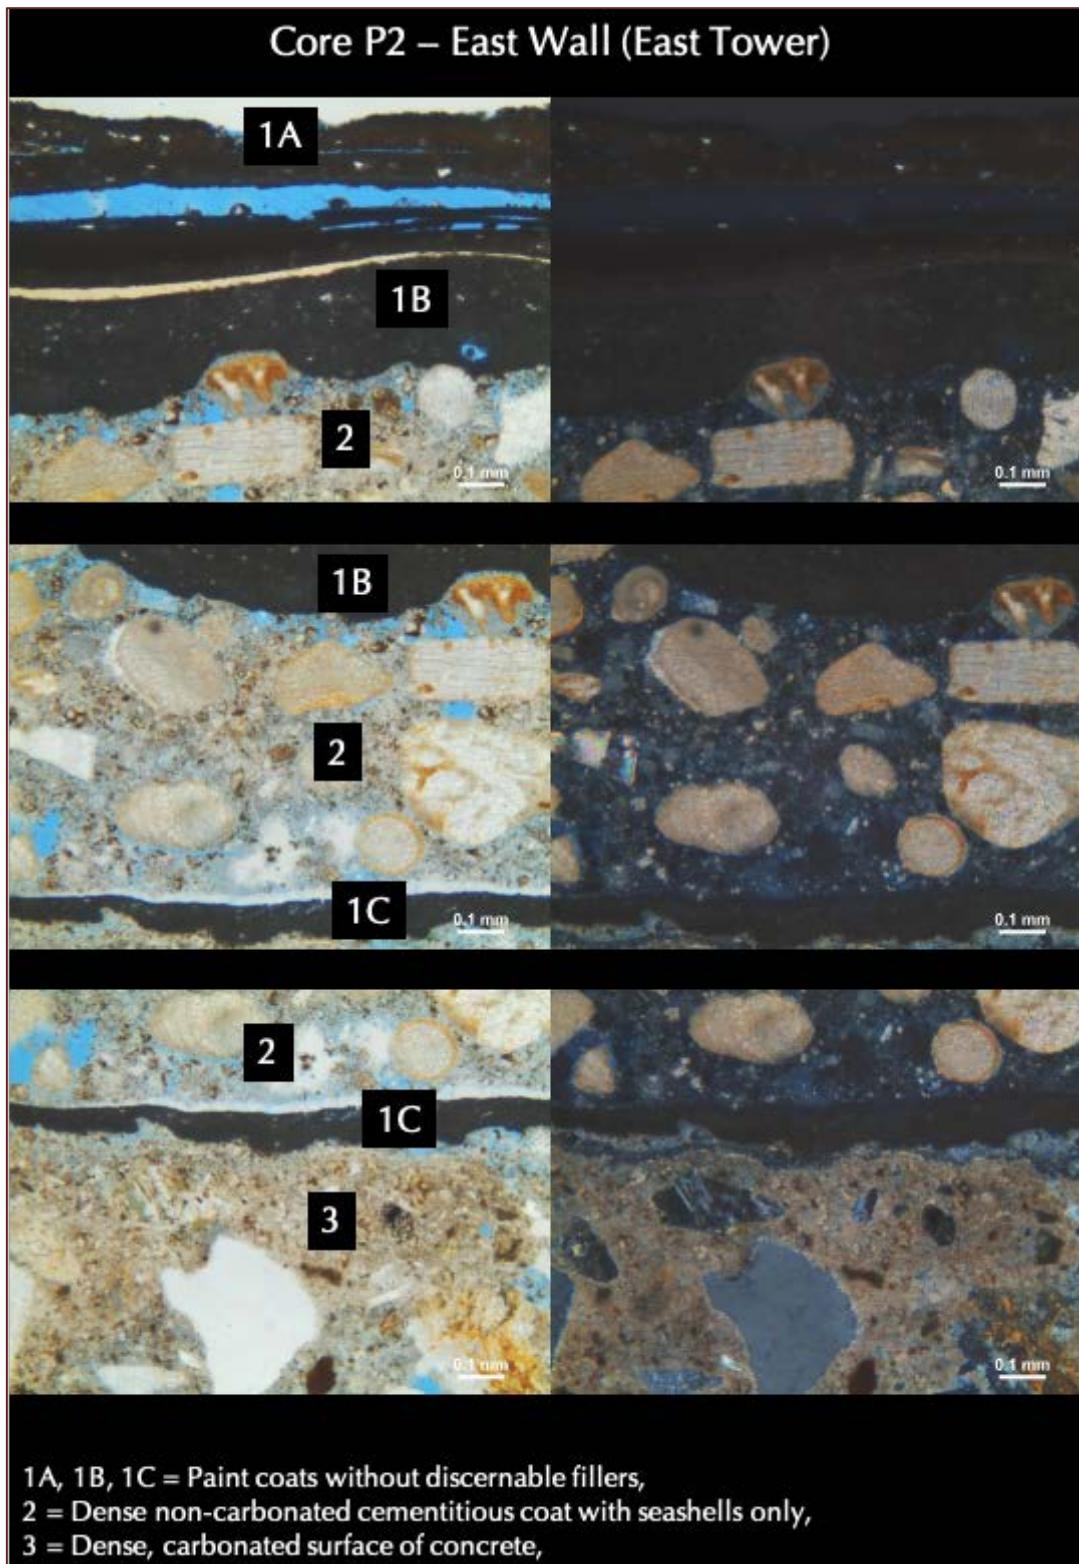
Figure 30:
Micrographs of thin section of Core P-2 from East Wall showing:

(A) The top **protective coating** consisting of alternating layers of: (A1) **paint coats** (marked as #1) and (A2) a middle dense, carbonated **cementitious coat** (marked as #2) of Portland cement paste and seashells (<1 mm size) where the cementitious seashell-cement paste coat is sandwiched between two paint coats (1B and 1C), altogether applied over

(B) The **main concrete body**. The concrete contains dark gray crushed stone coarse aggregate which is very different from crushed gravel found in Core P-1 from West Wall, natural siliceous sand fine aggregate, Portland cement paste, and some spherical entrained air voids highlighted by blue epoxy indicating marginally air-entrained nature as opposed to non-air-entrained nature of concrete in Core P-1 from West Wall, and overall dense and well-

consolidated nature of concrete. Therefore, the concrete used in the East Wall at the core location is from a different mix having different crushed stone coarse aggregate and some air-entraining agent compared to the concrete used in the West Wall at the location of Core P-1. Notice no mortar topping as seen in P-1 at this P-2 location, but a dense dark gray, carbonated finished top surface region of concrete (marked as #3) as also seen in Core P-1 of the main concrete body (#4).

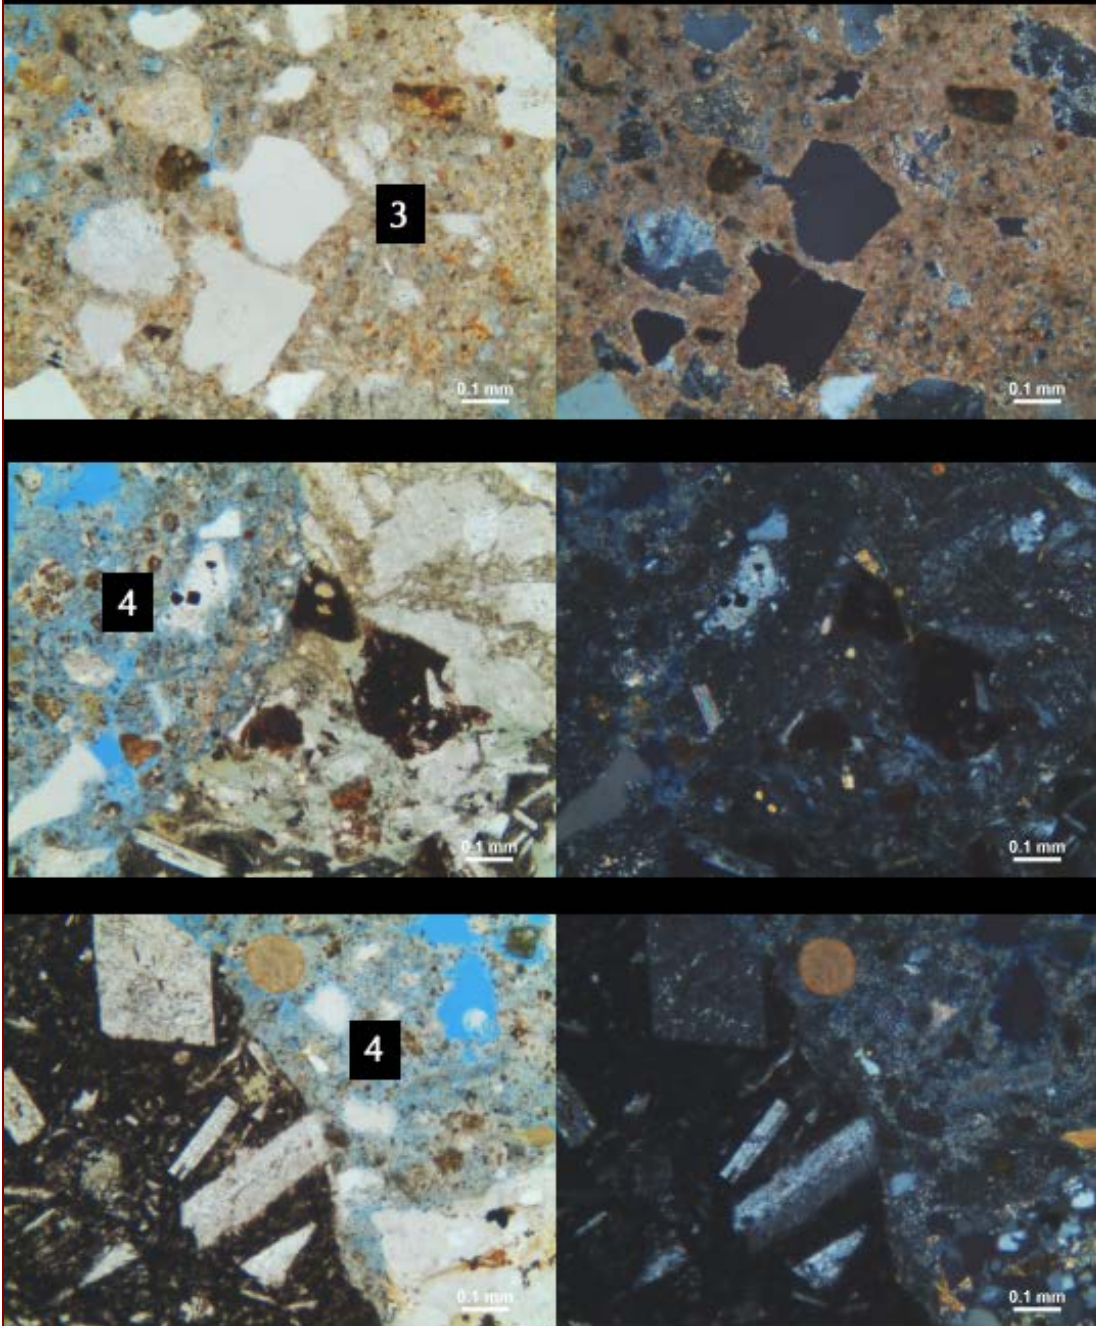
Core P2 – East Wall (East Tower)

3 = Dense, carbonated surface of concrete,
4 = Interior body of concrete, more porous than dense carbonated surface in Layer 3

Figure 31: Micrographs of thin section of Core P-2 from East Wall showing:

(a) The dense, carbonated finished surface region (#3) of

(b) The main concrete body (#4) containing crushed gravel coarse aggregate particles many of which show the typical volcanic texture and mineralogy of basalt-andesite-trachyte-dacite clan.

Left and right column photos were taken in PPL and corresponding XPL modes, respectively.

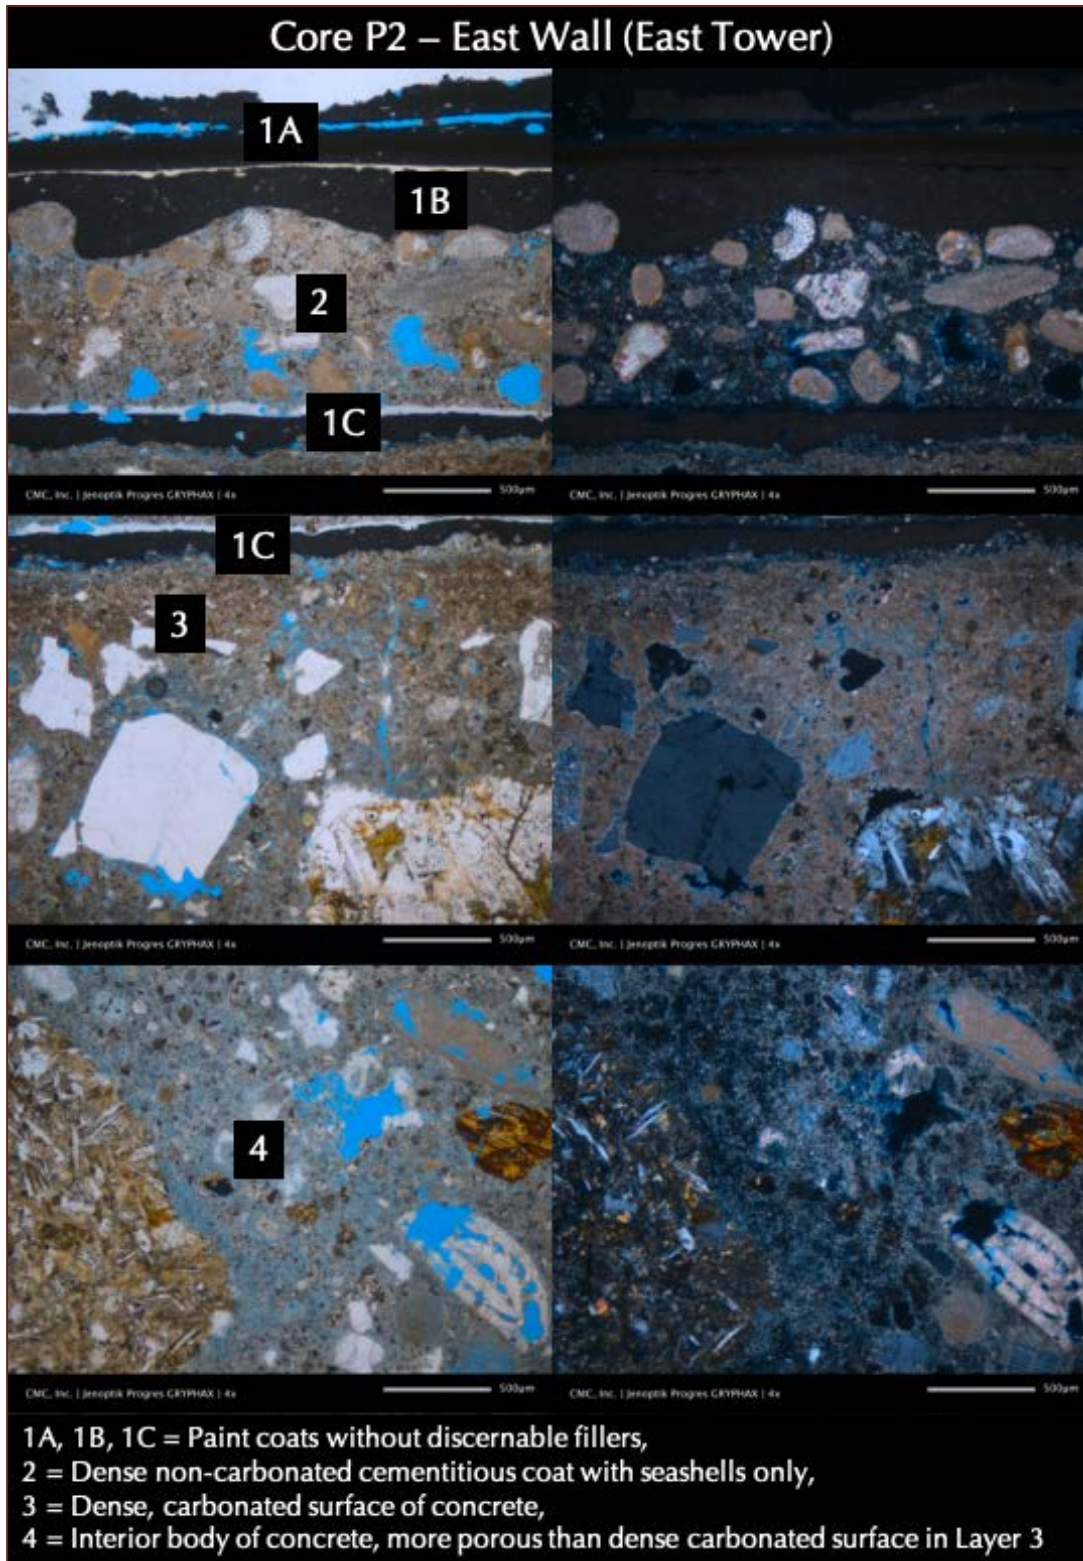
Figure 32:
Micrographs of thin
section of Core P-2
from East Wall
showing:

(a) Two paint coats
(#1A and #1B),
