ACID ATTACK IN A VITRIFIED CLAY PIPE (VCP) SEWER LINE – A PETROGRAPHIC AND CHEMICAL INVESTIGATION

THE DISTRESSED 33-IN. VCP OF THIS STUDY

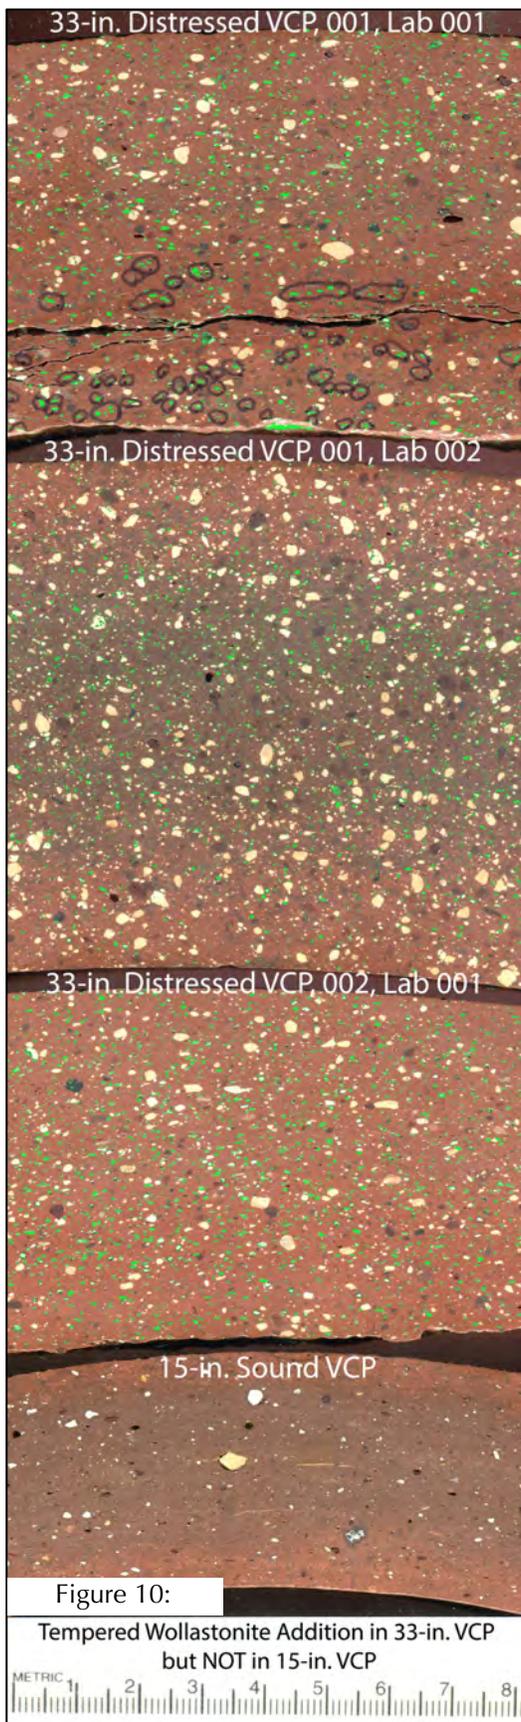
The major difference from the 33-in. distressed pipe samples are in: (a) far lesser abundance of argillaceous clay clots (ACCs) in the 15-in. sample (estimated to be 2.6 percent by volume), compared to as high as 9.6 percent by volume in the 33-in. pipe samples; and (b) absence of tempered wollastonite addition in the older 15-in. pipe, which is prevalent and uniformly distributed throughout the bodies of the 33-in. pipe samples.

Comparison of the lapped cross sections of three 33-in. distressed pipe samples with the 15-in. sound VCP at left clearly shows the *absence of wollastonite addition in the older 15-in. pipe, as opposed to numerous tempered wollastonite crystals (highlighted in green) in the 33-in. pipe samples*. Overall grain-sizes of wollastonite additives are smaller than ACCs and are short prismatic in shape (up to 0.4 mm in long prism lengths) as opposed to mostly equidimensional to some elongated subangular to well-rounded in shape for ACCs (mostly 3 mm in nominal size).
